REPAIR ESTIMATE FOR VOLKSWAGEN JETTA - SKQ 8764 G

VEHICLE DAMAGE INSPECTION REPORT

Claimant Vehicle No: SKQ8764G Insured Vehicle No: XE4149T

Date of Loss: 07/10/2019 Nature of Claim: TP Claim No: SNM19D204758

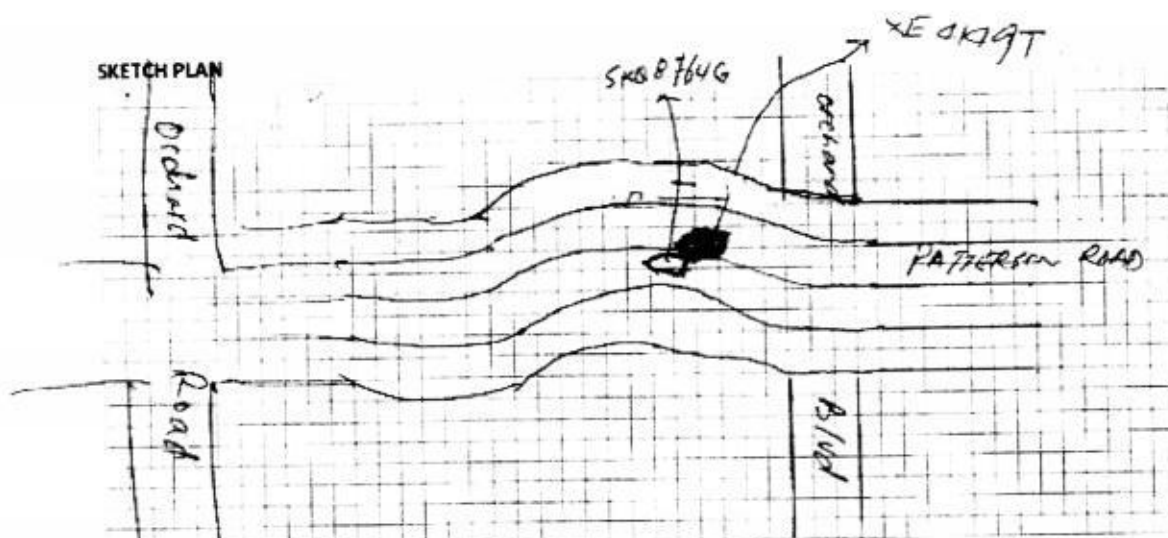
Accident Sketch Plan

THE INCIDENT TOOK PLACE ON THE ABOVEMENTIONED LOCATION. TRAVELLING ON MY LANE. IN THE MIDST OF TRAVELLING, HEARD A LOUD BANG AND IMPACT. VEHICLE B(XE4149T) WANTED TO CHANGE ONTO MY LANE, UNABLE TO CHANGE ON TIME. HIS VEHICLE FRONT LEFT HAND SIDE COLLIDED ONTO MY VEHICLE RIGHT HAND SIDE FENDER AND DOOR. WHICH RESULTED TO SUSTAIN DAMAGED. I HAVE A PASSENGER INSIDE MY CAR SEATED ON THE LEFT HAND SIDE. THAT IS WILLING TO BE MY WITNESS.
