**1. Policy Particulars :- THIRD PARTY CLAIM**

**4. Description of Damages**

THE VEHICLE SUSTAINED DAMAGES AT THE REAR PORTION. DAMAGES SEE DETAILS.
--

### ADJUSTMENT ON REPAIR COST FOR VEHICLE NO. SHA 3557R

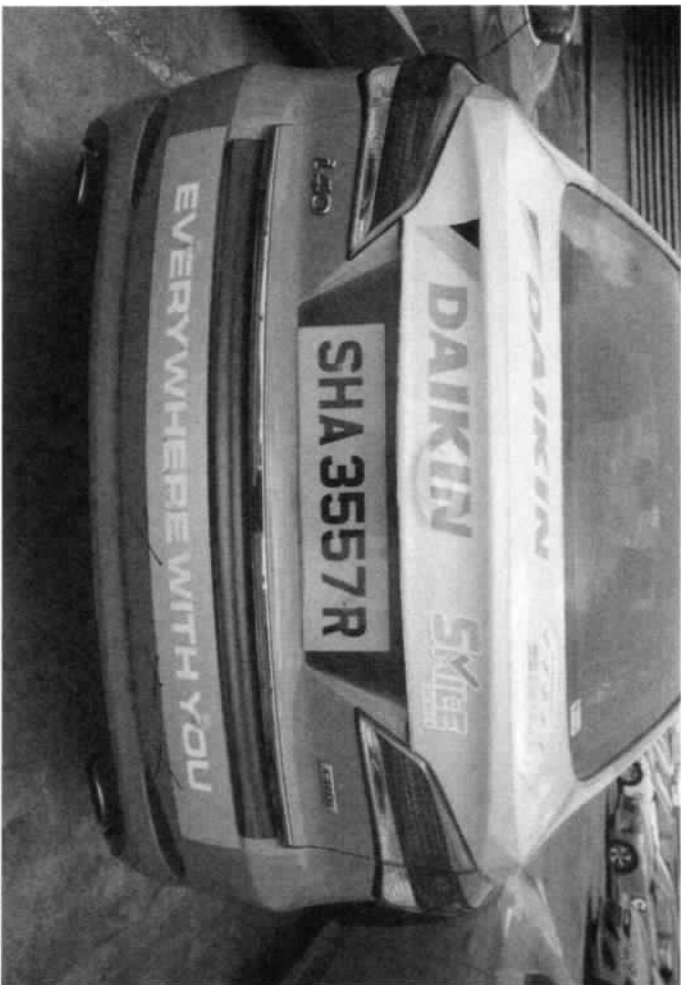
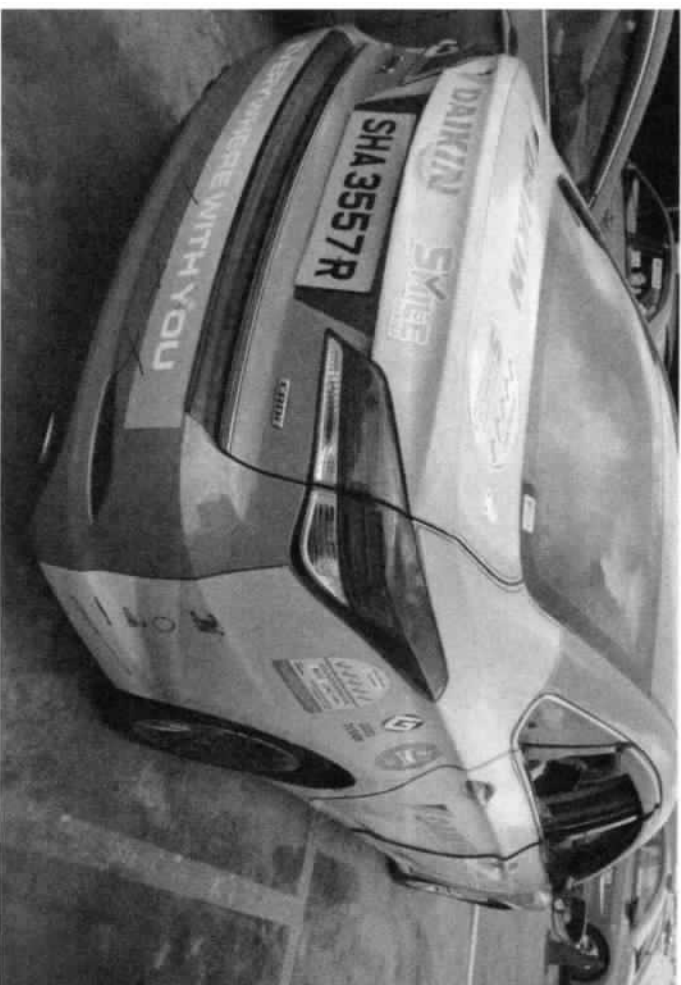
My taxi suffered a slight dent at the rear bumper, while the other vehicle suffered a slight dent at his front bumper. I am not sure what other damages are there to my vehicle. I have in-car camera facing the front of the vehicle.

Qty	Description of Parts	Condition	Estimate By Workshop (\$)	Our Adjusted (\$)
<b><u>REPLACEMENT OF PARTS</u></b>				
1	REAR BUMPER	DEFORMED	553.00	553.00
10	REAR BUMPER CLIP	NECESSARY	22.00	22.00
2	REAR BUMPER BRACKET @\$35.60	SERVICEABLE	71.20	-
1	REAR BUMPER UNDER COVER	SERVICEABLE	228.00	-
	LESS 20% DISCOUNT		-174.84	-115.00

730.00	510.00
<b>GRAND TOTAL</b>			<b>1,729.36</b>	<b>1,270.00</b>
<b>RECOMMENDED COST OF LUMP SUM REPAIRS (TO ITS PRE-ACCIDENT CONDITION) (CONFIRMED)</b>				<b>1,000.00</b>
