# TP Claims against NTUC Income: Follow-Through Survey

### 1. Policy Particulars :- THIRD PARTY CLAIM

THE VEHICLE SUSTAINED DAMAGES AT THE REAR AND O/S REAR PORTION. DAMAGES SEE DETAILS.
---

**ADJUSTMENT ON REPAIR COST FOR VEHICLE NO. SH 9922M**

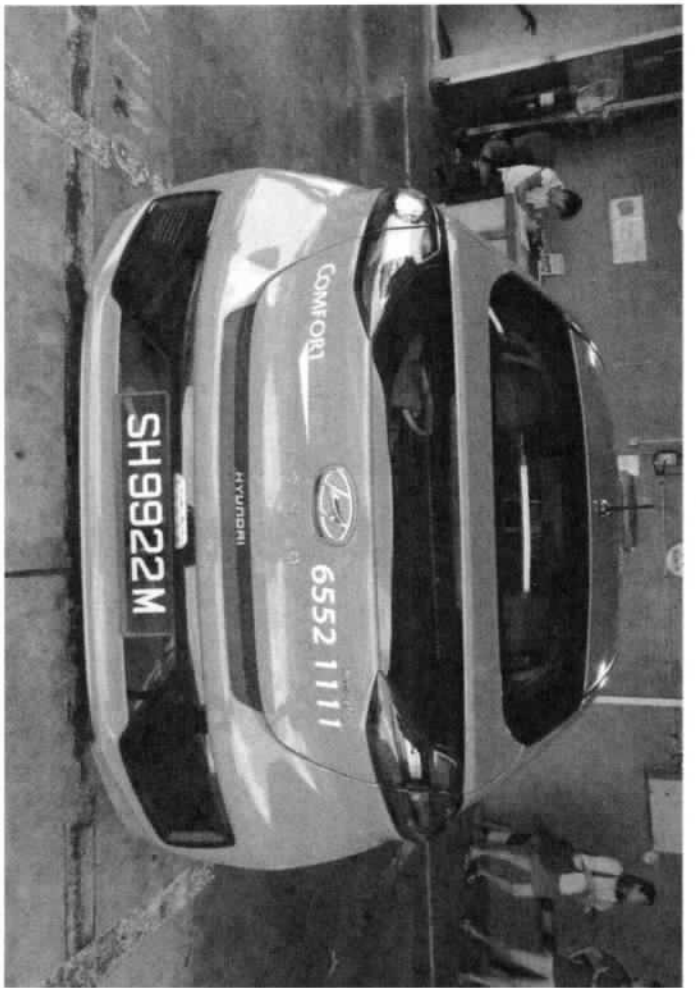
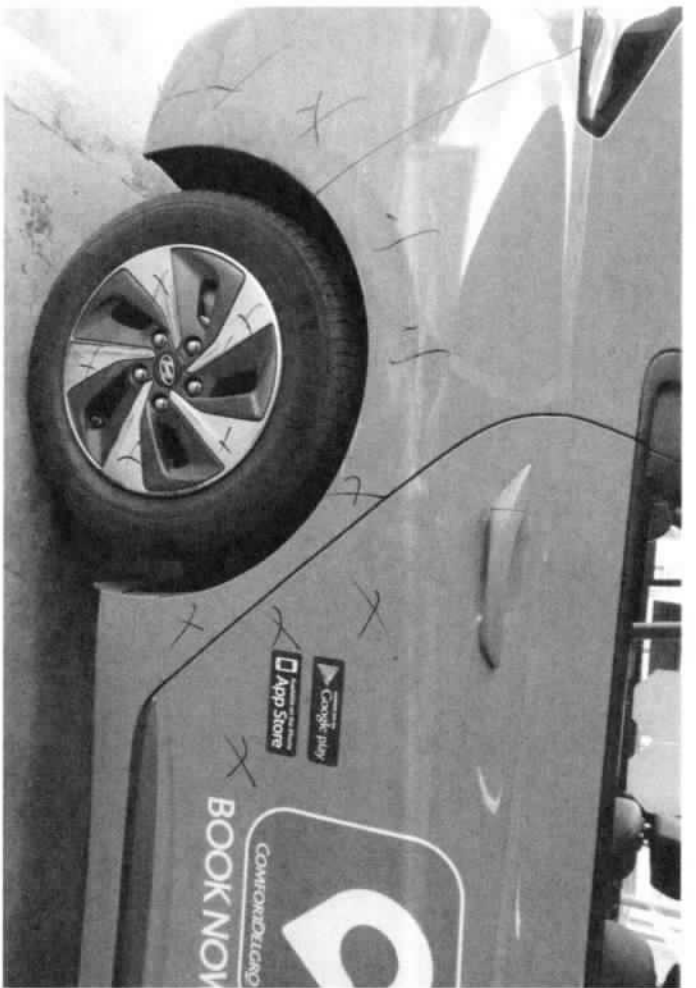
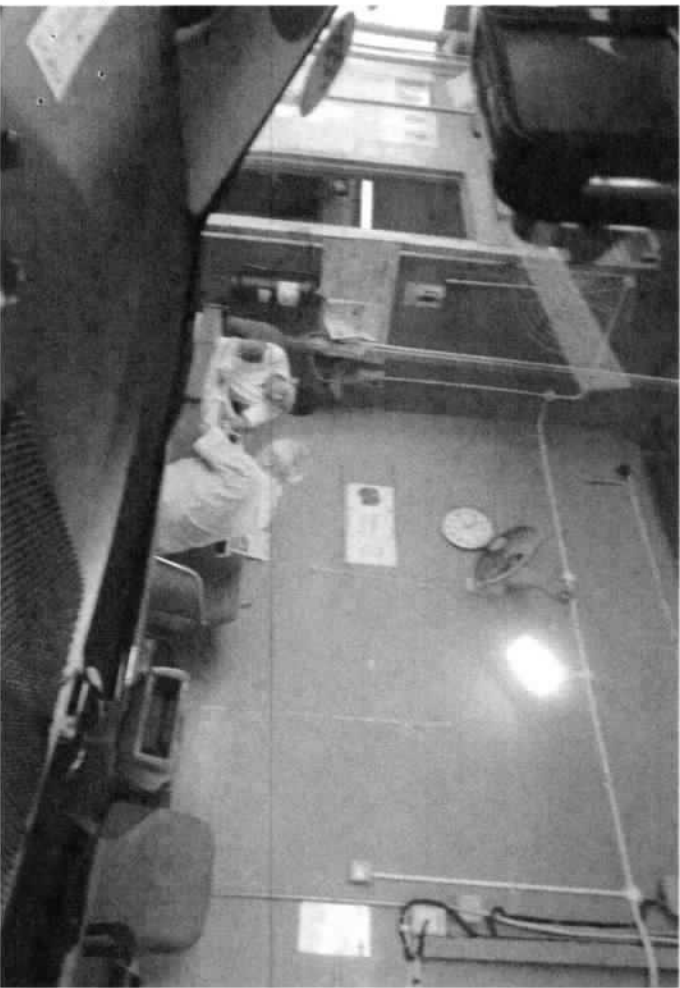
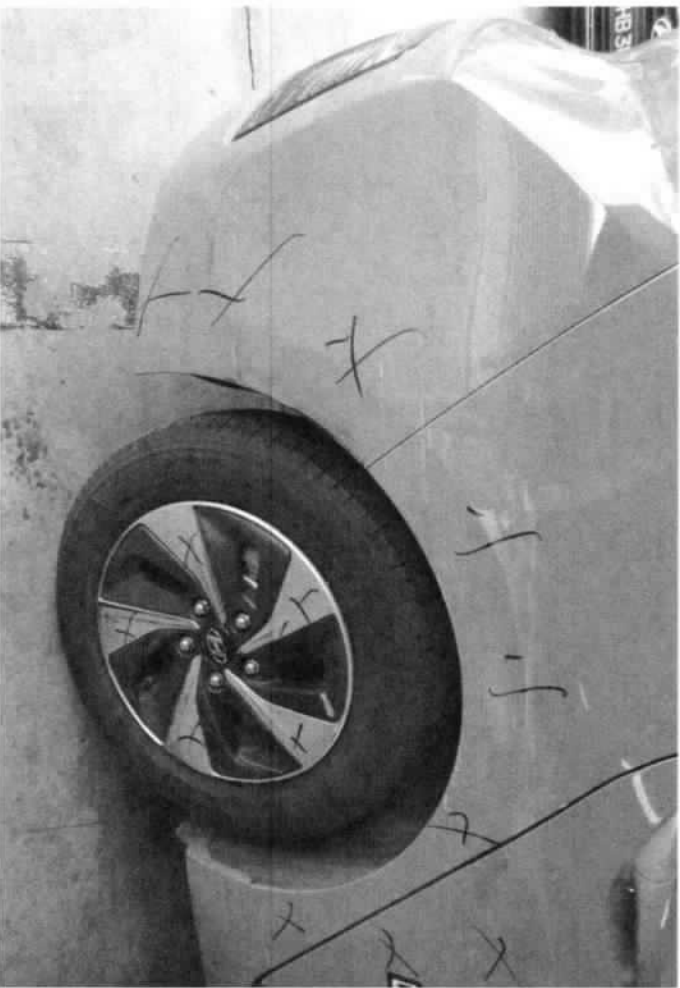
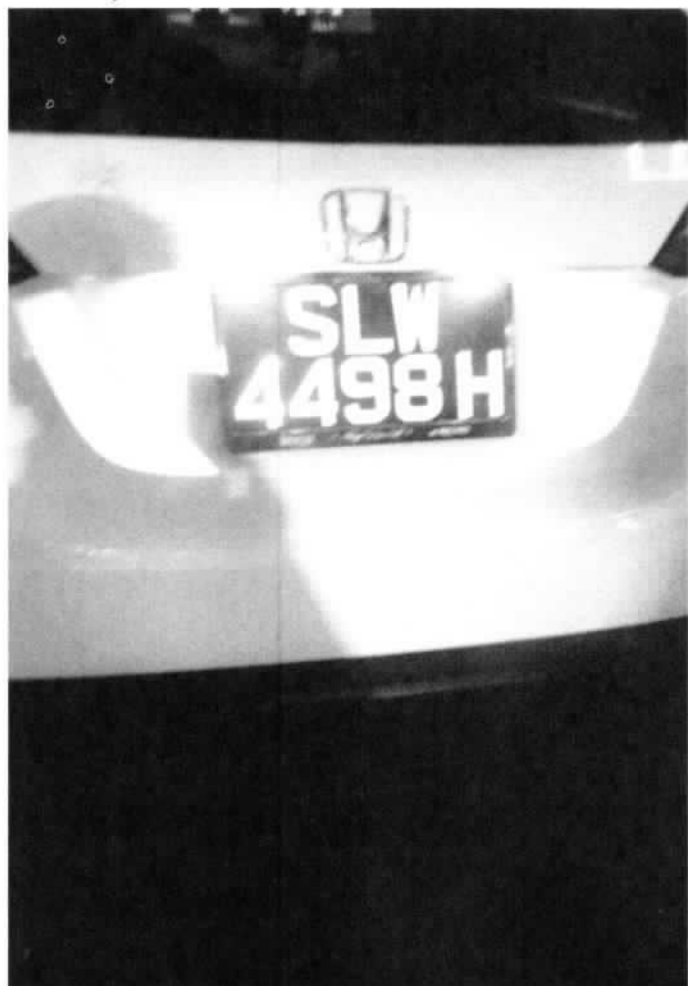
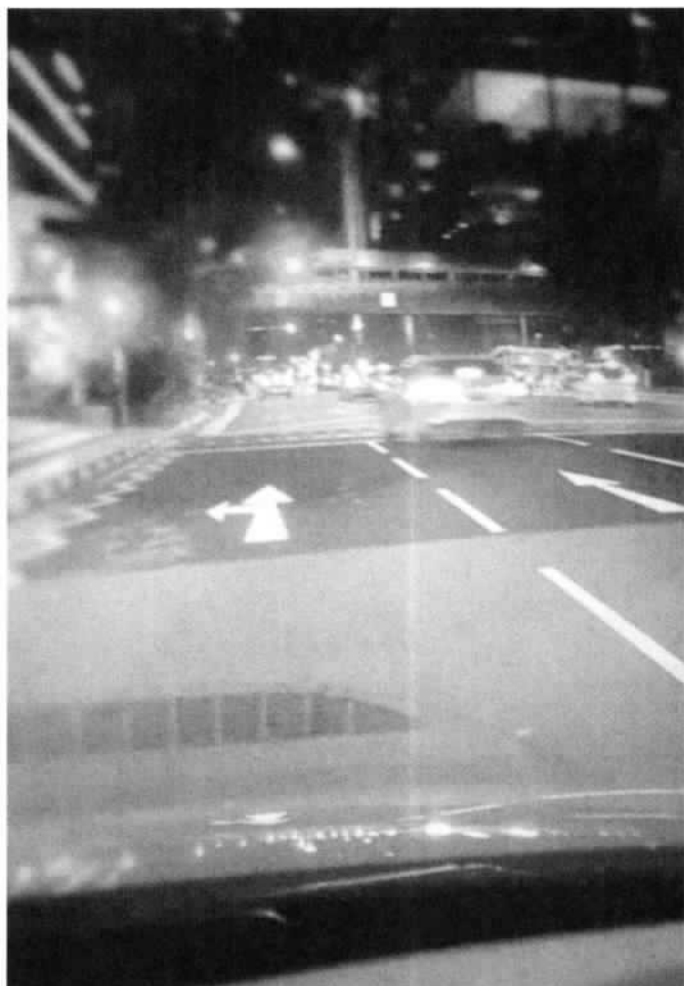
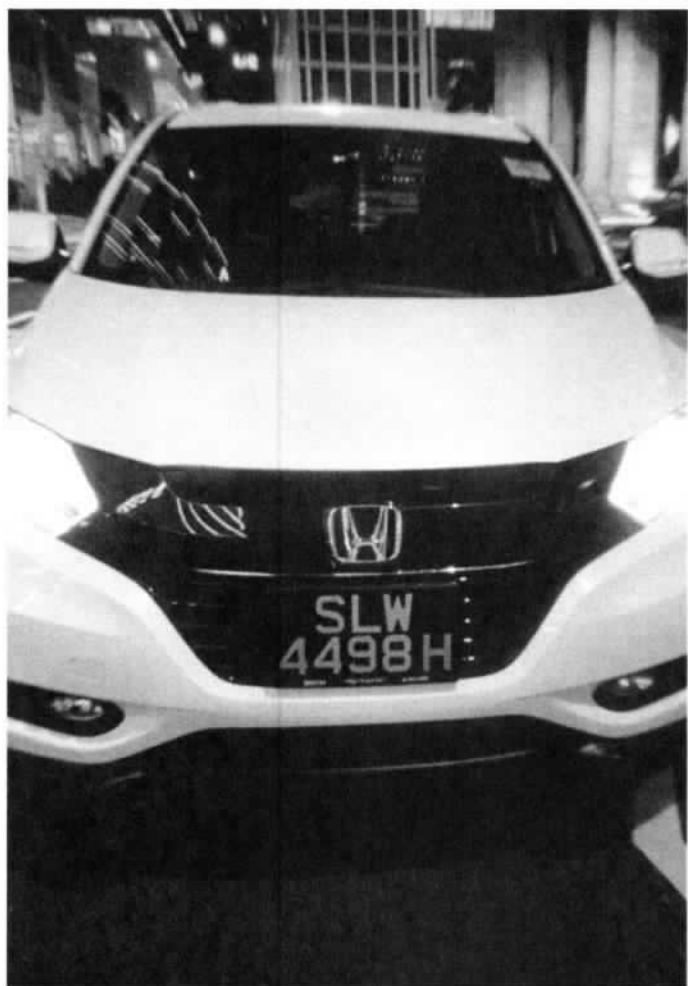
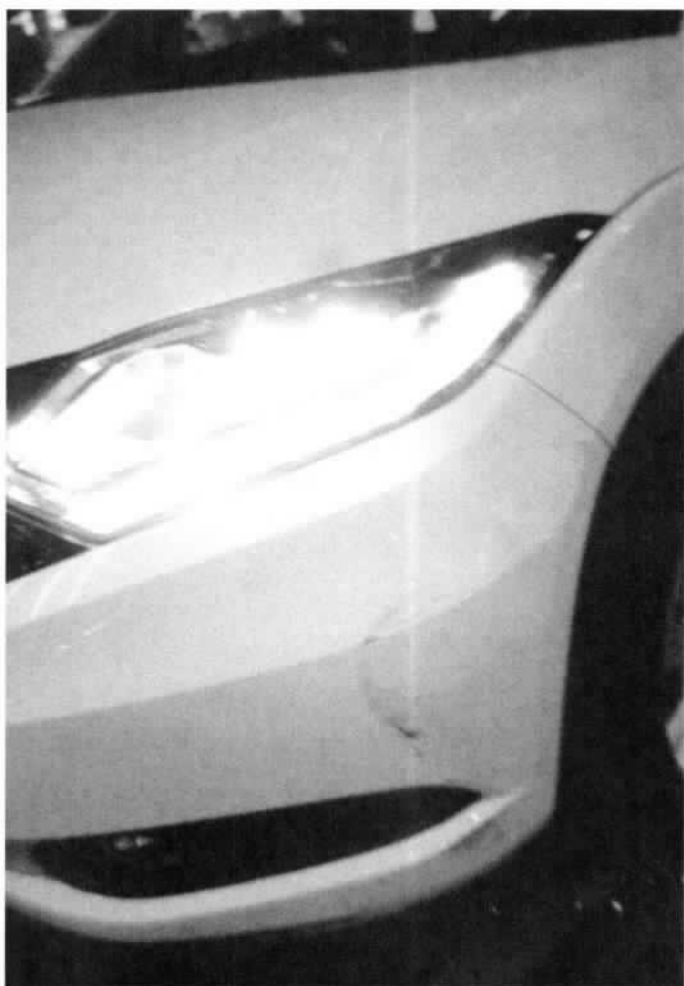
Des. of Damages: Frt / Rear / O/S / NIS / UIC / Rooftop or rear d b/s rear

Qty	Description of Parts	Condition	Estimate By Workshop (\$)	Our Adjusted (\$)
<b><u>REPLACEMENT OF PARTS</u></b>				
1	REAR BUMPER	TO REPAIR SEE LABOUR	459.40	-
1	REAR WHEEL HUP-CAP (RH)	SCRATCHED	134.10	134.10
1	REAR RH FENDER (NPA)	TO REPAIR SEE LABOUR	-	-
1	REAR RH DOOR (NPA)	TO REPAIR SEE LABOUR	-	-
	LESS 20% DISCOUNT		-118.70	-26.82

474.80	107.28
<b><u>NETT ITEMS</u></b>				
1	REAR BUMPER RUBBER MAT (N)	NOT NECESSARY	50.00	-
1	REAR DOOR COMFORTDELGRO & APPS STICKER (RH) (N)	NECESSARY	80.00	80.00
	LESS 10% DISCOUNT		-	-8.00

130.00	72.00
<b><u>LABOUR</u></b>				
	PANEL BEATING. INCLUSIVE OF THE REPAIR OF REAR BUMPER, REAR RH FENDER AND REAR RH DOOR.		500.00	320.00
	SPRAY PAINTING CHARGE.		750.00	600.00
	WIRING CHARGE.	NOT NECESSARY	50.00	-
	REMOVE / REFIX REVERSE SENSOR.	NOT NECESSARY	120.00	-
	REAR WHEEL ALIGNMENT.	NOT NECESSARY	120.00	-
			1,540.00	920.00
<b>GRAND TOTAL</b>			<b>2,144.80</b>	<b>1,099.28</b>
<b>RECOMMENDED COST OF REPAIRS (CONFIRMED)</b>				<b>1,099.28</b>
