AUTOMOBILE INSPECTION REPORT

Registration No. : SLB 4940 H
Make/Model : MERCEDES BENZ E 200CGI
Yr of Manuf/Regn : 2011
Carrying Capacity : 4 Seater
Chassis No. : WDD2120482A398580
Engine No. : 27186030200056
Colour : Metallic Silver
Class : Passenger (Private)

VEHICLE DAMAGE INSPECTION REPORT**Our File No:** CS3/MSG19013095/R1TF3E2-1**Date:** 17/10/2019REFERENCE

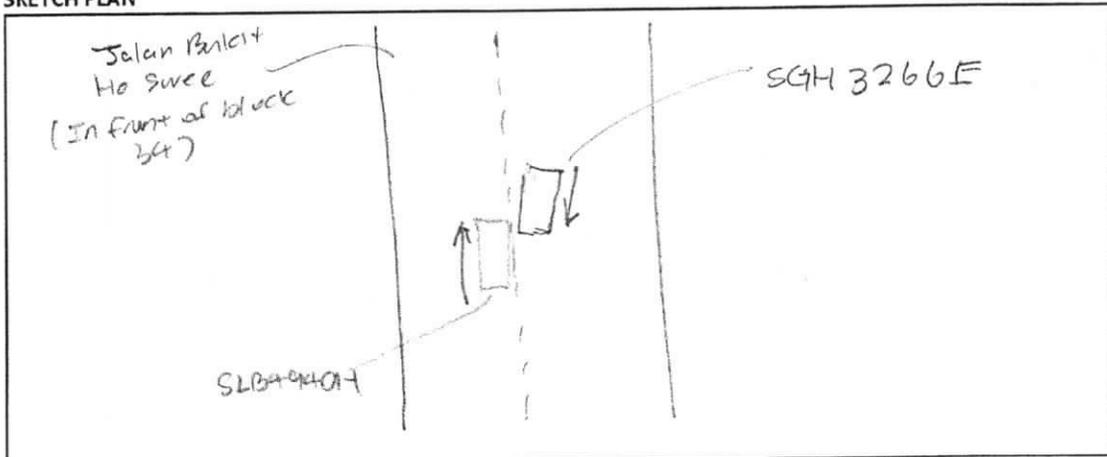
Sketch Plan #2 Pg. 1

I (~~was~~ ^{KONG WEI REN}) was driving vehicle (SLB4940H) in my lane when ~~the~~ ~~oncoming~~ vehicle SGH 3266E was driving towards my lane and hit the right side of my vehicle.

~~From~~ just before the moment of impact, I saw the driver in ~~SGH~~ SGH 3266E was looking down and not straight at the road (see frame of video provided).

Also, in the video, it is very obvious the vehicle SGH3266E was not driving straight (he had ample space on the left) but at an angle towards my vehicle.

The accident happened along Jalan Bukit Ho Swee, in front of block 34

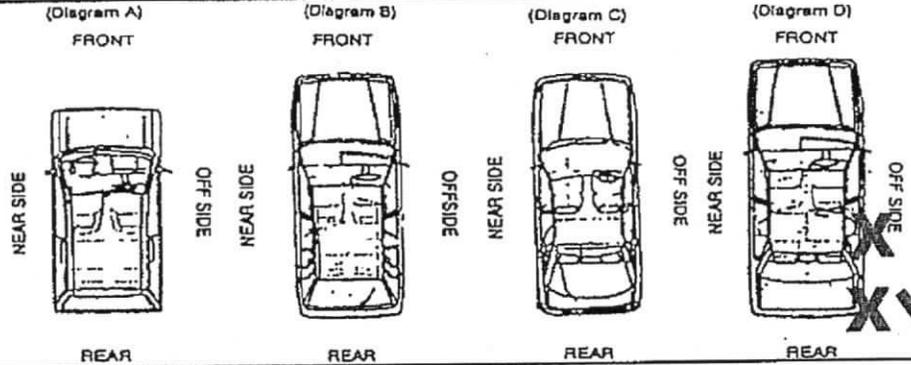
APPENDIX A

The vehicle sustained impact along its Rear O/s Portion. (see Diagram D)

The rear o/s door and wheel rim, rear o/s fender and wheel arch, rear bumper were dented.

A static inspection was carried out on 30/07/2019 & our report is here with enclosed for your perusal. The Repairs Estimate submitted by M/s GHEE SENG PAINT SPRAYING WORKS as per attached Appraisal Schedule have been revised and scrutinised thoroughly by us & in our opinion, we consider it to be fair and reasonable. The repairer has agreed to effect repairs to the owners satisfaction & to roadworthy condition on an agreed Lump Sum Repair Basis of \$ 3,800.00 after deducting the Policy Excess Clause of \$ NA. As instructed, we have not authorised any of the repairs on your behalf.
