# TP Claims against NTUC Income: Follow-Through Survey

Code: INC4	
<b>1. Policy Particulars :- THIRD PARTY CLAIM</b>				
Insured Veh.	SGU 2403P	Veh. Inspected	SH 7942T	
Policy No.		Coverage (\$)	0.00	
Claim No.	MT/1066675-002	Excess (\$)	0.00	
Assign From		Assign Date	14/10/2019	
<b>2. Vehicle Particulars &amp; Condition</b>				
Make & Model	HYUNDAI I40	c.c	1685	
Engine No.	HIDDEN	Year of Reg.	2015	
Chassis No.	KMHLB41UMFU068960	Colour	BLUE	
Odometer	656676	Steering	IN ORDER	
Brakes	IN ORDER	Modification	STANDARD ALLOY RIM	
General	FAIR			
<b>3. Conditions of Tyres</b>				
	Size	Make	Balance	
R/H Front Tyre	205/60 R16	WEST LAKE	7 mm	
L/H Front Tyre	205/60 R16	WEST LAKE	7 mm	
R/H Rear Tyre	205/60 R16	WEST LAKE	7 mm	
L/H Rear Tyre	205/60 R16	WEST LAKE	7 mm	
<b>4. Description of Damages</b>				
THE VEHICLE SUSTAINED DAMAGES AT THE FRONT AND N/S FRONT PORTION. DAMAGES SEE DETAILS.

**ADJUSTMENT ON REPAIR COST FOR VEHICLE NO. SH 7942T**

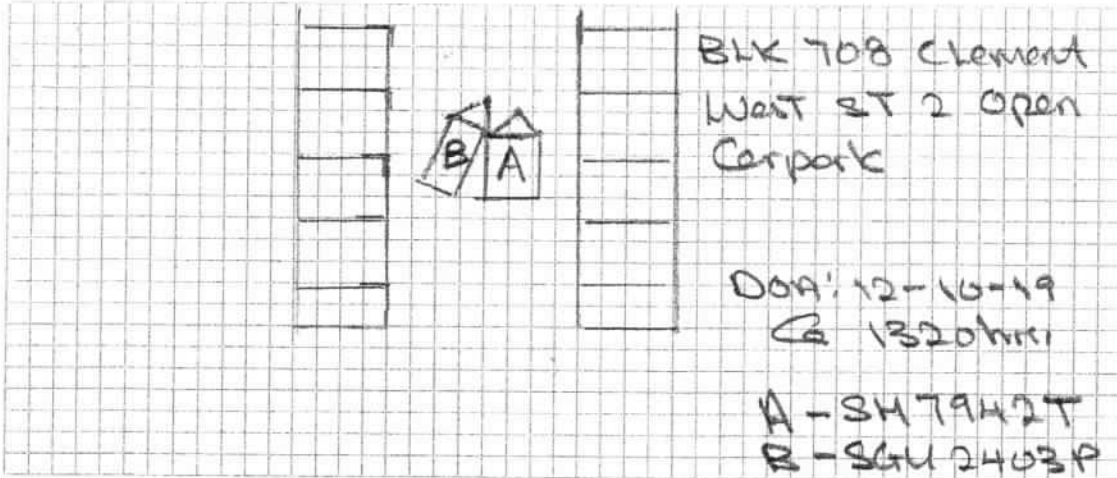
## SKETCH PLAN

BLK 708 Clement West ST 2 Open Carpark

DOA: 12-10-19  
G 1320hrs

A-SH7942T  
B-SGU2403P

I was driving along the car park in front of BLK 708 Clement West Street 2. As I drove past a stationary car, this car reverse a knock onto me.
