## ASSIGNMENT (Office)

To Inspect Vehicle No: GBF 8800A Insured:

Vehicle Made & Model: NISSAN URVAN NV350

## VEHICLE DAMAGE INSPECTION REPORT

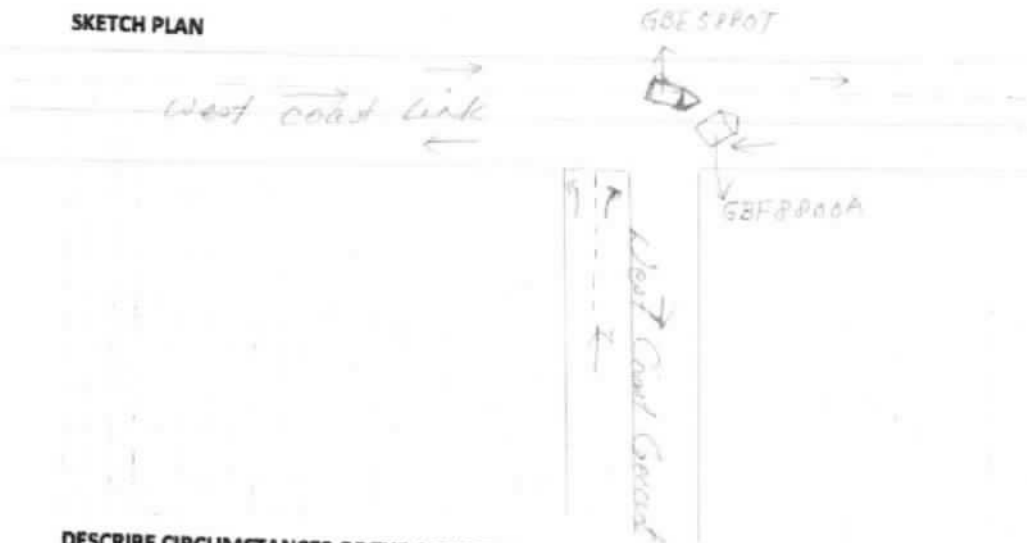
## SKETCH PLAN

On 11/10/19 @ 10.53 am I was driving my vehicle GBF8800A from West Coast Crescent toward West Coast Link. After checking there was no oncoming vehicle on the left, I proceed to turn right to West Coast Link. After turning, a fast moving vehicle no GBE588OT suddenly hit my vehicle and cut into my lane.

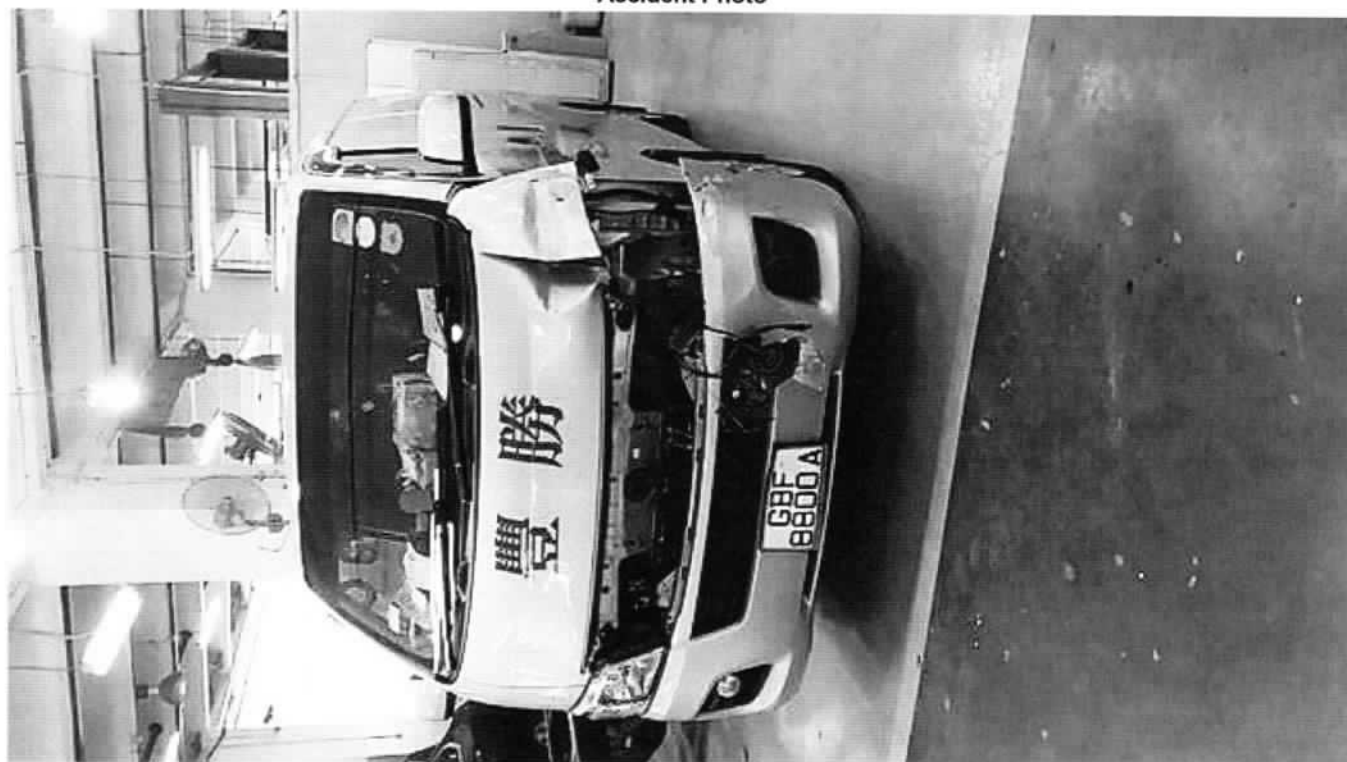
Accident Photo

The U/C / Chassis frame / Body Structure affected due to collision.
