08/CTE/19018527/65 d302

SML 9483 M

## ASSIGNMENT

## VEHICLE DAMAGE INSPECTION REPORT

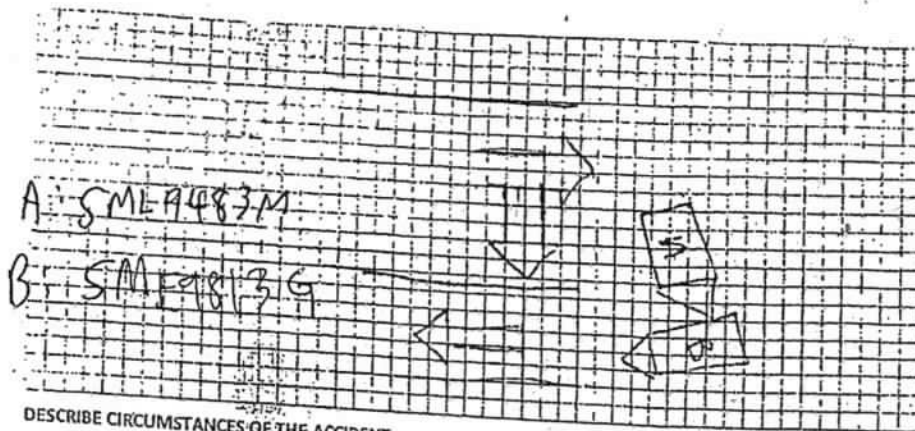
**SKETCH PLAN**

On 15/10/2019 at about 0850 Hours, I was driving my BMW 525 bearing plate number SML9483M along Balmoral Road towards Dunearn Road.

Upon green light, I turned right after the car in front drove off. I stopped, looked left and right to ensure clearance and drove on. A car came speeding towards my left and collided into my front. She failed to slow down as I was already turning having my right of way. She apologised for the accident. We exchanged particulars. It caused severe damages to my car.
