SURVEY REPORT

Vehicle No.	: GBG 4279 B	Propellant	: Diesel, Manual
Make	: Nissan	Capacity	: 3000 cc
Type of Body	: Lorry, Metal	Mileage	: 63566
Year & Model	: 2017, Cabstar	Engine No	: ZD30024412N
Colour	: White	Chassis No	: JN1SC2F24Z0859824
Passenger-cap	: 1	Road Tax	: August, 2019

The vehicle sustained impact to the front.

VEHICLE DAMAGE INSPECTION REPORT

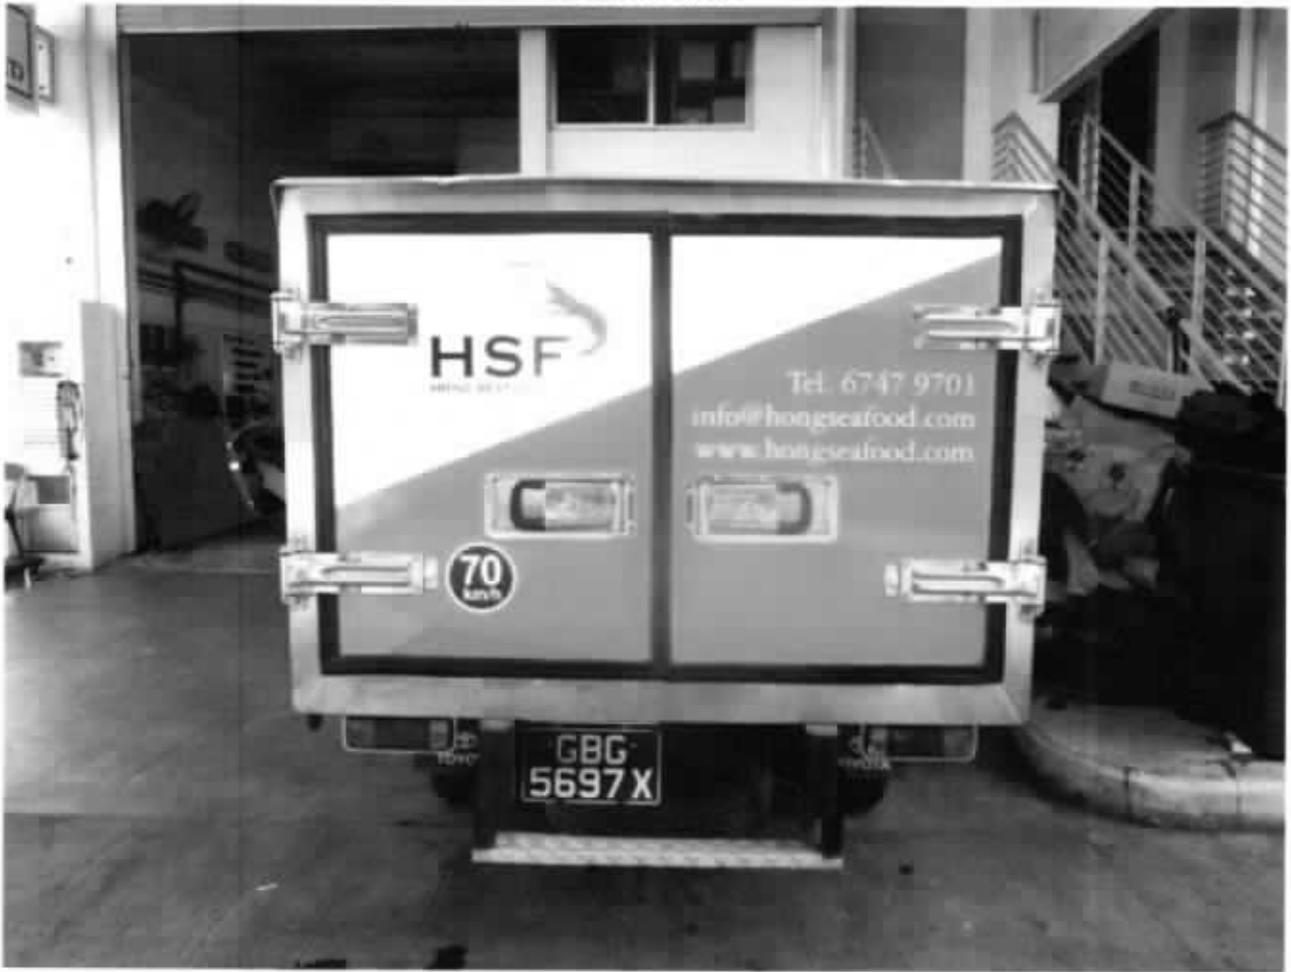
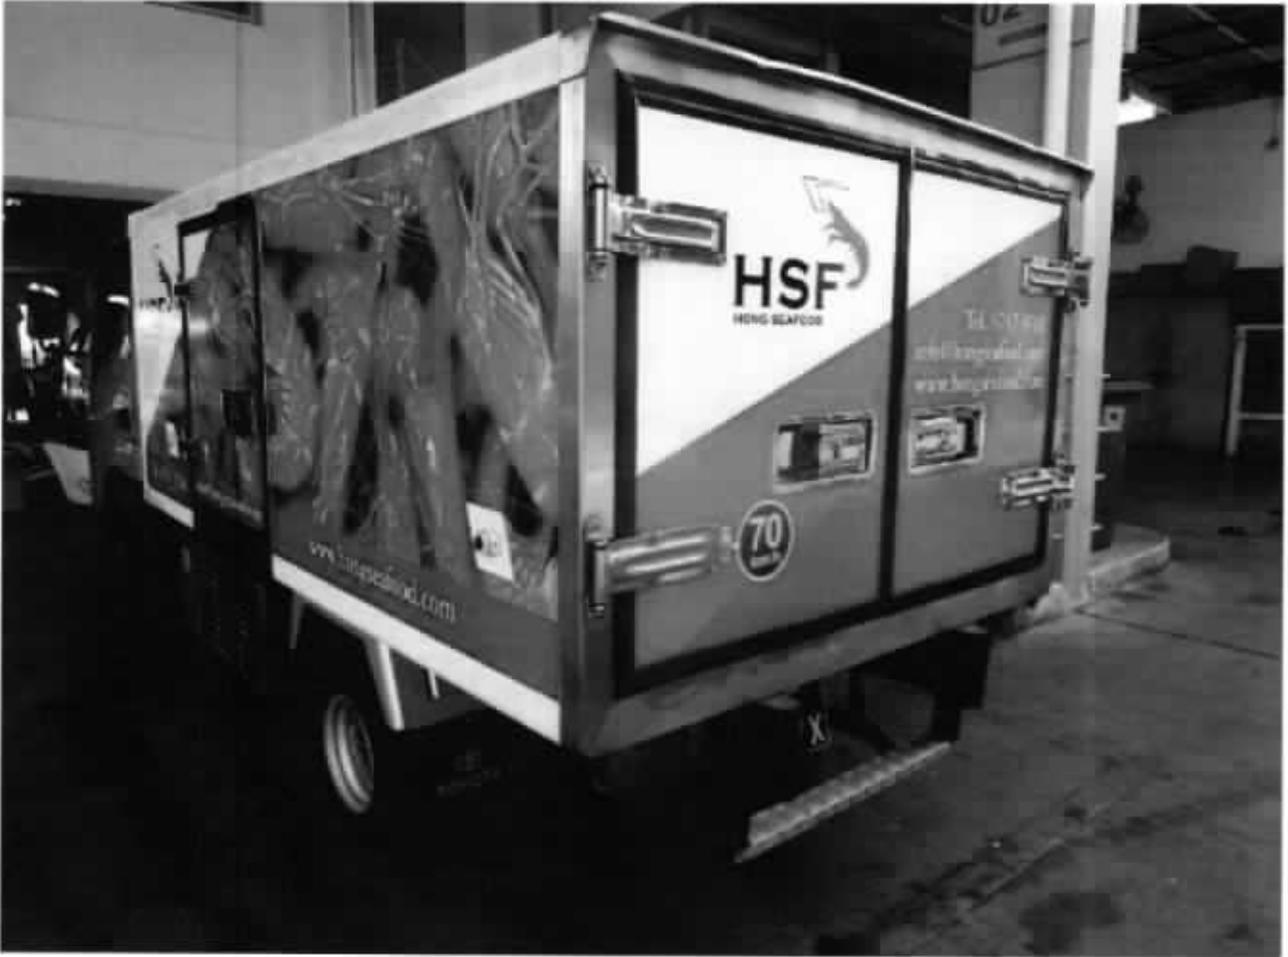
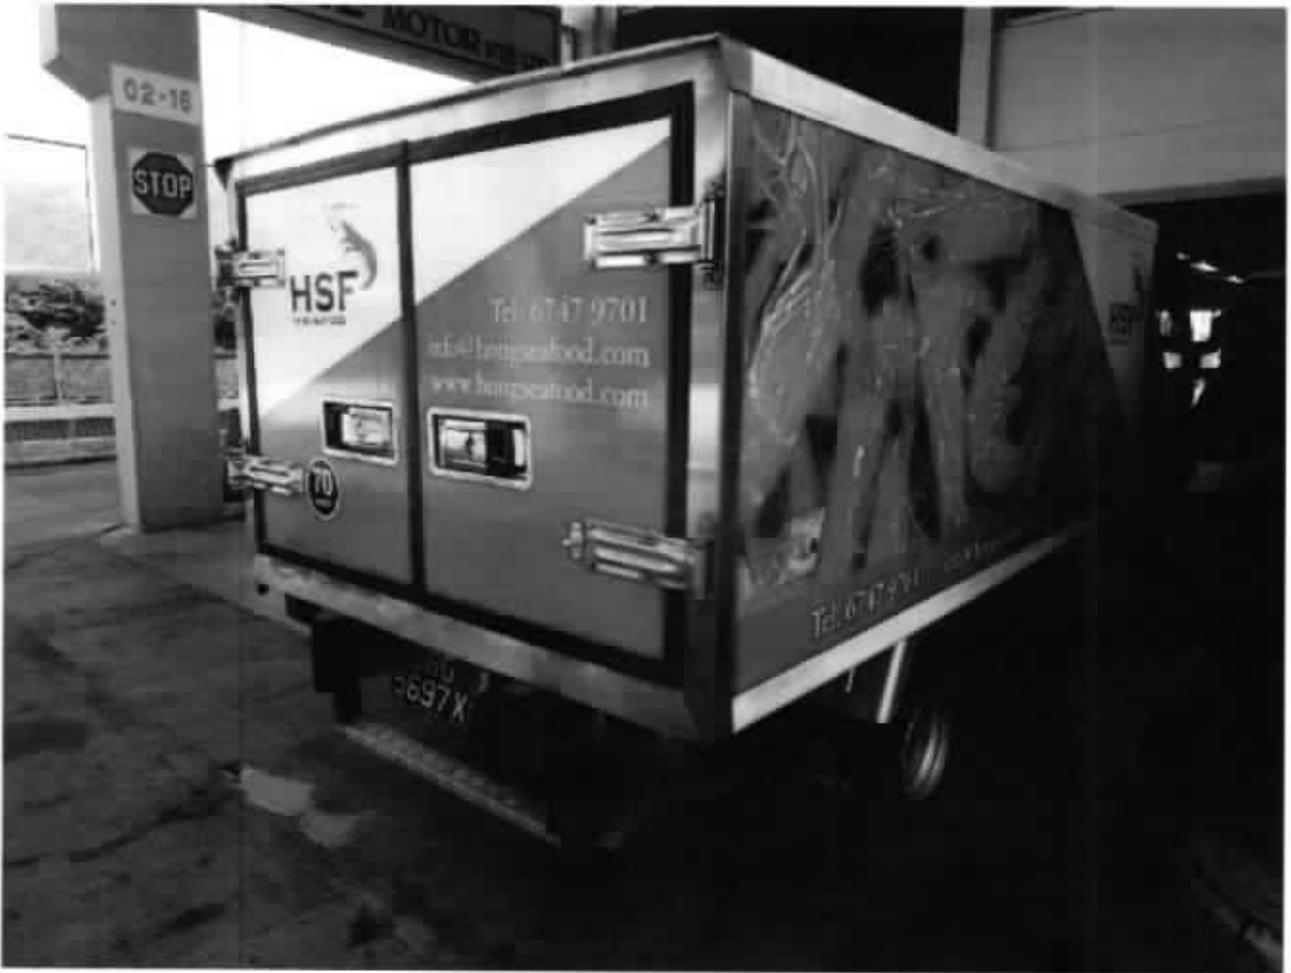
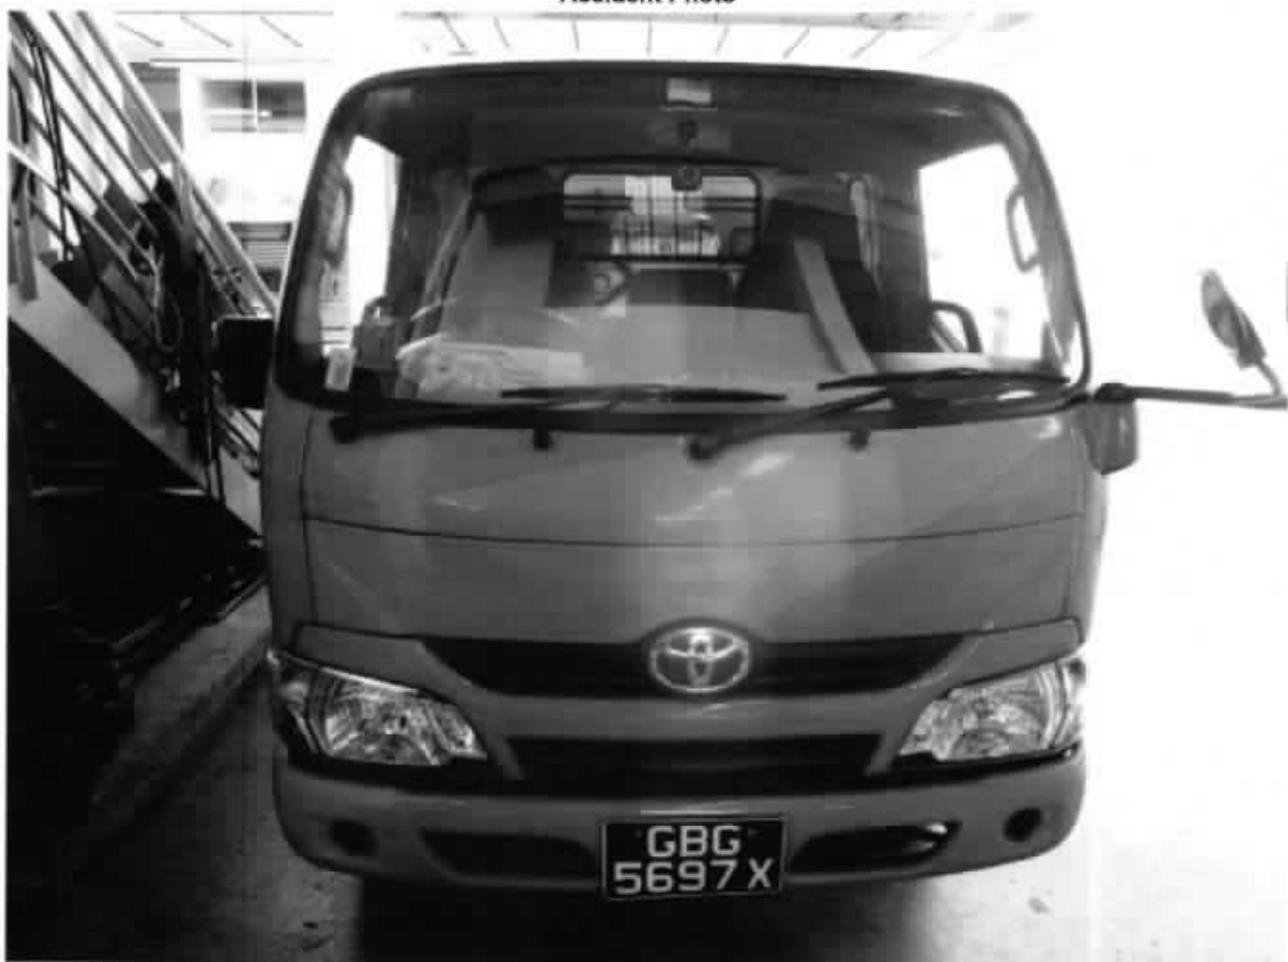
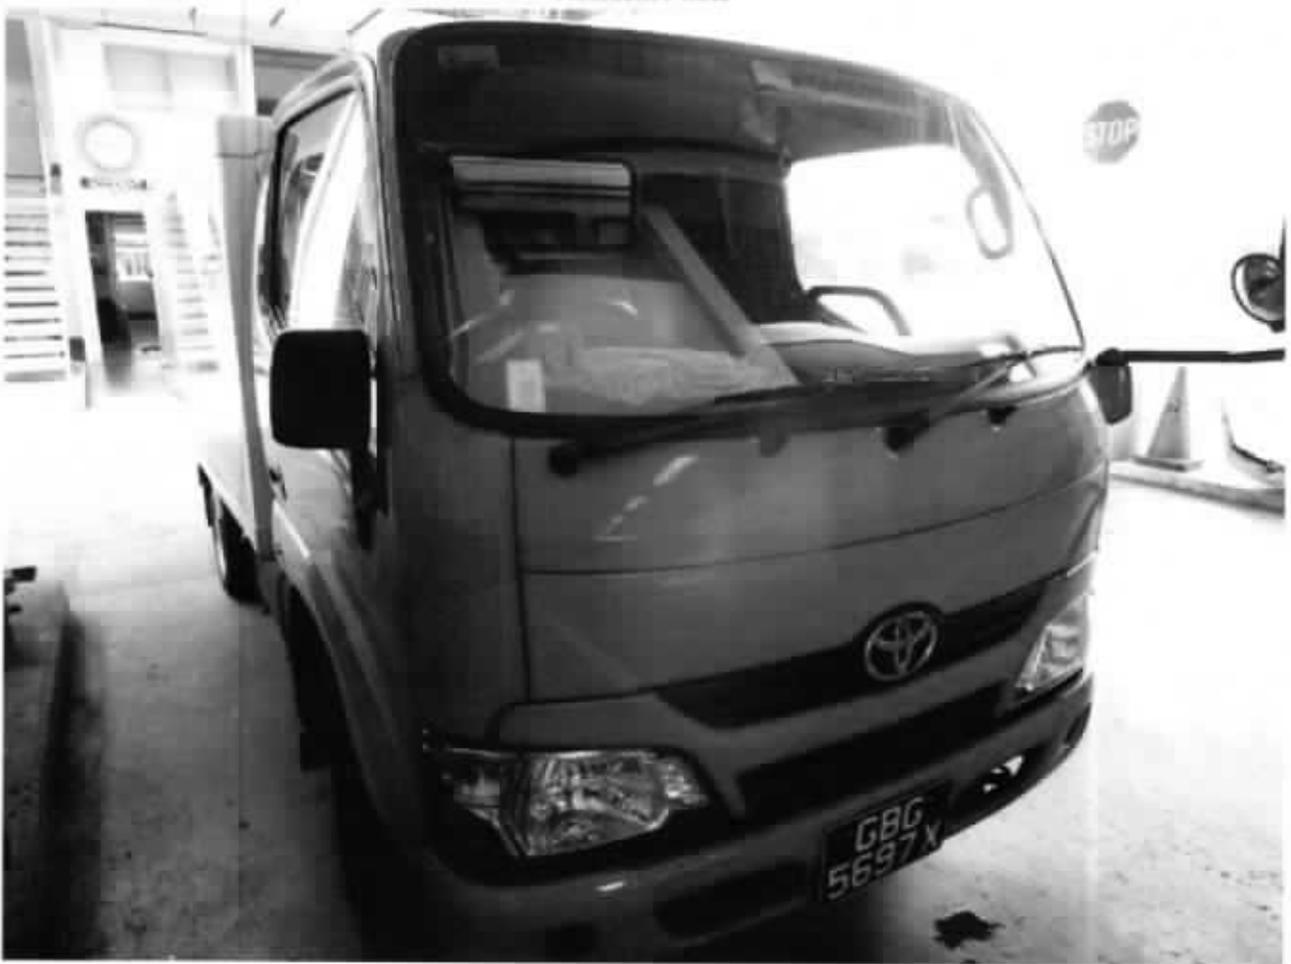
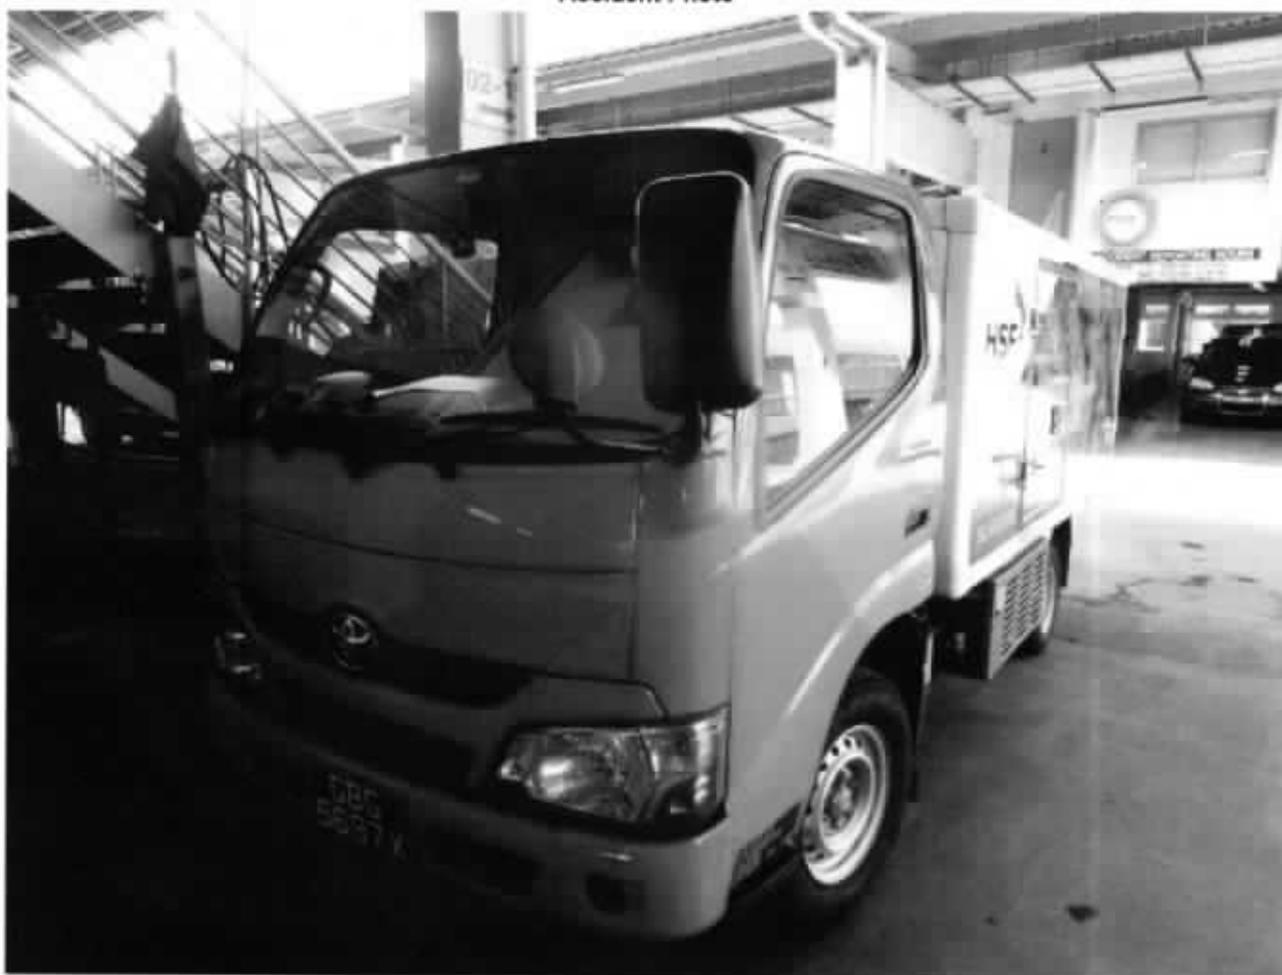
Accident Photo

Having checked the scope of repair works we were satisfied that it was in accordance with the damage sustained. We also checked each item and have indicated its nature of damage. It was our opinion that these items were found damaged beyond repair and require replacement.

We checked the damage carefully and were of the opinion that the vehicle could be repaired. We would therefore recommend repairs to be carried out at: **\$ 7,700.00** on a lump-sum basis.
