## VEHICLE INSPECTION REPORT

Report No. : PAS/TP/0641218

Vehicle Registration No. : SJX7211S  
Make & Model : Volkswagen Scirocco  
Date of Registration : 06/07/2010  
Colour : Met. Grey

## VEHICLE DAMAGE INSPECTION REPORT

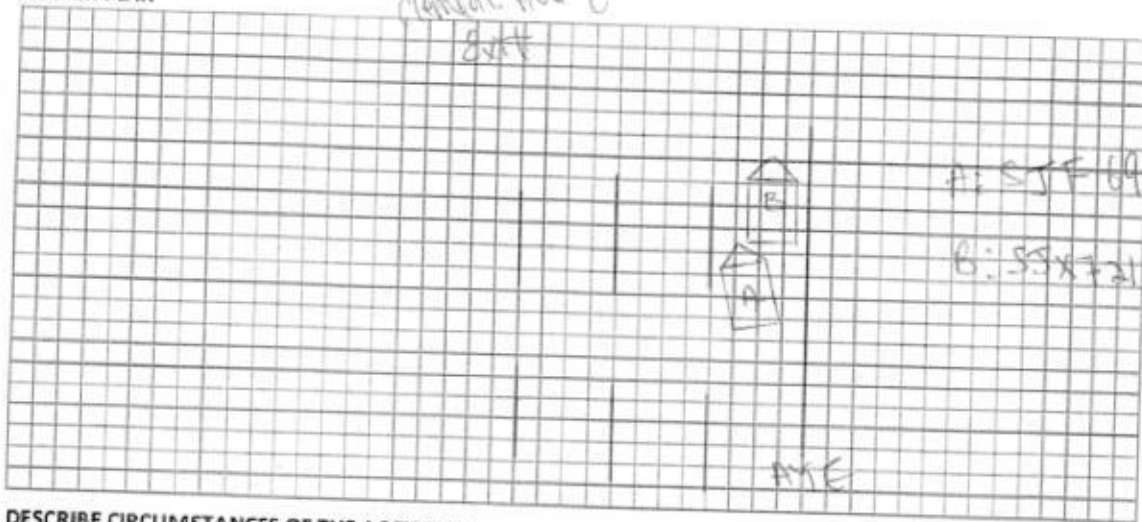
## SKETCH PLAN

AS I WAS TRAVELING NEAR CLEMENTI AVE 6 EXIT, VEHICLE B(SJX7211S) AHEAD OF ME SUDDENLY BRAKE. I WAS UNABLE TO REACT IN TIME, I TRIED TO SWERVE TO MY LEFT TO AVOID COLLISION HOWEVER THE FRONT RIGHT PORTION OF MY VEHICLE STILL COLLIDED ONTO THE REAR LEFT PORTION OF VEHICLE B(SJX7211S)

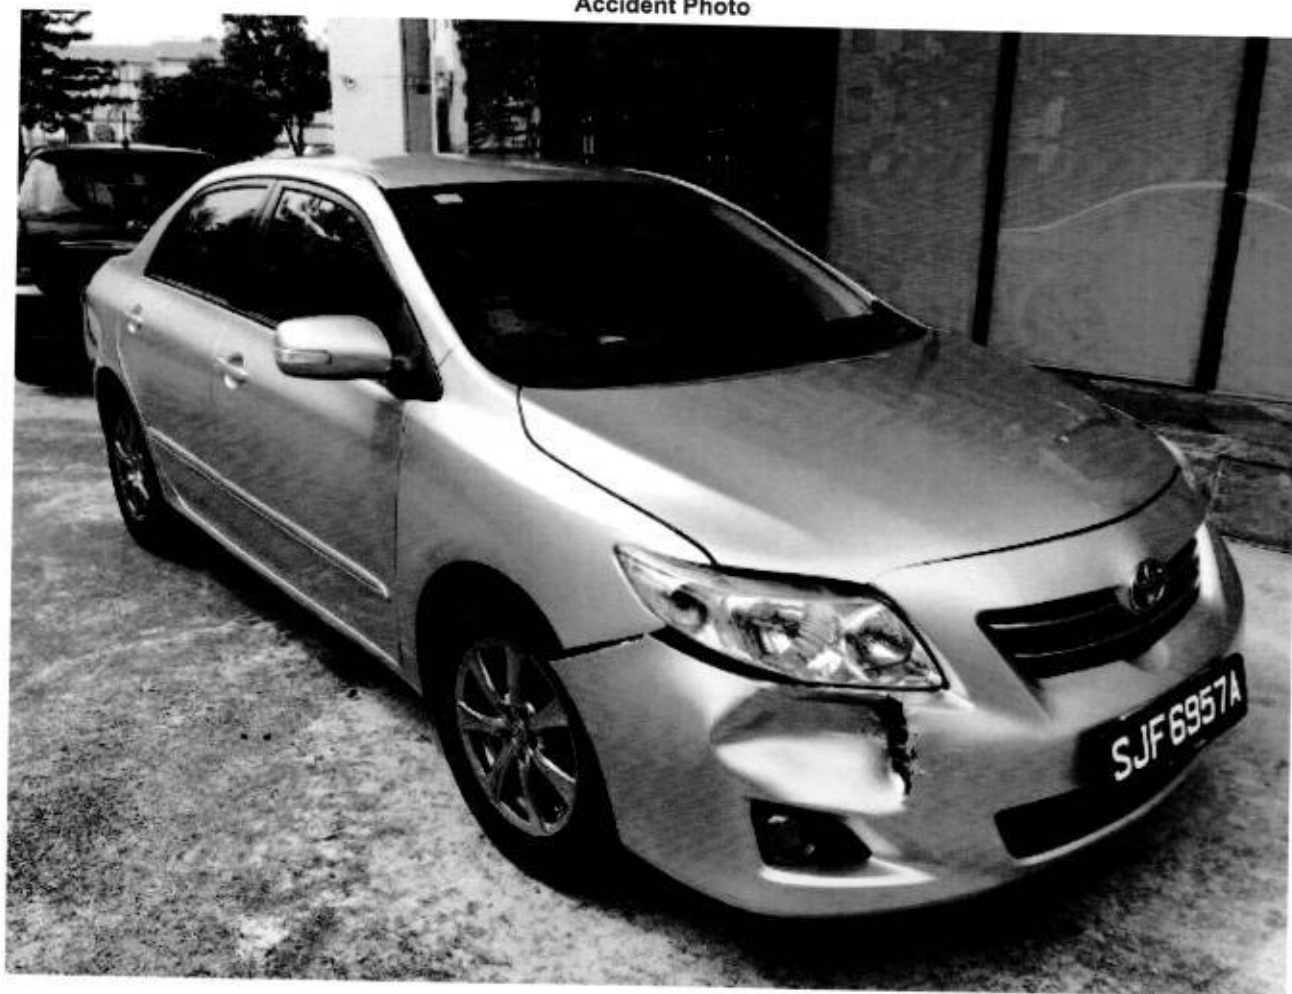
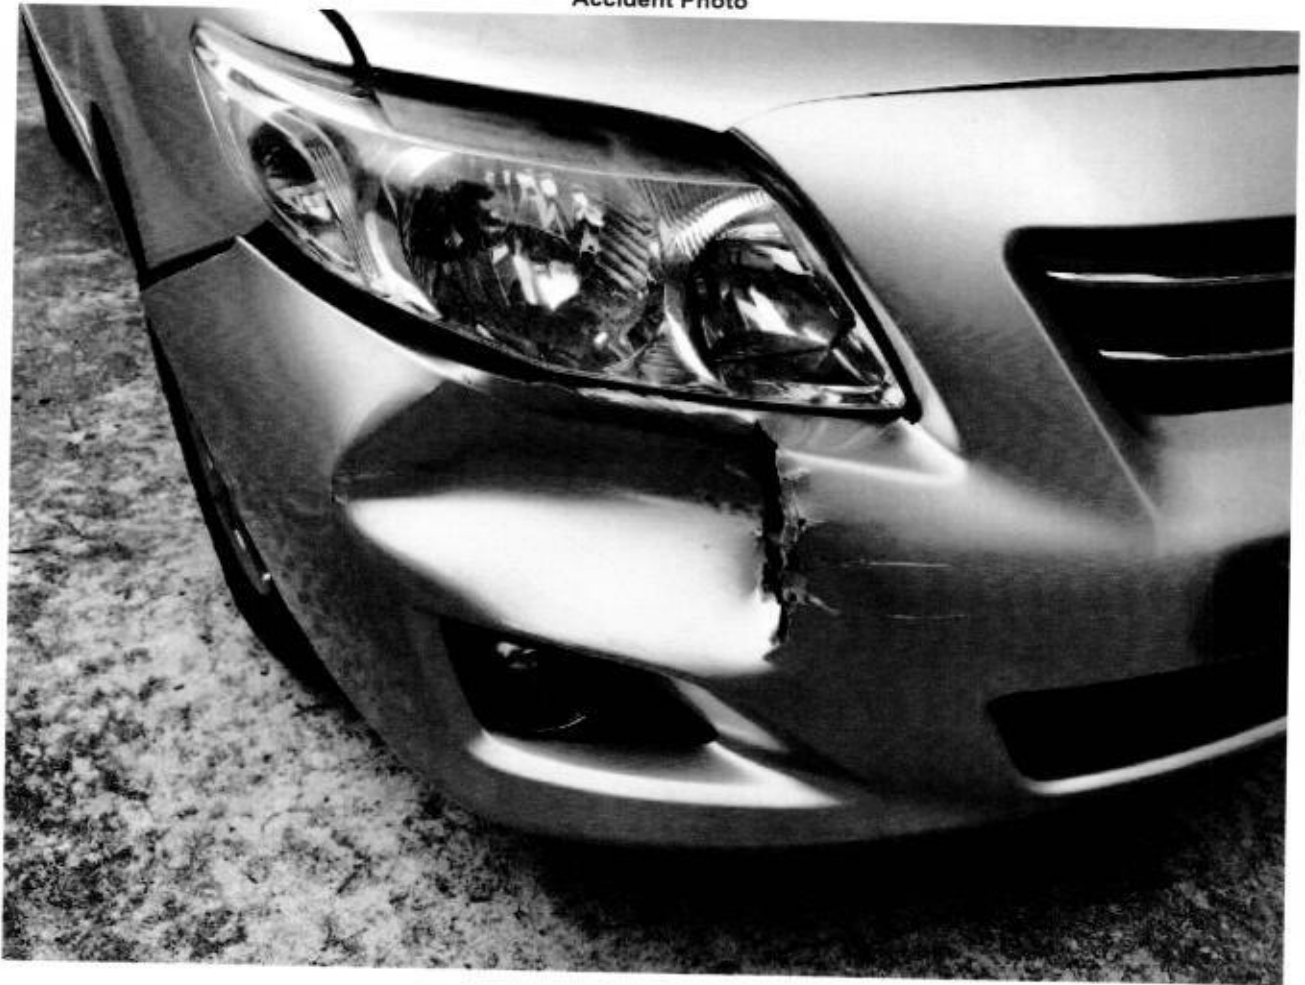
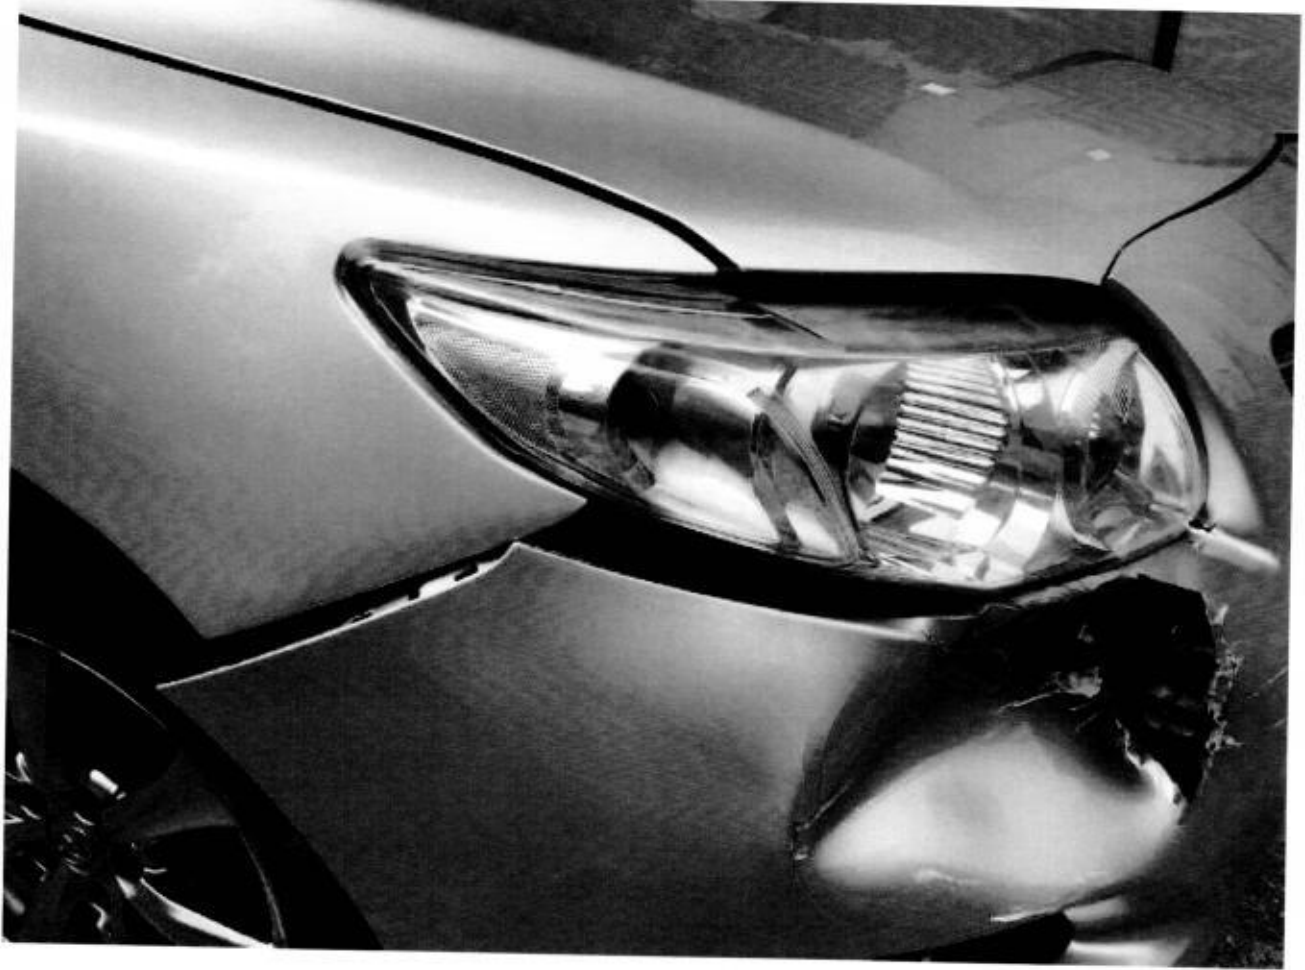
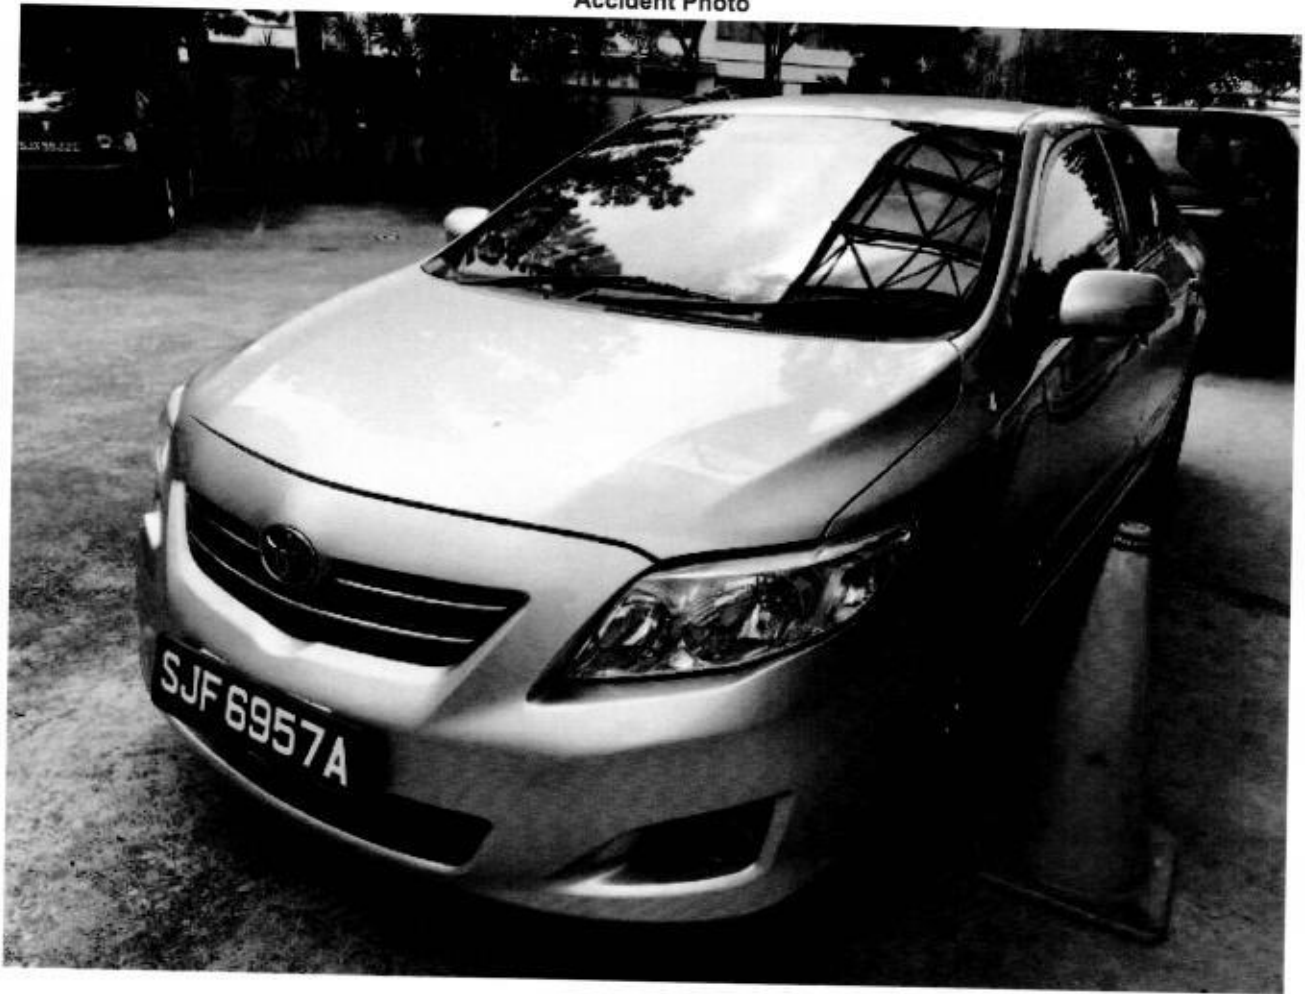
Accident Photo

DUE TO THE IMPACT, MY VEHICLE WAS DAMAGE ON THE FRONT RIGHT PORTION.

VEHICLE B DAMAGE ON THE REAR LEFT PORTION.

DAMAGES FOUND ON VEHICLE A & B
