NSI INC 19018601 / KHf3n2

1. Policy Particulars :- THIRD PARTY CLAIM			
Insured Veh.	S 2710CD	Veh. Inspected	SHA 7881C
Policy No.	5111450504	Coverage (\$)	0.00
Claim No.	MT/1067890-002	Excess (\$)	0.00
Assign From		Assign Date	21/10/2019

4. Description of Damages			
THE VEHICLE SUSTAINED DAMAGES AT THE N/S FRONT PORTION. DAMAGES SEE DETAILS.			
5. General Information			
Accident Date	20/10/2019	Inspection Date	21/10/2019
Survey held at	COMFORTDELGRO ENGINEERING PTE LTD 59 LOYANG DRIVE SINGAPORE 508969		
5a. Remarks			
A)THE INSPECTION WAS CONDUCTED ON A"WITHOUT PREJUDICE" BASIS. B)IN ACCORDANCE TO YOUR INSTRUCTIONS, WE HAVE NOT AUTHORISED REPAIRS.			
5b. Estimate Days of Repair			
ESTIMATED NORMAL PERIOD FOR REPAIR:		2 Working Days

ADJUSTMENT ON REPAIR COST FOR VEHICLE NO. SHA 7881C

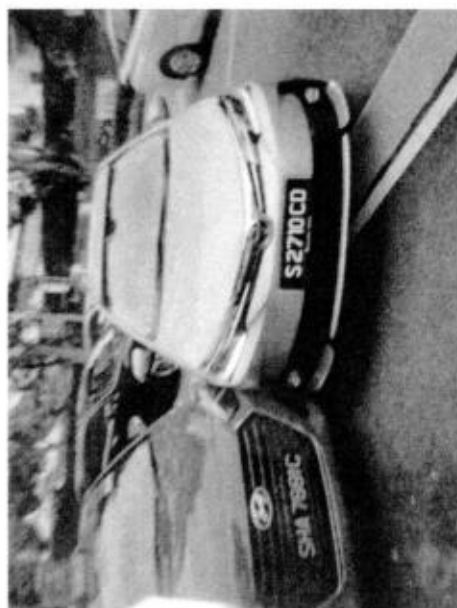
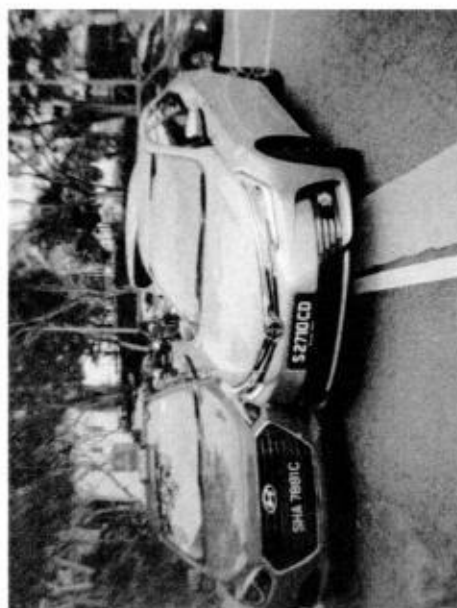
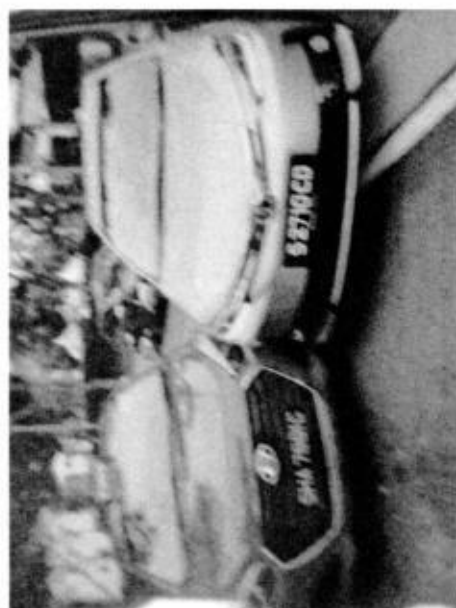
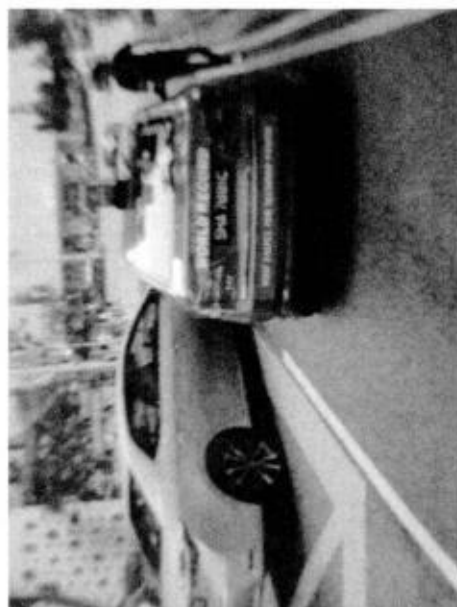
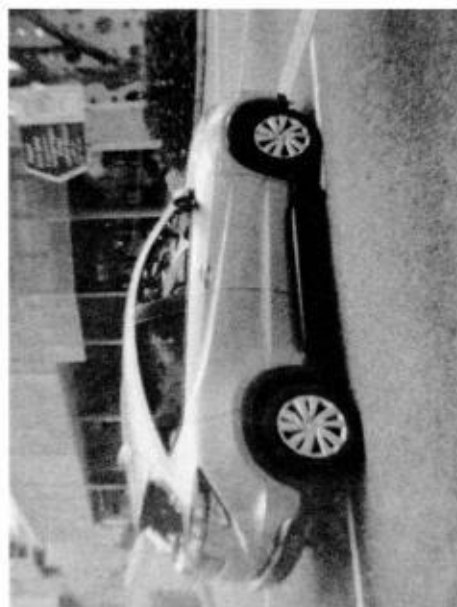
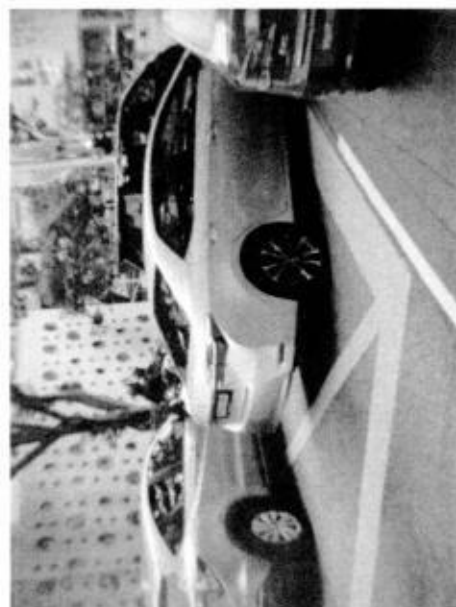
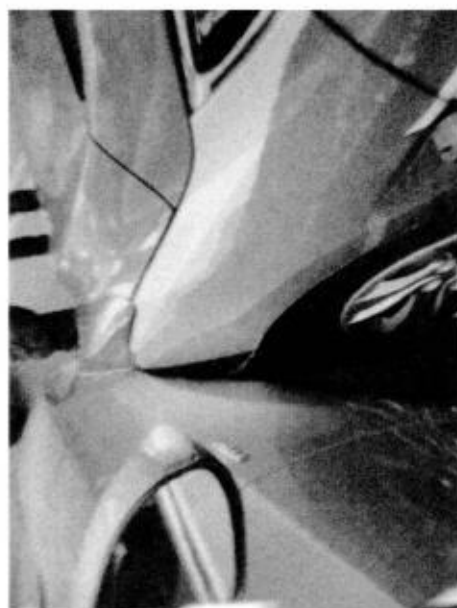
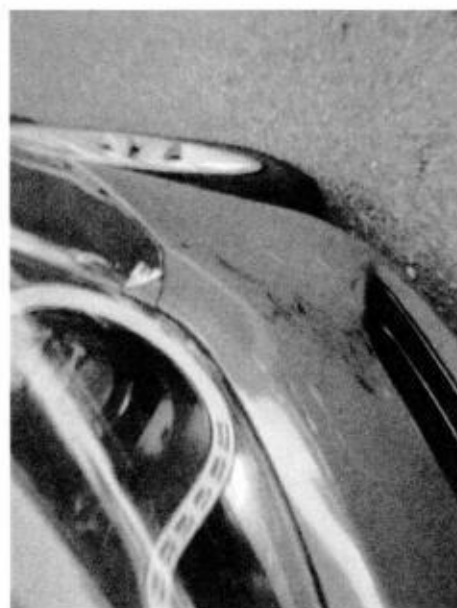
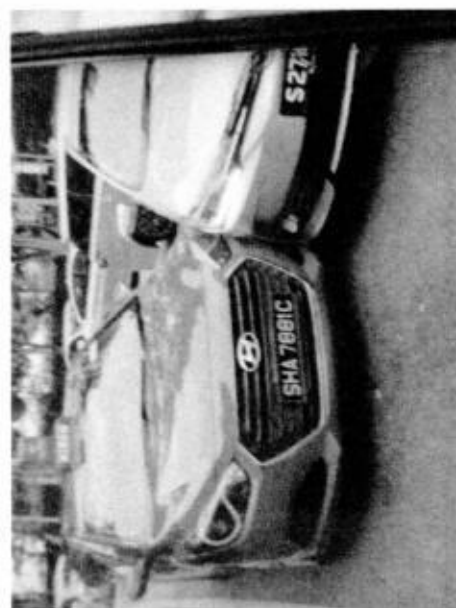
My vehicle suffered dented on the left front bumper, headlight cracked and front wheel not straight. NTUC insurance came and requested us to move our vehicle as not to obstruct the traffic. The other driver and NTUC insurance then left the incident location. I contacted my comfort company and at about 7pm, my company tow truck came and towed away my vehicle.

Qty	Description of Parts	Condition	Estimate By Workshop (\$)	Our Adjusted (\$)
<u>REPLACEMENT OF PARTS</u>				
1	FRONT BUMPER COVER	CUT	1,052.20	1,052.20
1	FRONT BUMPER BRACKET TOP (LH)	SERVICEABLE	22.40	-
1	FRONT BUMPER BRACKET (LH)	SERVICEABLE	24.60	-
1	HEADLAMP (LH)	CRACKED	1,388.00	1,388.00
1	FRONT FENDER (LH)	TO REPAIR SEE LABOUR	566.30	-
1	FRONT FENDER SHIELD (LH)	SERVICEABLE	175.90	-
1	FRONT FENDER RETAINER	SERVICEABLE	24.60	-
1	FRONT WHEEL HUB CAP, LH	SERVICEABLE	107.10	-
	LESS 20% DISCOUNT		-672.22	-488.04
			2,688.88	1,952.16
<u>SPECIAL NETT ITEMS</u>				
1	FRONT FENDER ADVERTISEMENT LOGO (LH)(SN)	NECESSARY	100.00	100.00

100.00	100.00
<u>LABOUR</u>				
	PANEL BEATING. INCLUSIVE OF THE REPAIR OF FRONT FENDER (LH).		560.00	280.00
	SPRAY PAINTING CHARGE.		500.00	400.00
	WIRING.		50.00	20.00
	TUFF KOTE.	NOT NECESSARY	50.00	-
	FRT WHEEL ALIGNMENT.	NOT NECESSARY	80.00	-
			1,240.00	700.00
GRAND TOTAL			4,028.88	2,752.16
RECOMMENDED COST OF LUMP SUM REPAIRS (TO ITS PRE-ACCIDENT CONDITION) (CONFIRMED)				2,200.00
