REF: NS/INC 19018717/ K1 v f302

REPORT OF A TRAFFIC ACCIDENT

ADJUSTMENT ON REPAIR COST FOR VEHICLE NO. SHC 8518K

Report Ref No. NS/INC19018717/K1vf3e2

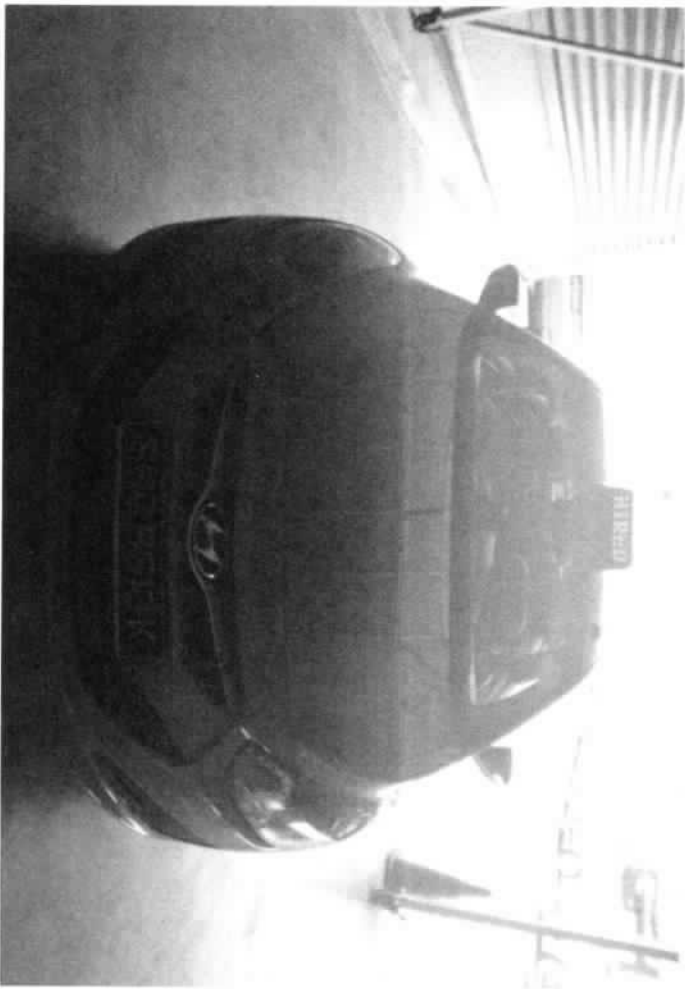
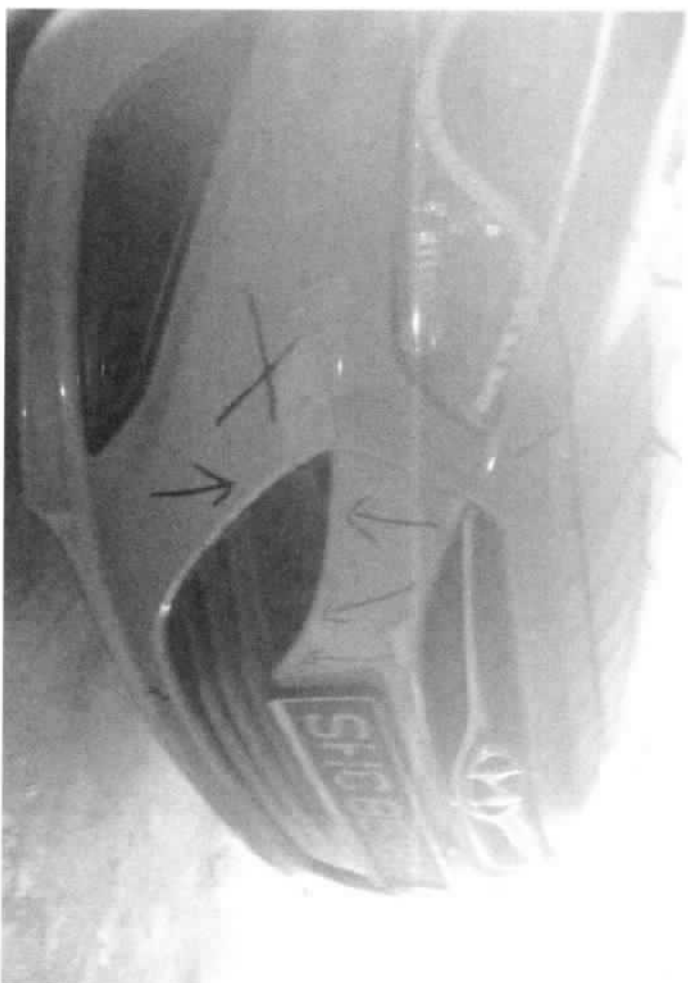
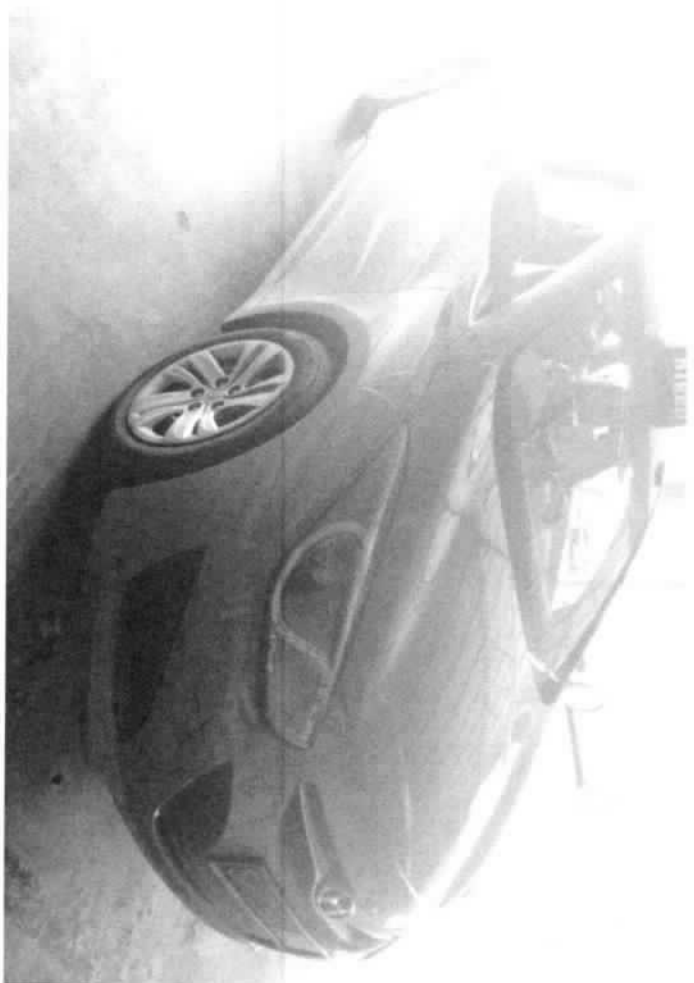
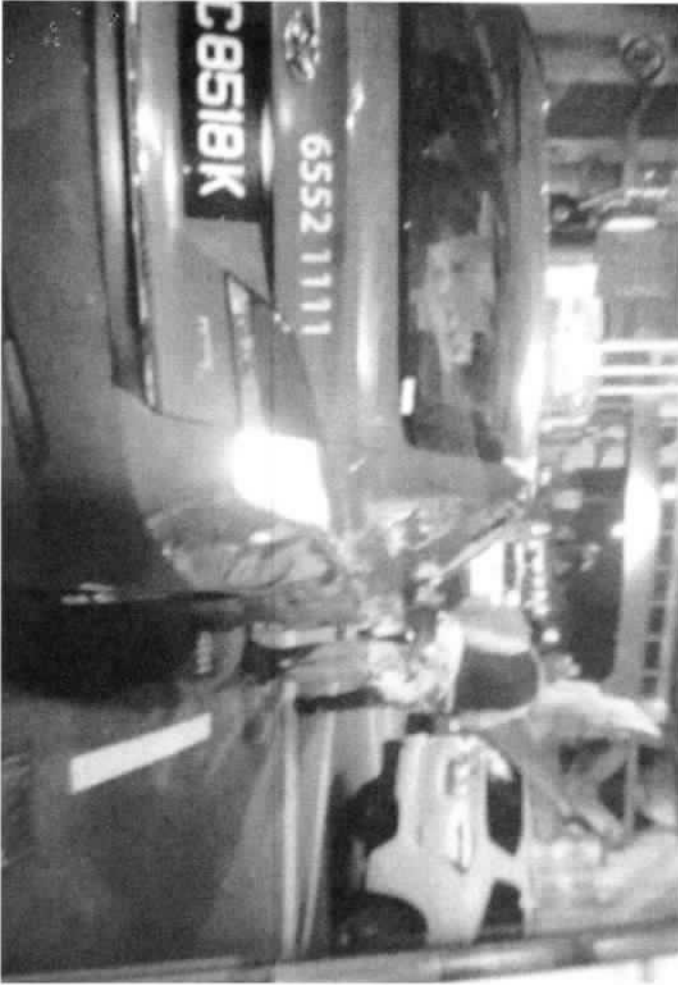
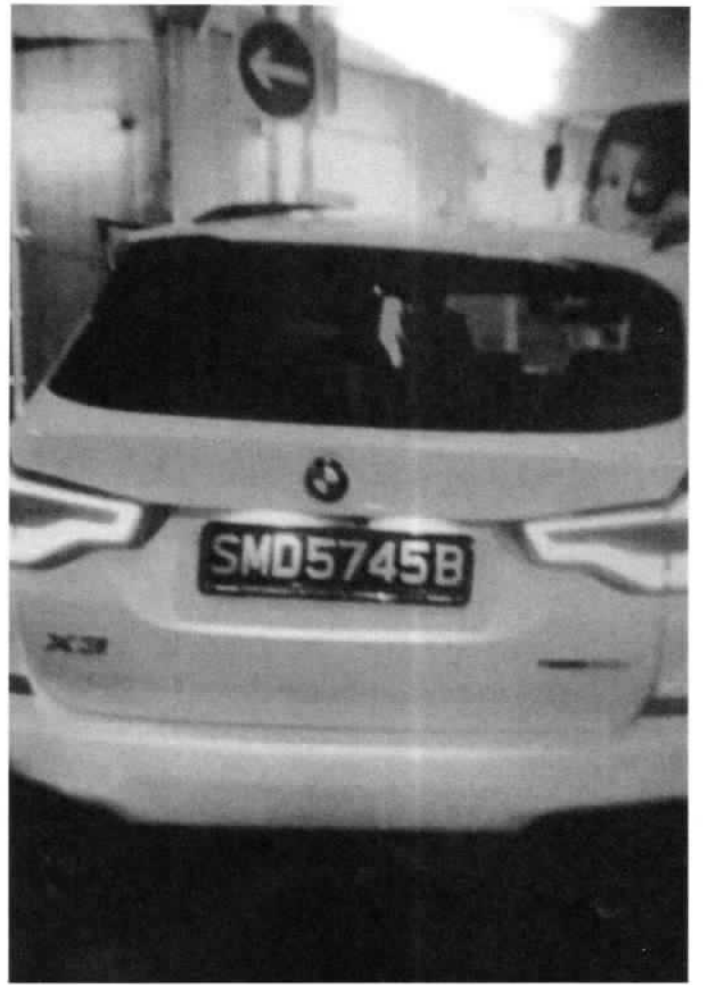
The U/C / Chassis frame / Body Structure affected due to collision.

My taxi sustained dents and scratches on the front right portion of my car.

4. Description of Damages			
THE VEHICLE SUSTAINED DAMAGES AT THE FRONT O/S PORTION. DAMAGES SEE DETAILS.			
5. General Information			
Accident Date	19/10/2019	Inspection Date	22/10/2019
Survey held at	COMFORTDELGRO ENGINEERING PTE LTD 59 LOYANG DRIVE SINGAPORE 508969		
5a. Remarks			
A)THE INSPECTION WAS CONDUCTED ON A"WITHOUT PREJUDICE" BASIS. B)IN ACCORDANCE TO YOUR INSTRUCTIONS, WE HAVE NOT AUTHORISED REPAIRS.			
5b. Estimate Days of Repair			
ESTIMATED NORMAL PERIOD FOR REPAIR:		2 Working Days

Qty	Description of Parts	Condition	Estimate By Workshop (\$)	Our Adjusted (\$)
<u>REPLACEMENT OF PARTS</u>				
1	FRONT BUMPER COVER	CRACKED	1,052.20	553.00
1	FRONT BUMPER CENTRE GRILLE	SERVICEABLE	178.60	-
2	FRONT BUMPER CENTRE GRILLE TOP GARNISH @\$80.00	SERVICEABLE	160.00	-
2	FRONT BUMPER BRACKET TOP (LH/RH) @\$22.40	SERVICEABLE	44.80	-
2	FRONT BUMPER BRACKET (LH/RH) @\$24.60	SERVICEABLE	49.20	-
1	FRONT BUMPER CLIPS (NPA)	NECESSARY	-	-
	LESS 20% DISCOUNT		-296.96	-110.60
			1,187.84	442.40
<u>SPECIAL NETT ITEMS</u>				
1	FRONT NUMBER PLATE (SN)	SERVICEABLE	25.00	-
1	FRONT NO PLATE TRIM COVER (SN)	SERVICEABLE	30.00	-

750.00	480.00
GRAND TOTAL			1,992.84	922.40
RECOMMENDED COST OF LUMP SUM REPAIRS (TO ITS PRE-ACCIDENT CONDITION) (CONFIRMED)				750.00
