## **ACCIDENT INVOLVING SGM1028M & SGR6720M ON 19-10-2019**

| <b><u>Preliminary Advice</u></b> | | | |

## VEHICLE DAMAGE INSPECTION REPORT

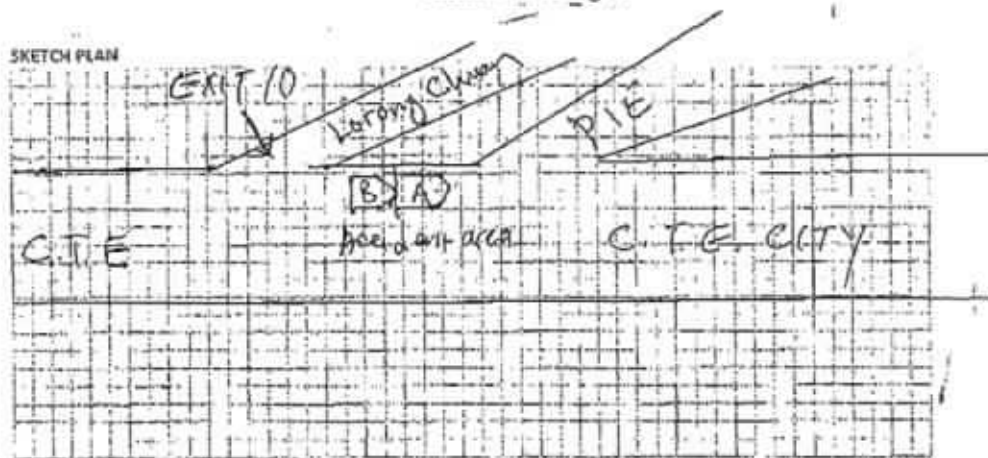
## SKETCH PLAN

On 19 Oct 2019, I was travelling along CTE towards PIE around 10:30 am. Somewhere near Exit 10, the car in front of me stopped and I followed and stopped too. However, the vehicle behind suddenly, there was a loud bang behind my car. The impact was very great. I got a shock and came out to investigate. I saw the back of my car was badly damaged by Vehicle No. SGR 6720 M. The driver who came out and he acknowledged his fault. We exchanged particulars and took pictures of the damaged vehicles. The driver of Vehicle No. SGR 6720 M asked me to provide with the claim against his insurance. About now, I felt my neck and back pain. I went to the nearby clinic at my place for consultation and was given 2 days rest & medication.
