1. Policy Particulars :- THIRD PARTY CLAIM			
Insured Veh.	GBF 6184H	Veh. Inspected	SH 6253E
Policy No.	5087277026-02	Coverage (\$)	0.00
Claim No.	MT/1069227-001	Excess (\$)	0.00
Assign From		Assign Date	24/10/2019

4. Description of Damages			
THE VEHICLE SUSTAINED DAMAGES AT THE REAR N/S PORTION.			
DAMAGES SEE DETAILS.			
5. General Information			
Accident Date	23/10/2019	Inspection Date	24/10/2019
Survey held at	COMFORTDELGRO ENGINEERING PTE LTD 59 LOYANG DRIVE SINGAPORE 508969		
5a. Remarks			
A)THE INSPECTION WAS CONDUCTED ON A"WITHOUT PREJUDICE" BASIS. B)IN ACCORDANCE TO YOUR INSTRUCTIONS, WE HAVE NOT AUTHORISED REPAIRS.			
5b. Estimate Days of Repair			
ESTIMATED NORMAL PERIOD FOR REPAIR:		2 Working Days

ADJUSTMENT ON REPAIR COST FOR VEHICLE NO. SH 6253E

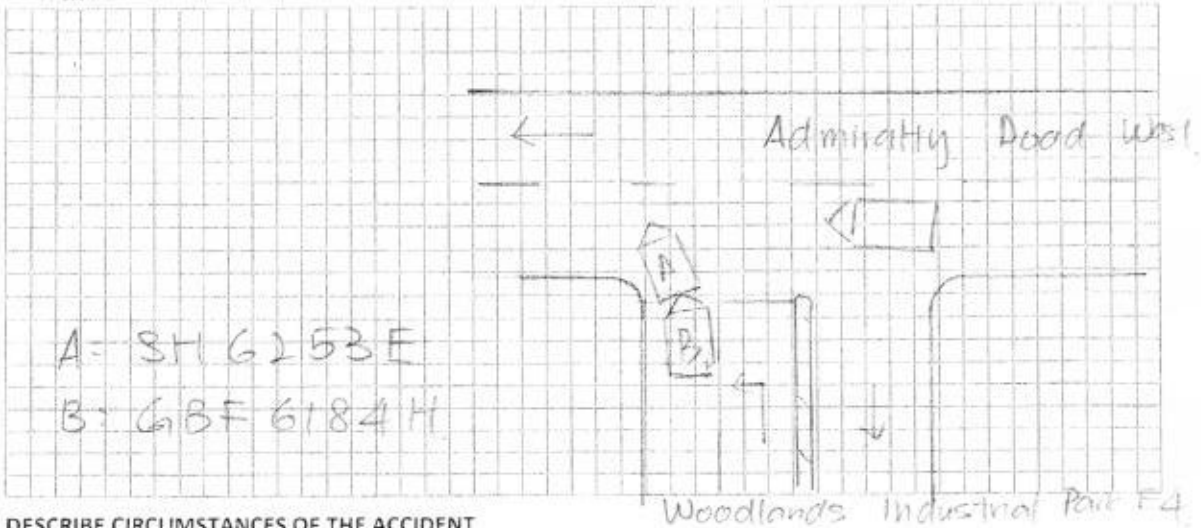
SKETCH PLAN

On 23/10/19 at about 12:25 hrs, I wanted to turn left at above said junction. I applied brake to stop my taxi upon seeing a lorry oncoming along main road. A split second later, I felt an impact from behind followed by a jerk. Ven B front portion collided onto the rear portion of my taxi. No passenger in my taxi. I feel pain on my right hand, will consult doctor later on.

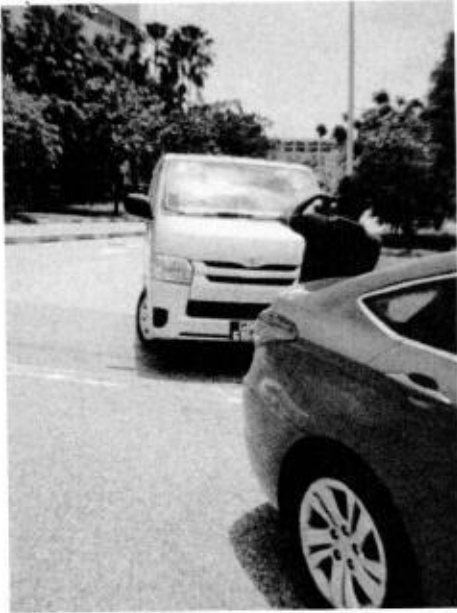
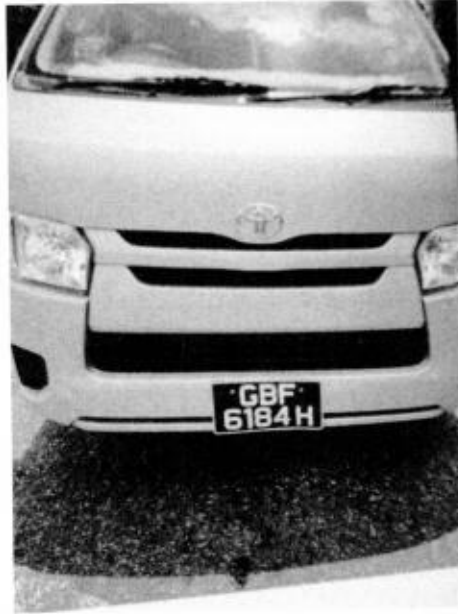
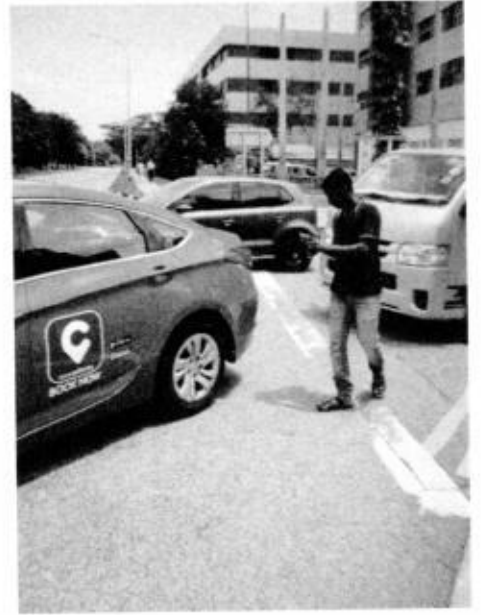
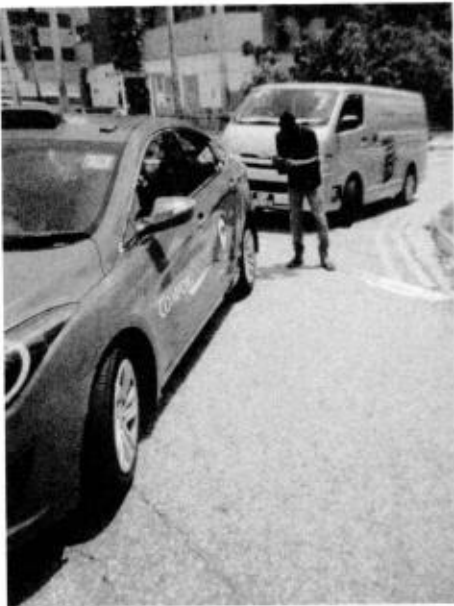
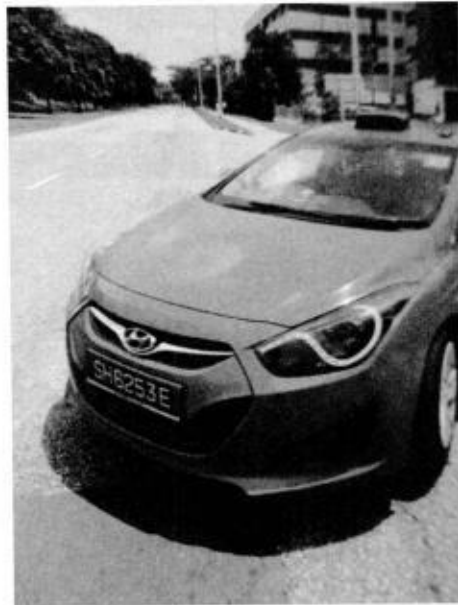
Qty	Description of Parts	Condition	Estimate By Workshop (\$)	Our Adjusted (\$)
<u>REPLACEMENT OF PARTS</u>				
1	REAR BUMPER	DEFORMED	553.00	553.00
10	REAR BUMPER CLIP	NECESSARY	22.00	22.00
2	REAR BUMPER BRACKET @\$35.60	SERVICEABLE	71.20	-
1	REAR BUMPER UNDER COVER	CUT	228.00	228.00
	LESS 20% DISCOUNT		-174.84	-160.60
			699.36	642.40
<u>SPECIAL NETT ITEMS</u>				
1	REAR BUMPER REVERSE SENSOR (SN)	SERVICEABLE	135.70	-
			135.70	-
<u>LABOUR</u>				
	PANEL BEATING.		350.00	280.00
	SPRAY PAINTING CHARGE.		250.00	200.00
	WIRING CHARGE.	NOT NECESSARY	50.00	-
	REMOVE / REFIX REVERSE SENSOR.		80.00	30.00
			730.00	510.00
GRAND TOTAL			1,565.06	1,152.40
RECOMMENDED COST OF LUMP SUM REPAIRS (TO ITS PRE-ACCIDENT CONDITION) (CONFIRMED)				900.00
