NTUC INCOME INSURANCE CO-OPERATIVE LTD Ref: NS/INC19019125/K1vf3e2

1. Policy Particulars :- THIRD PARTY CLAIM

4. Description of Damages

ADJUSTMENT ON REPAIR COST FOR VEHICLE NO. SHA 4979A

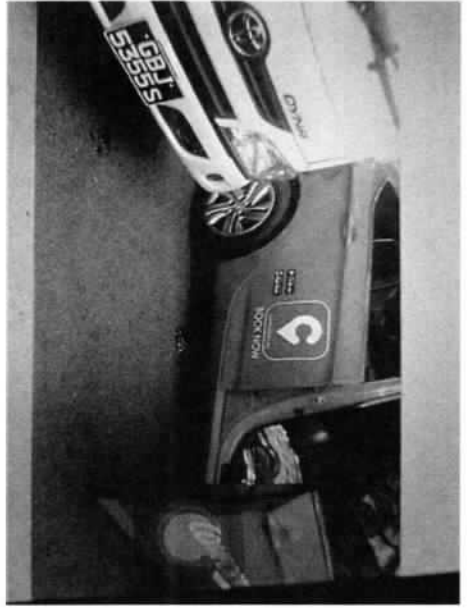
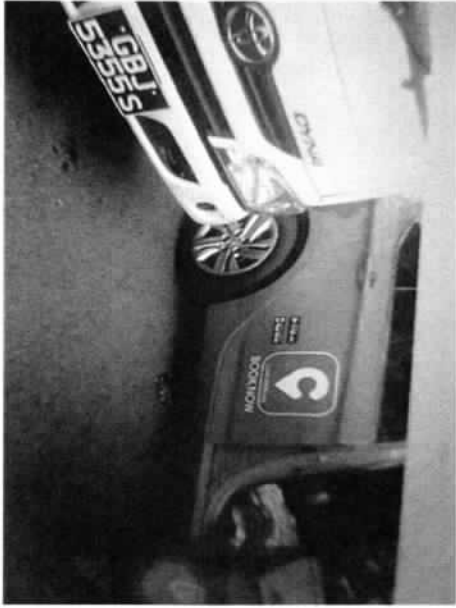
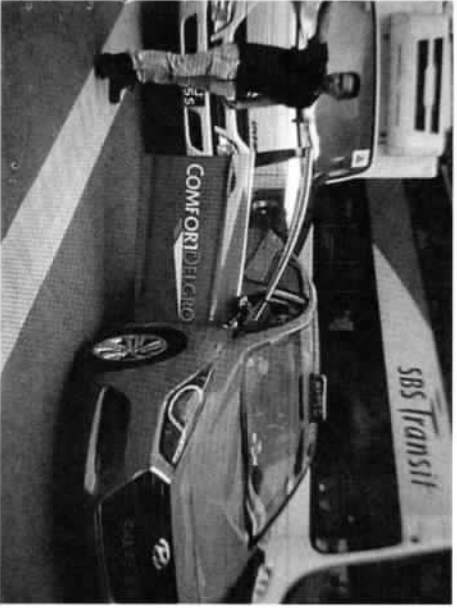
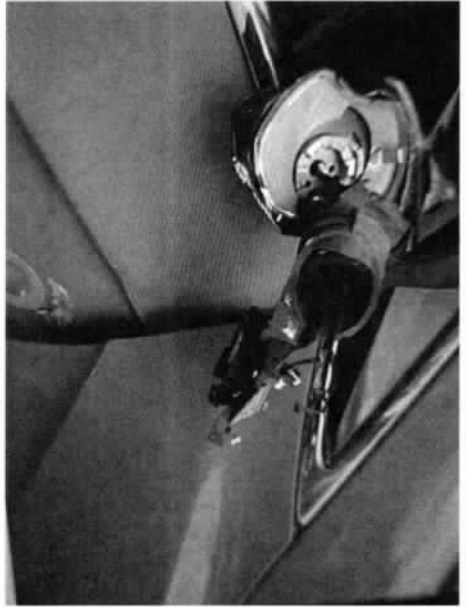
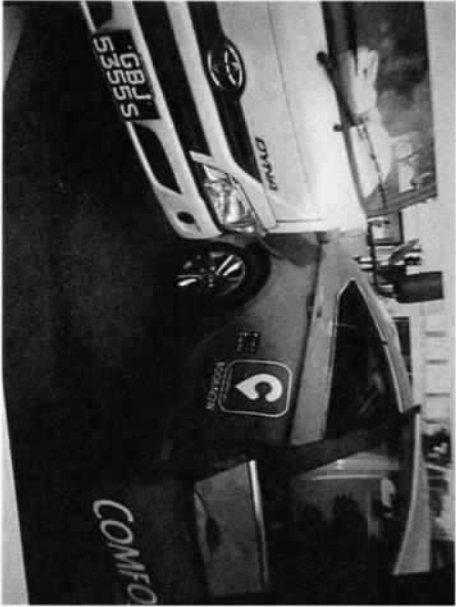
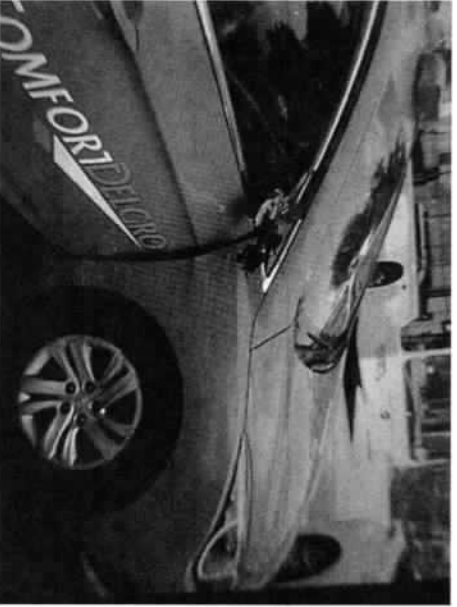
THE VEHICLE SUSTAINED DAMAGES AT THE O/S FRONT PORTION. DAMAGES SEE DETAILS.

Qty	Description of Parts	Condition	Estimate By Workshop (\$)	Our Adjusted (\$)
<u>REPLACEMENT OF PARTS</u>				
1	FRONT DOOR (RH)	BUCKLED	2,256.40	2,256.40
1	FRONT DOOR MIRROR ASSY (RH)	BROKEN	670.00	670.00
1	FRONT WHEEL HUB CAP (RH)	GRAZED	107.10	107.10
1	FRONT FENDER (RH)(NPA)	TO REPAIR SEE LABOUR	-	-
1	REAR DOOR (RH)(NPA)	TO REPAIR SEE LABOUR	-	-
	LESS 20% DISCOUNT		-606.70	-606.70
			2,426.80	2,426.80
<u>NETT ITEMS</u>				
1	FRONT DOOR COMFORT LOGO (RH)(N)	NECESSARY	75.00	75.00
1	FRONT DOOR ADVERTISEMENT LOGO (RH)(N)	NOT NECESSARY	100.00	-
1	REAR DOOR COMFORTDELGRO & APPS STICKER (RH)(N)	NECESSARY	80.00	80.00
	LESS 10% DISCOUNT		-	-15.50

RECOMMENDED COST OF LUMP SUM REPAIRS (TO ITS PRE-ACCIDENT CONDITION) (CONFIRMED)			2,800.00
--	--	--	----------
