## REPAIR ESTIMATE\*

NTUC INCOME INSURANCE CO-OPERATIVE LTD Ref: NS/INC19019132/K1qf3s2				
73 BRAS BASAH ROAD #05-01 NTUC TRADE UNION HOUSESINGAPORE 189556			Date: 05-11-2019	 
			Code: INC4	
<b>1. Policy Particulars :- THIRD PARTY CLAIM</b>				
Insured Veh.	SLM 9867X	Veh. Inspected	SHC 1912B	
Policy No.	5113072884	Coverage (\$)	0.00	
Claim No.	MT/1069496-001	Excess (\$)	0.00	
Assign From		Assign Date	29/10/2019	
<b>2. Vehicle Particulars &amp; Condition</b>				
Make & Model	HYUNDAI I40	c.c	1685	
Engine No.	HIDDEN	Year of Reg.	2017	
Chassis No.	KMHLB41UMHU100063	Colour	BLUE	
Odometer	233883	Steering	IN ORDER	
Brakes	IN ORDER	Modification	STANDARD ALLOY RIM	
General	FAIR			
<b>3. Conditions of Tyres</b>				
	Size	Make	Balance	
R/H Front Tyre	205/60 R16	HANKOOK	7 mm	
L/H Front Tyre	205/60 R16	HANKOOK	7 mm	
R/H Rear Tyre	205/60 R16	HANKOOK	7 mm	
L/H Rear Tyre	205/60 R16	HANKOOK	7 mm	
<b>4. Description of Damages</b>				
THE VEHICLE SUSTAINED DAMAGES AT THE REAR PORTION. DAMAGES SEE DETAILS.

**ADJUSTMENT ON REPAIR COST FOR VEHICLE NO. SHC 1912B**

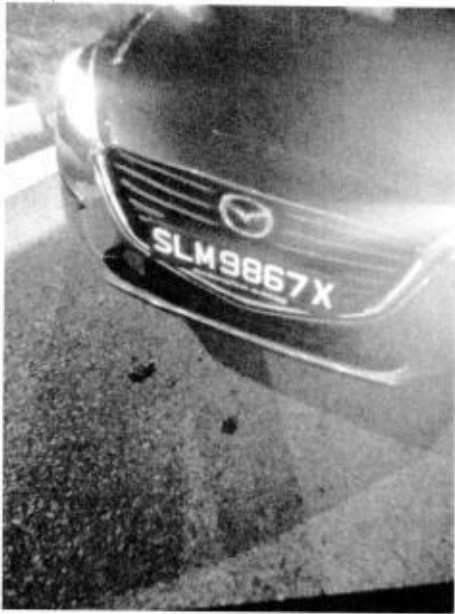
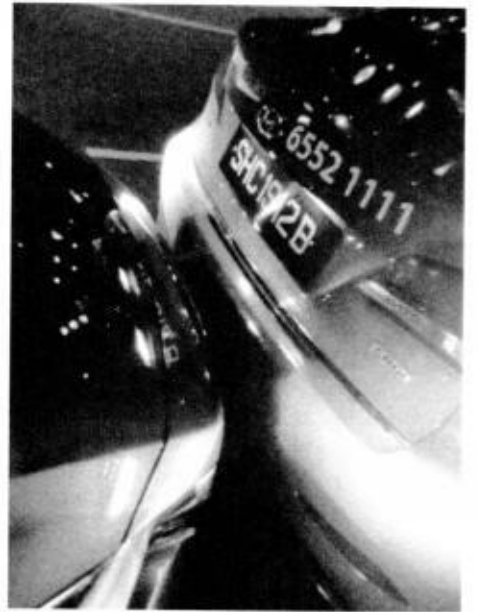
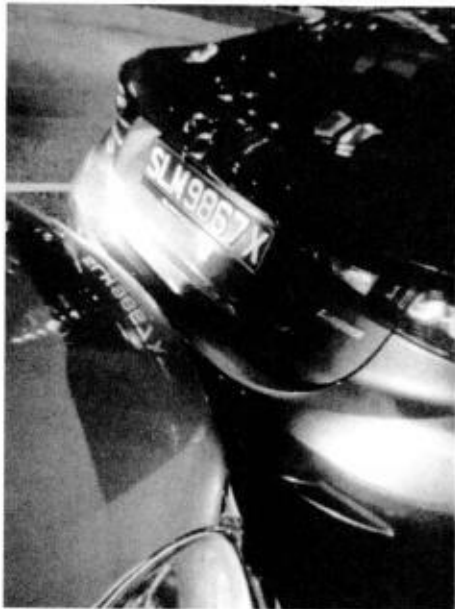
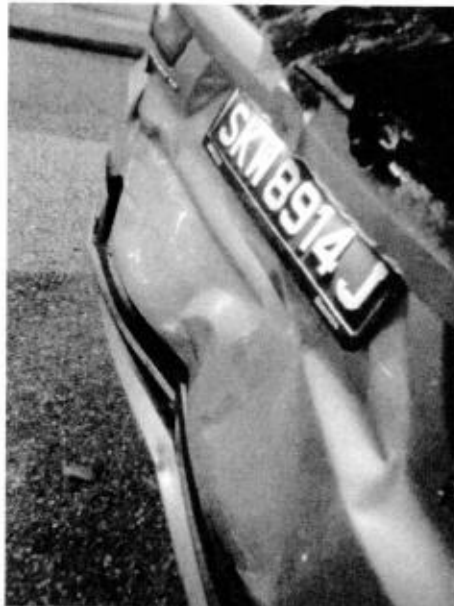
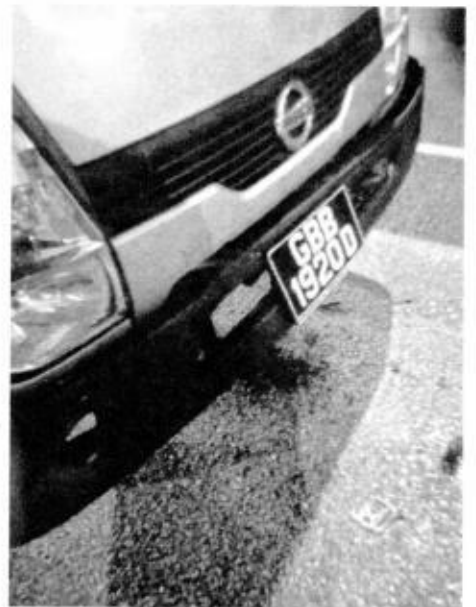
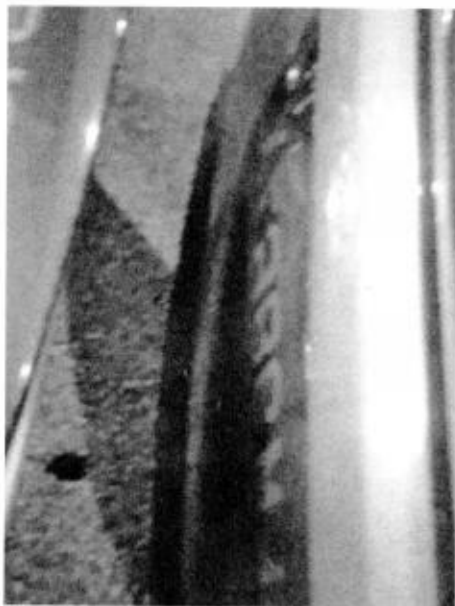
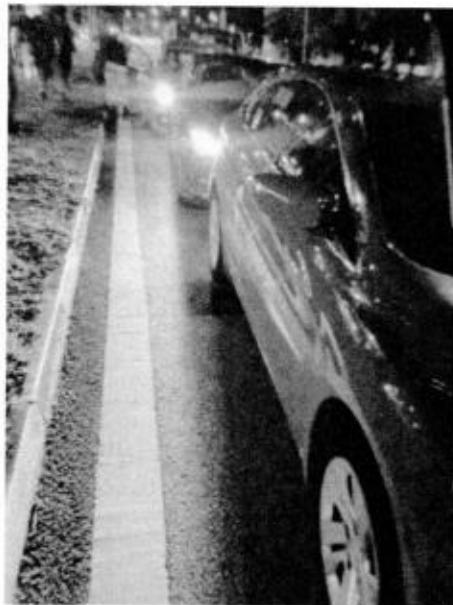
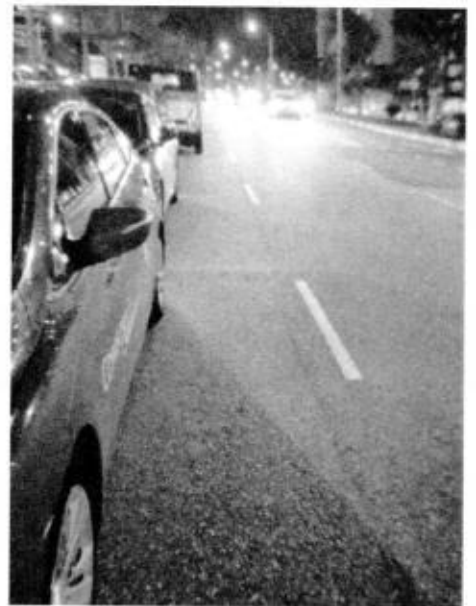
Photos

The UIC / Chassis frame / Body Structure affected due to collision.

Qty	Description of Parts	Condition	Estimate By Workshop (\$)	Our Adjusted (\$)
<b>REPLACEMENT OF PARTS</b>				
1	REAR BUMPER	TO REPAIR SEE LABOUR	553.00	-
1	REAR BUMPER REINFORCEMENT	SERVICEABLE	428.40	-
2	REAR BUMPER REINFORCEMENT BRACKET (LH/RH) @ \$80.30	SERVICEABLE	160.60	-
10	REAR BUMPER CLIP	NOT NECESSARY	22.00	-
2	REAR BUMPER BRACKET @ \$35.60	SERVICEABLE	71.20	-
1	REAR BUMPER SPONGE	SERVICEABLE	103.50	-
1	REAR BUMPER UNDER COVER	SERVICEABLE	228.00	-
	LESS 20% DISCOUNT		-313.34	-
			1,253.36	-
<b>LABOUR</b>				
	PANEL BEATING. INCLUSIVE OF THE REPAIR OF REAR BUMPER.		350.00	100.00
	SPRAY PAINTING CHARGE.		250.00	200.00
			600.00	300.00
<b>GRAND TOTAL</b>			<b>1,853.36</b>	<b>300.00</b>
<b>RECOMMENDED COST OF REPAIRS (CONFIRMED)</b>				<b>300.00</b>
