**1. Policy Particulars :- THIRD PARTY CLAIM**

Insured Veh.	SLS 5334L	Veh. Inspected	XD 8493C
Policy No.		Coverage (\$)	0.00
Claim No.	C10004447/LA	Excess (\$)	0.00
Assign From	IVY RATILLA	Assign Date	31/10/2019

**4. Description of Damages**

**ADJUSTMENT ON REPAIR COST FOR VEHICLE NO. XD 8493C**

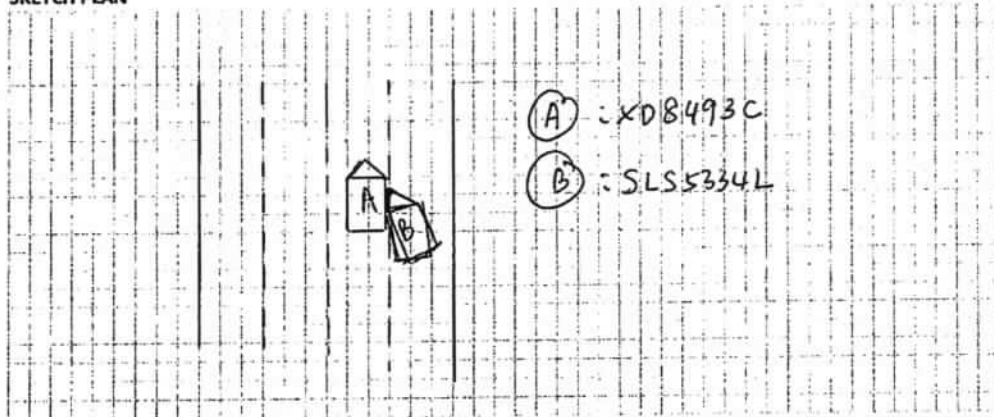
SKETCH PLAN

On 30/10/2019, when I was driving on Paya Lebar Road. I was moving very slowly at 2nd lane. Suddenly, I feel my vehicle right side was hit by the vehicle beside me. I immediately stop my vehicle and get down from my vehicle to check. I saw vehicle [SLS5334L] hit my lorry right side.
