To Inspect Vehicle No: PC L933M Insured: PA 90604

From: Tang Hock Lye <hocklye.tang@sg.cntaiping.com>
Sent: Tuesday, 5 November 2019 3:15 PM
To: Winnie Chai
Cc: Claims Dept of CTI; Jeffrey Tay; assignments@lkkauto.com
Subject: RE: OUR REF: SNM19D205180-PA9060Y-CML- Request for pre repair inspection for accident involving PC6933M & PA9060Y (yr insured) 31/10/19on

Cost of Repair to Vehicle PC6933M

VEHICLE DAMAGE INSPECTION REPORT

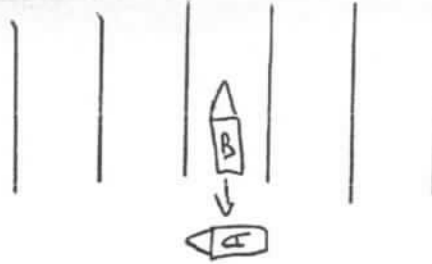
SKETCH PLAN

on 31/10/19 around 06:5hrs at Amk Ave 1 Heavy Vehicle Car Park
 My Bus PA 6933M was traveling straight, suddenly Veh B
 PA 90605 reversed out from parking lot collided onto my Bus
 right portion.
