AUTOMOBILE ASSESSMENT REPORT

ASSESSMENT OF VEHICLE NO. YN 4991 T

**ROAD TRAFFIC ACCIDENT INVOLVING MOTOR VEHICLES YN 4991T & XE 3384L ON
28.06.2019 @ 1030HRS ALONG ADMIRALTY ROAD**

VEHICLE DAMAGE INSPECTION REPORT

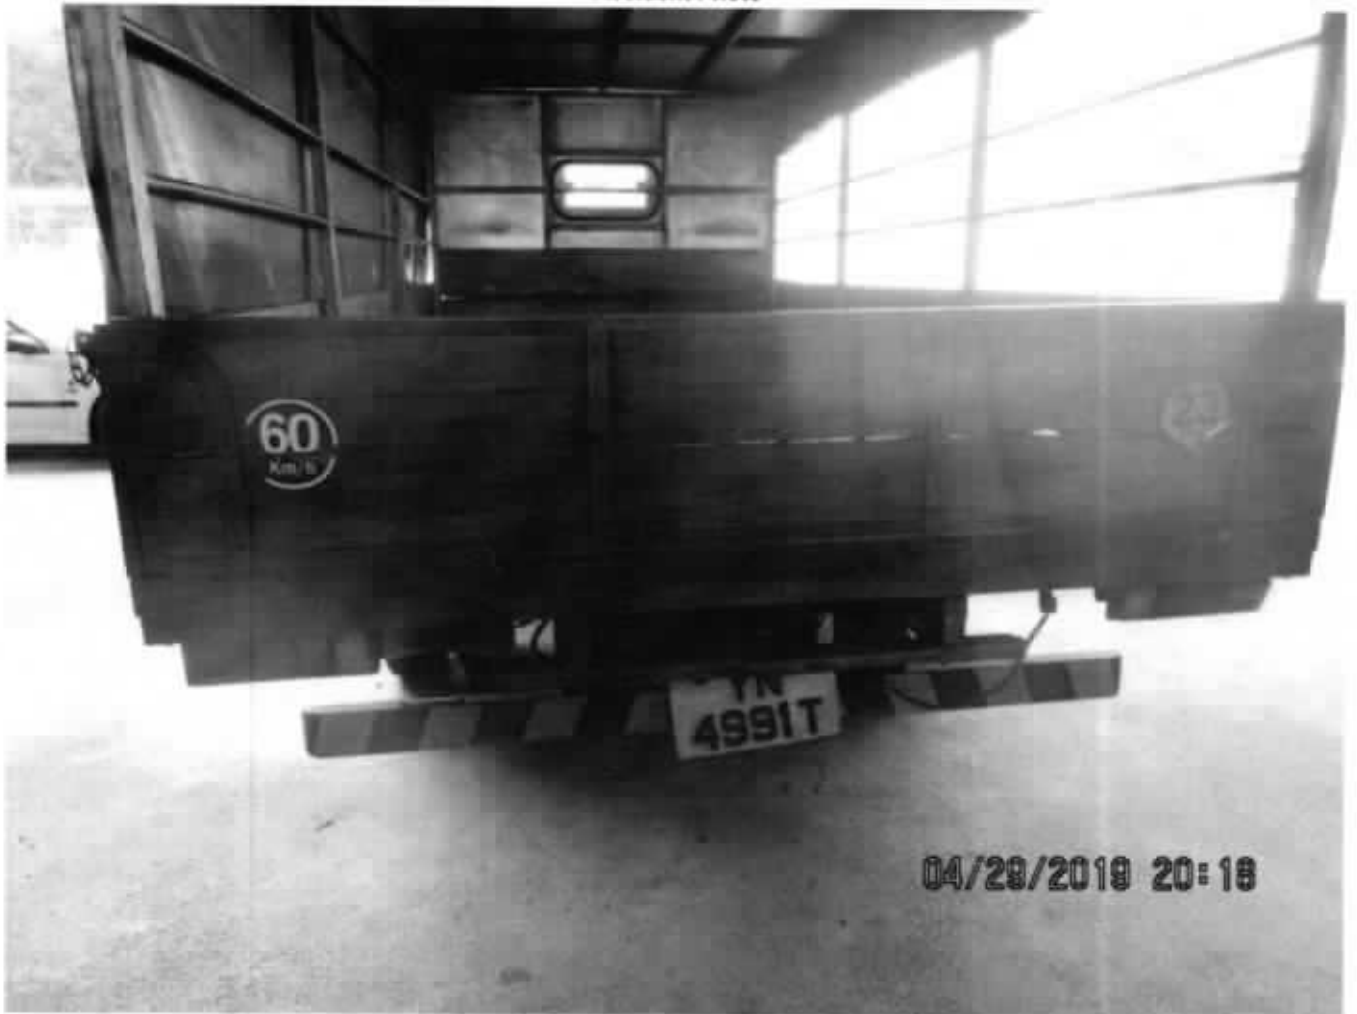
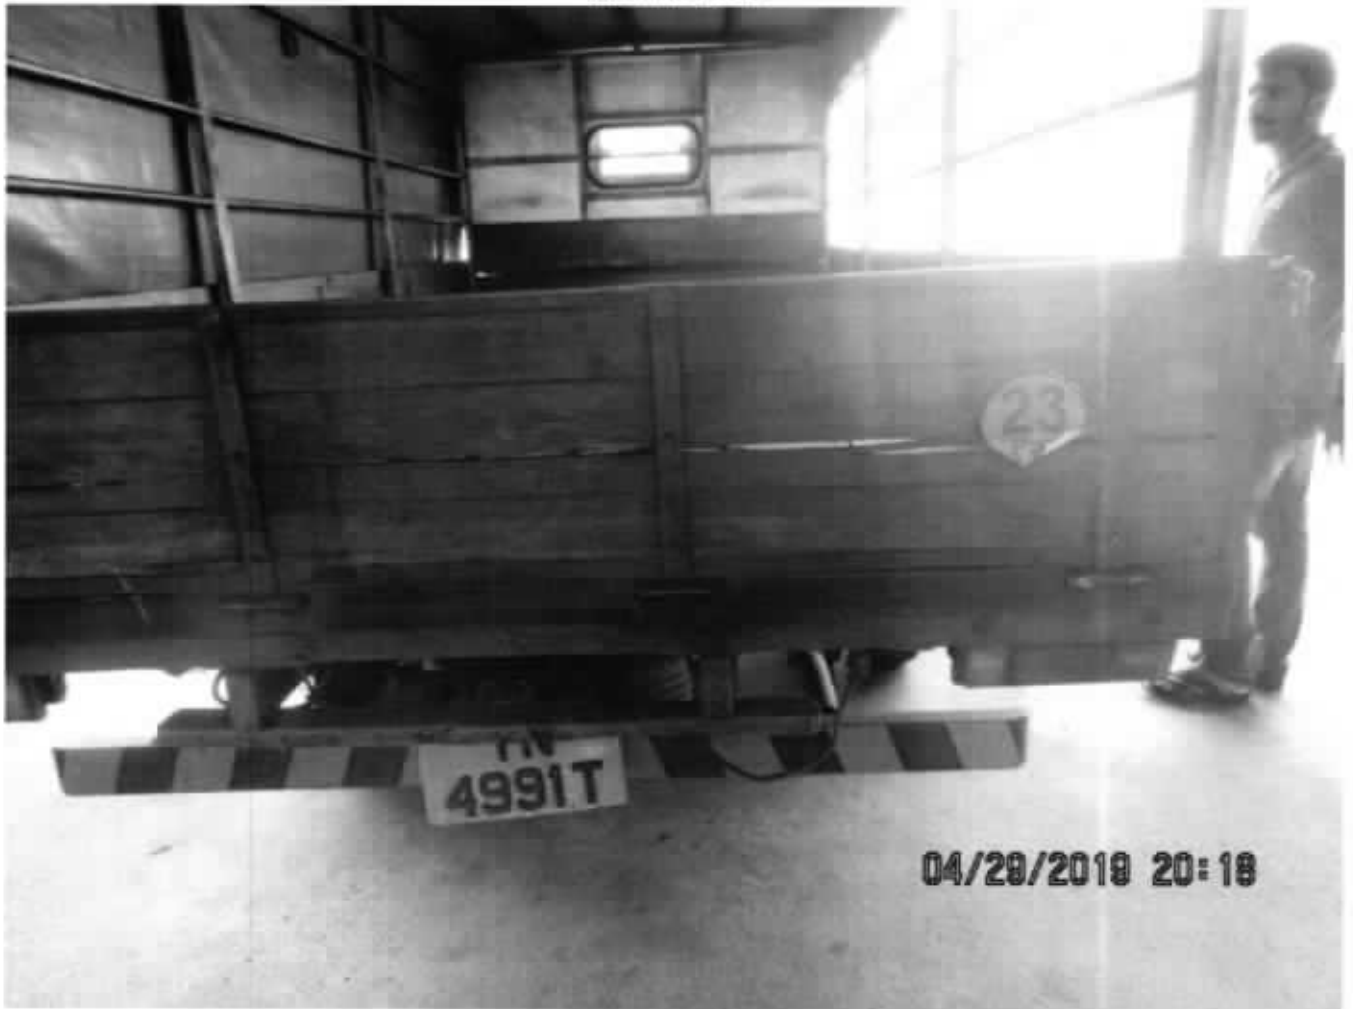
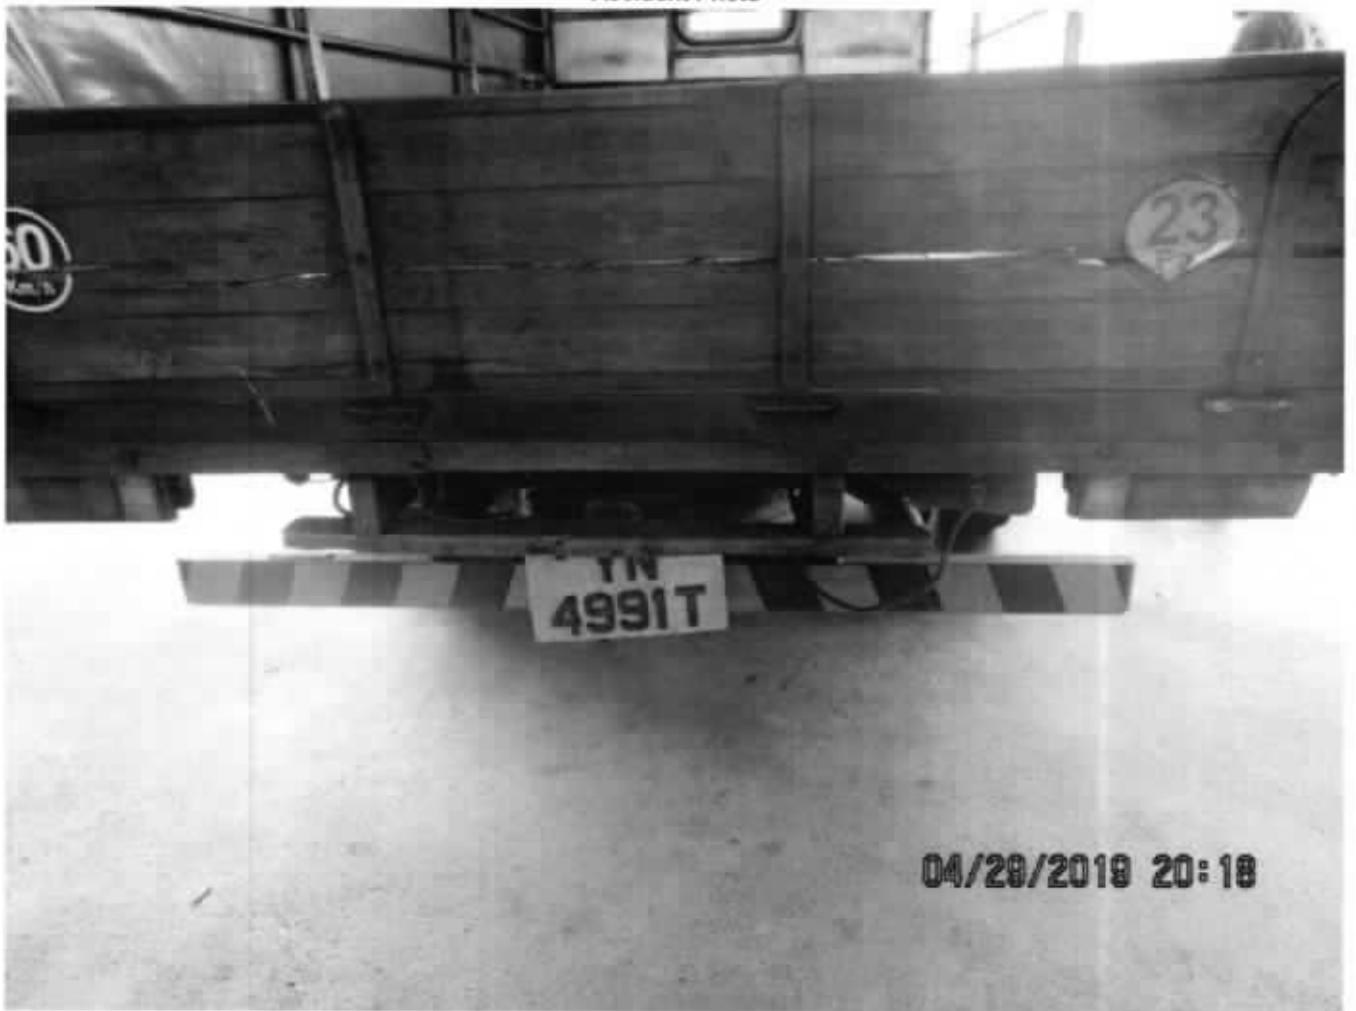
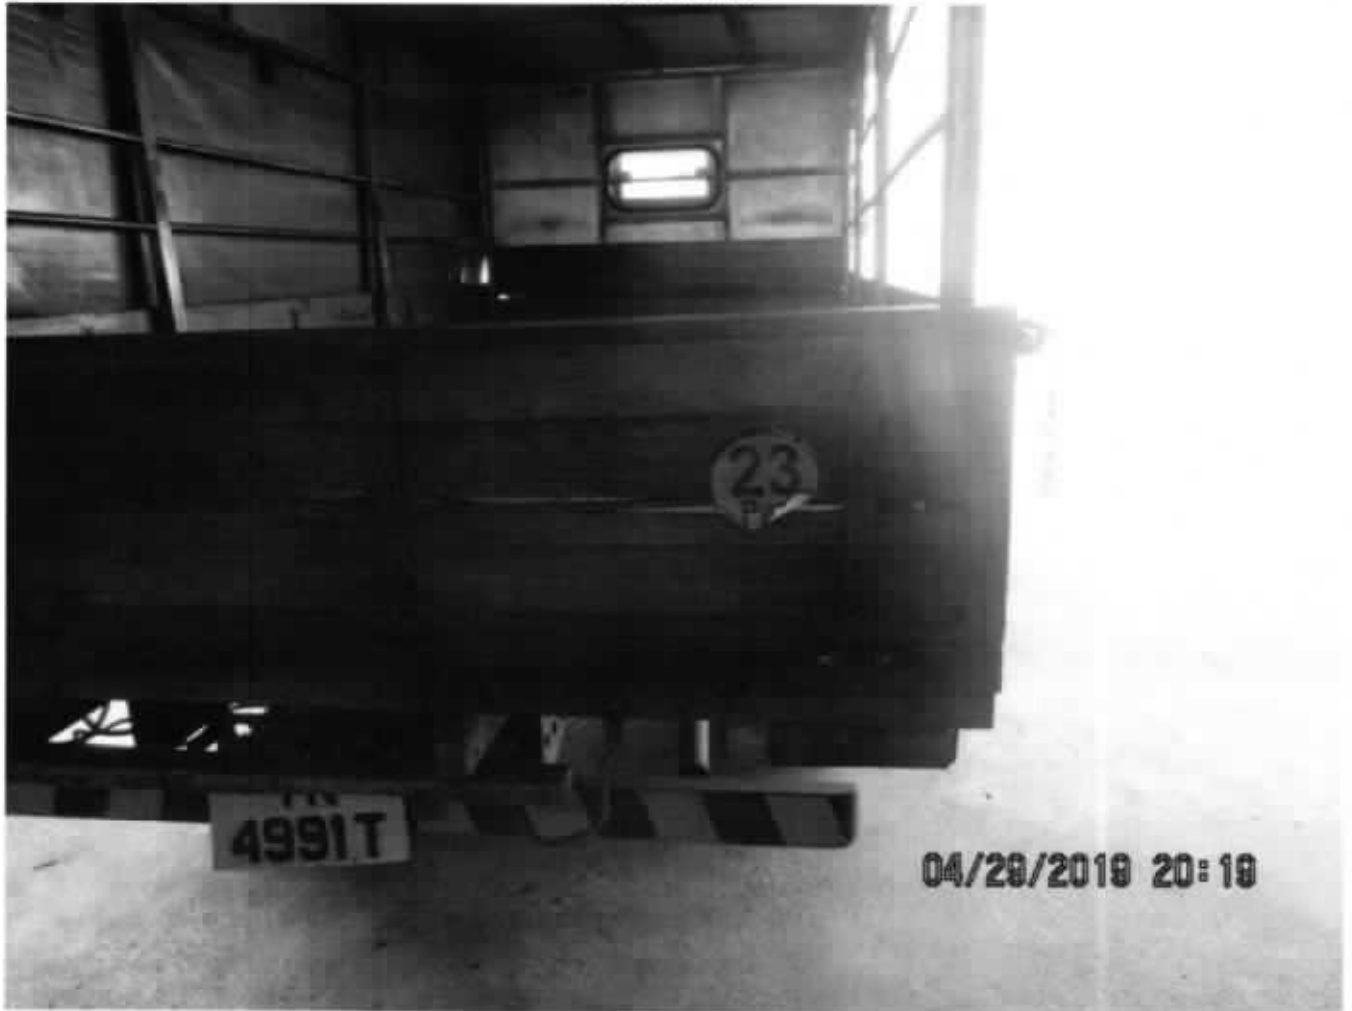
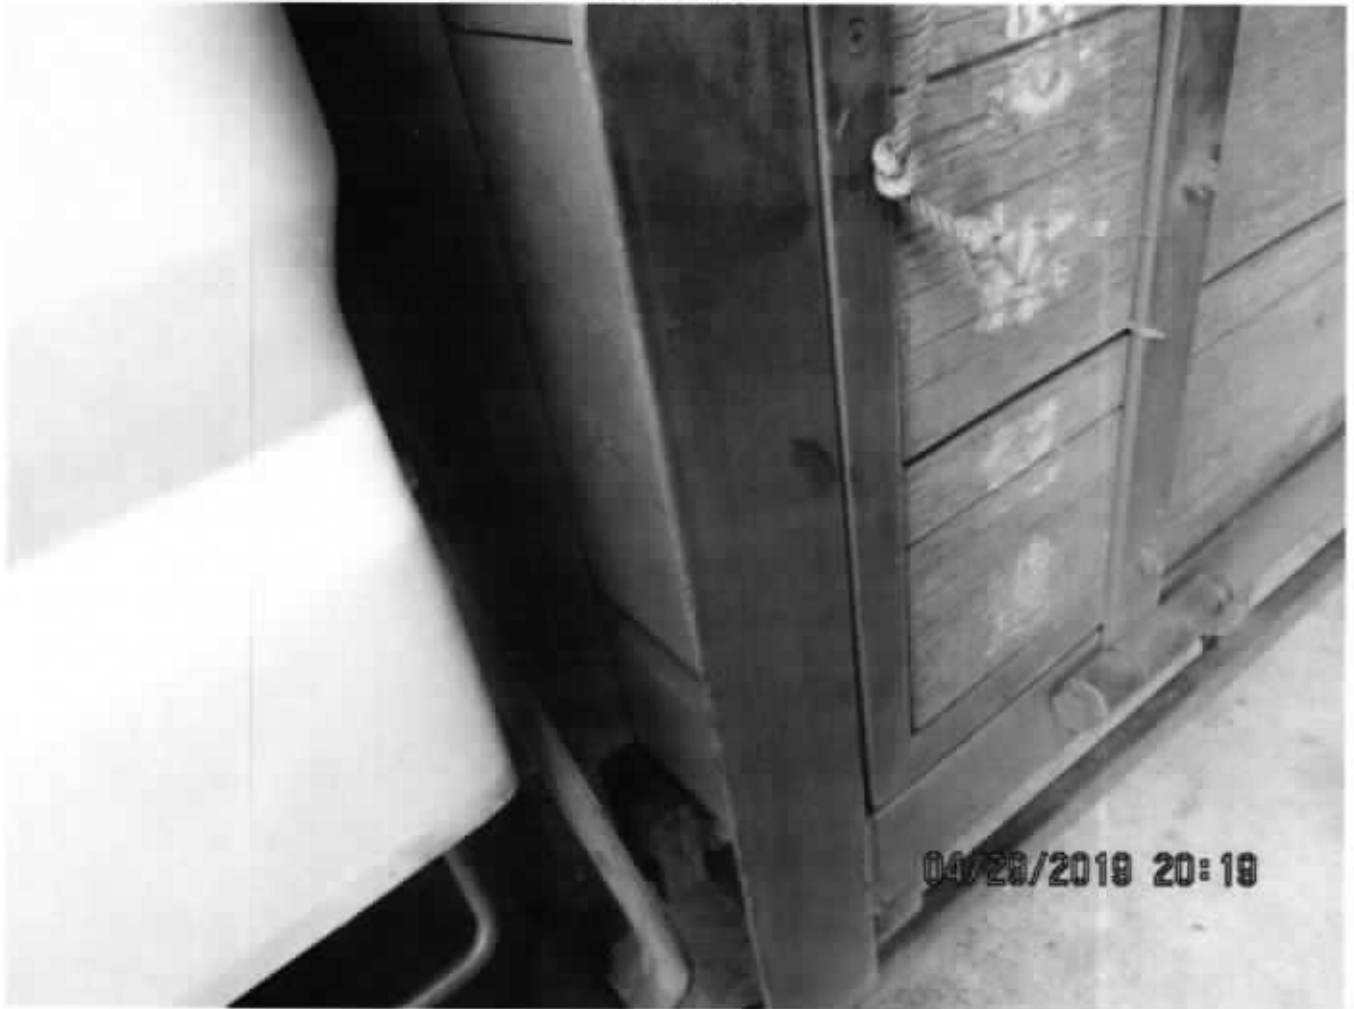
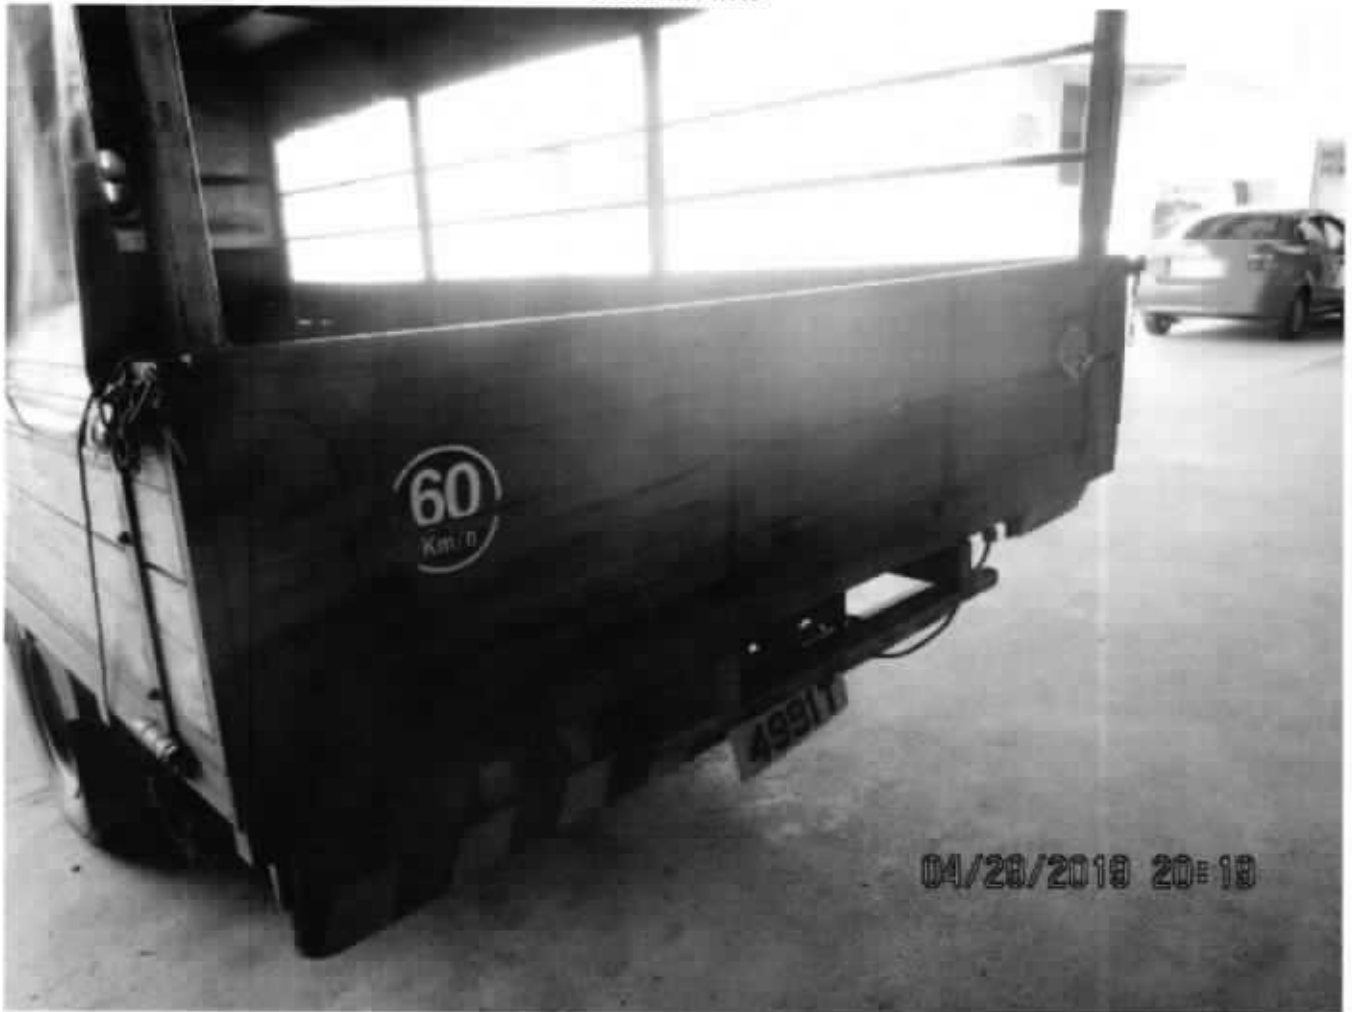
Accident Photo

At the time of the inspection, the vehicle sustained damages to the REAR portion.

MY VEHICLE WAS STOPPED AT THE JUNCTION ADMIRALTY ROAD DUE TO "RED" LIGHT INFRONT, ALL OF A SUDDEN, A TRUCK CAME FROM BEHIND AND HIT ONTO THE REAR PORTION OF MY VEHICLE.
