To Inspect Vehicle No: WC 7631U Insured: WC 6440Kat Workshop m/s AE Auto Tel: 9382 5367of 160 Sin Ming Drive #06-01Policy No: DMLVSN1A00000361900 Claim No: SNM19D205252

Date Of Report	06/11/2019 11:29
Date Of Accident	05/11/2019 19:15
Exact Location Of Accident	MARINA GROVE - (CONCRETE PLANT)
Country/State of Loss	SINGAPORE

QUOTATION -THIRD PARTY CLAIM

VEHICLE DAMAGE INSPECTION REPORT

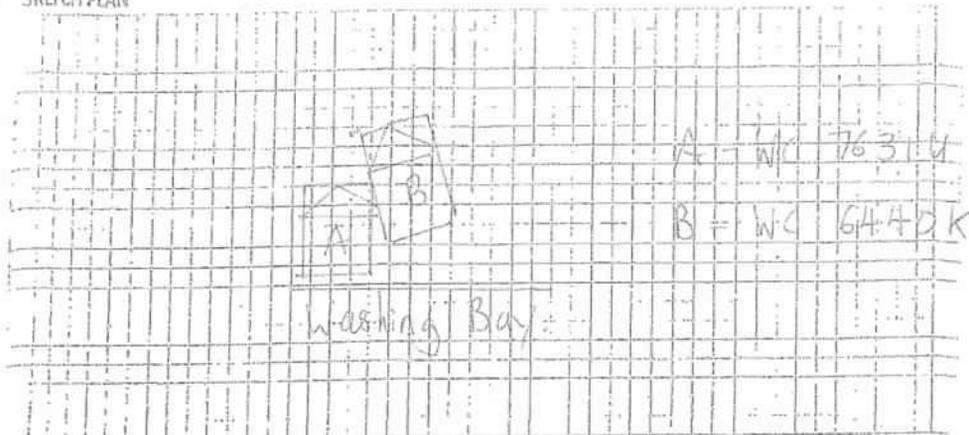
SKETCH PLAN

My vehicle stationary, In Wash bay, I was standing at the back of my vehicle waiting. (WC 76314)

Vehicle WC 6440K on my right hit onto my vehicle.

at the time of accident no one in vehicle WC 76314 was Injurd.
