CLAIMANT: CHIN LOR RENOVATION SERVICE
CLAIM ARISING FROM A ROAD TRAFFIC ACCIDENT ON 04 SEPTEMBER 2019 AT ABOUT 09:40HRS
INVOLVING MOTOR VEHICLES NO(S). GBD4324U AND FBA5045J ALONG BRADDELL ROAD
TOWARDS BARTLEY ROAD

ACCIDENT DAMAGED VEHICLE INSPECTION REPORT

VEHICLE NO : GBD4324U
 MODEL : TOYOTA DYNA 150 MANUAL

ASSESSMENT OF REPAIRS AND SPARE PARTS COSTS

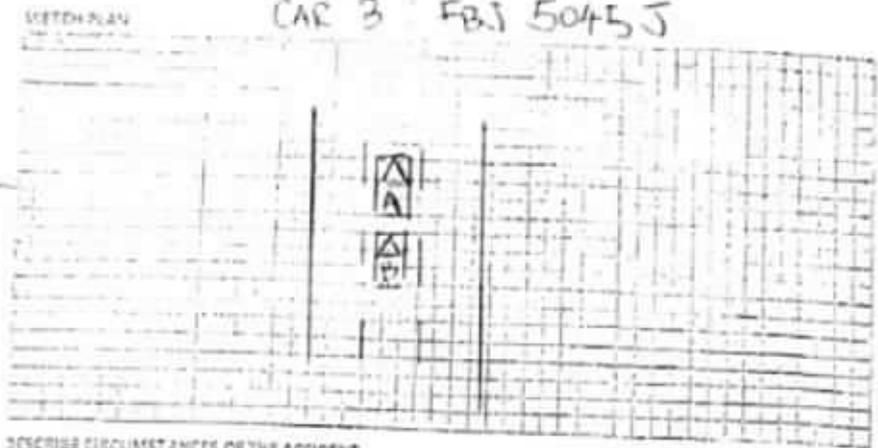
Along BRADDELL ROAD
TO BARTLEY ROAD

CAR A 32U 1324U
CAR B FB3 5045J

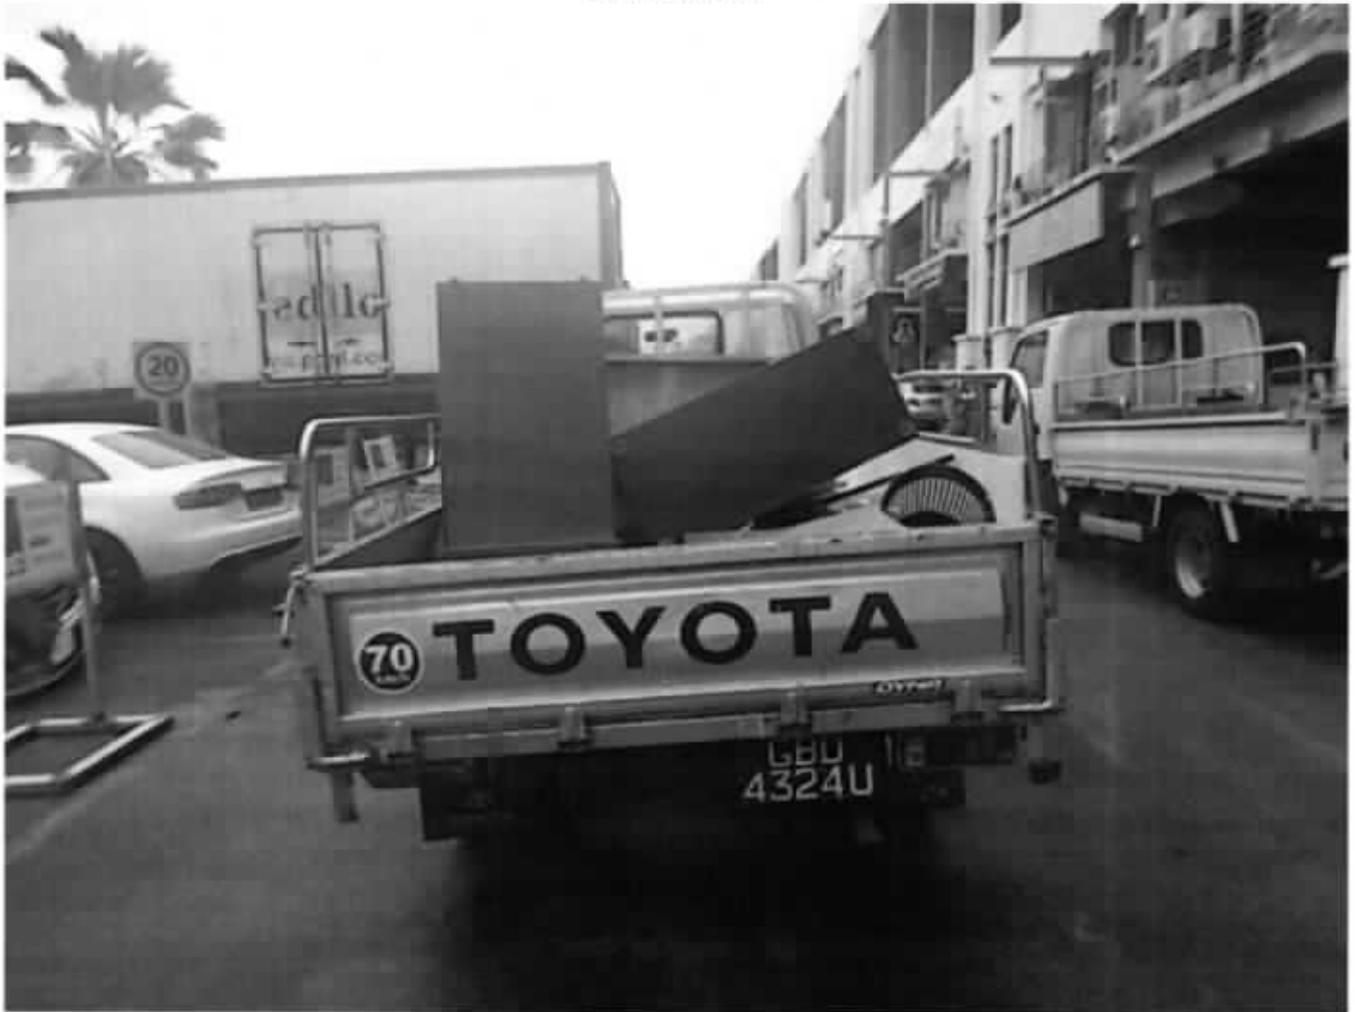
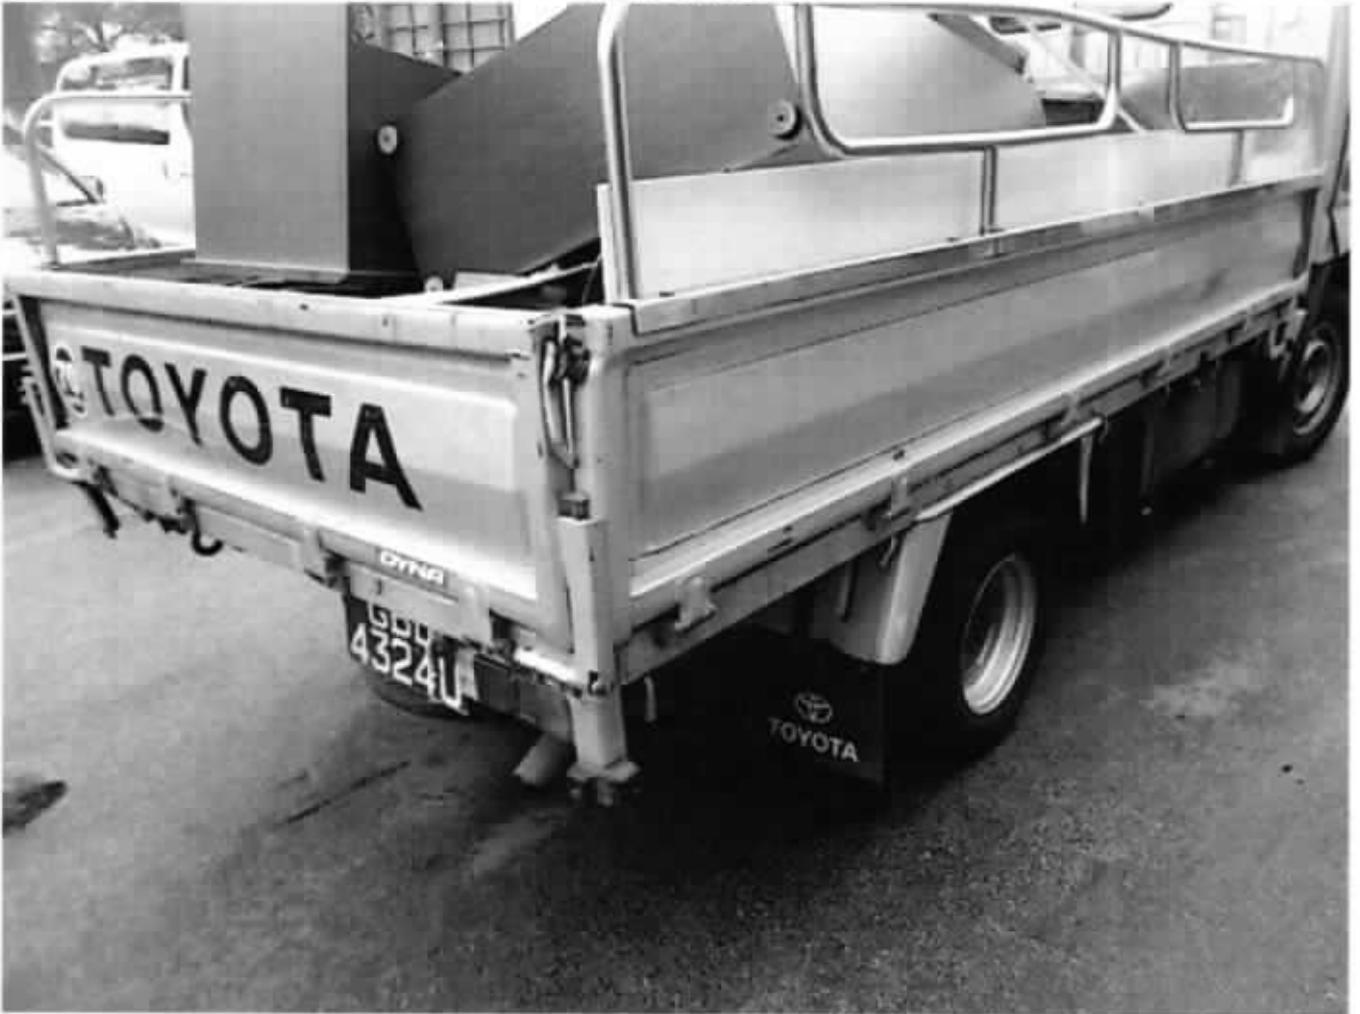
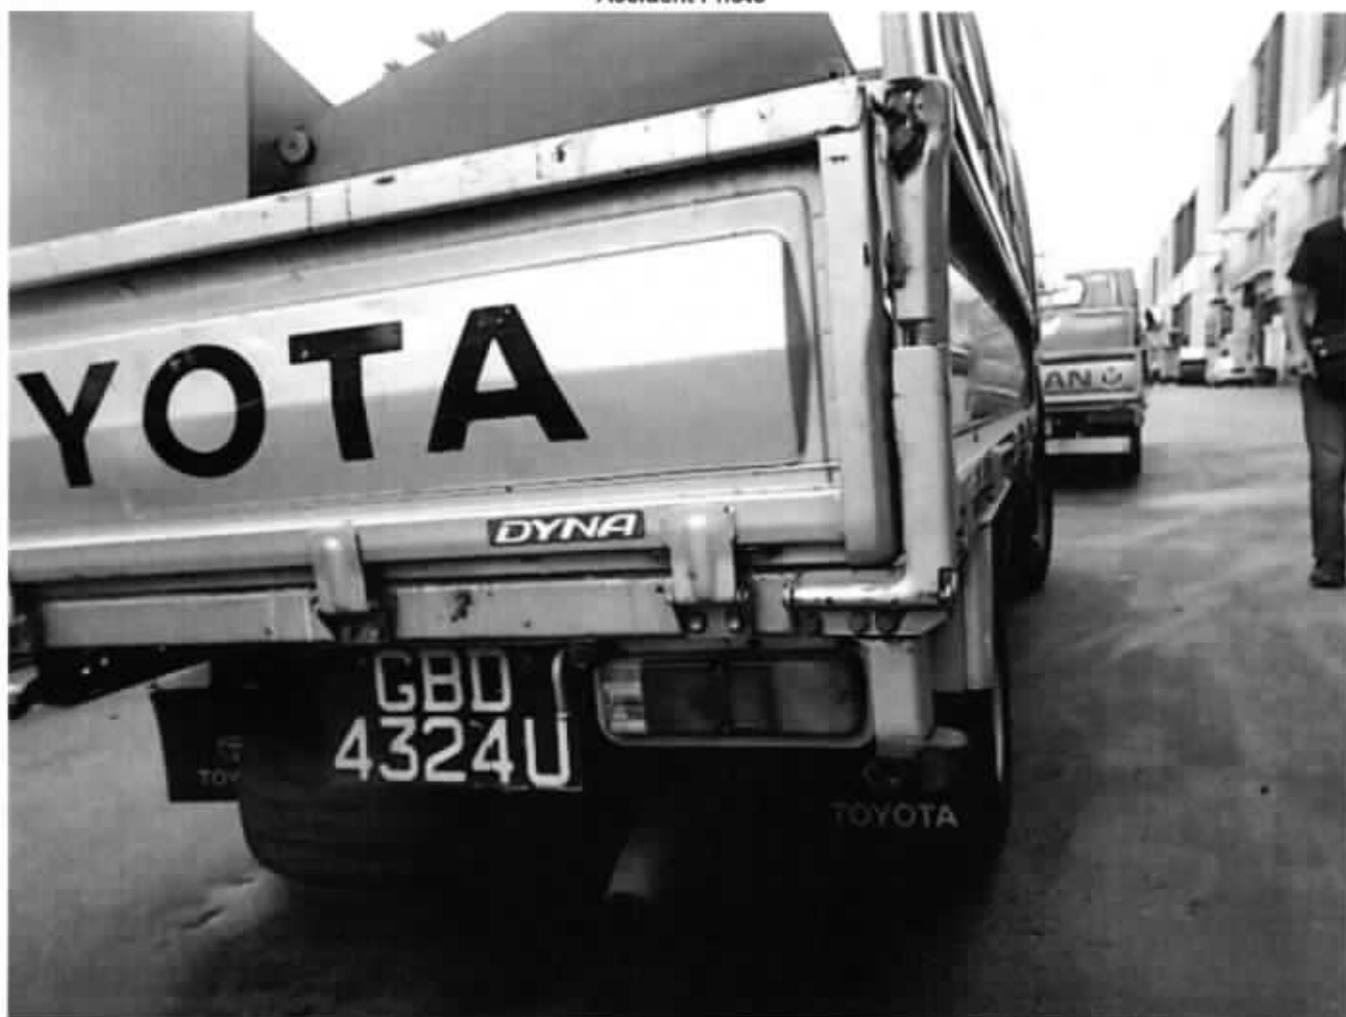
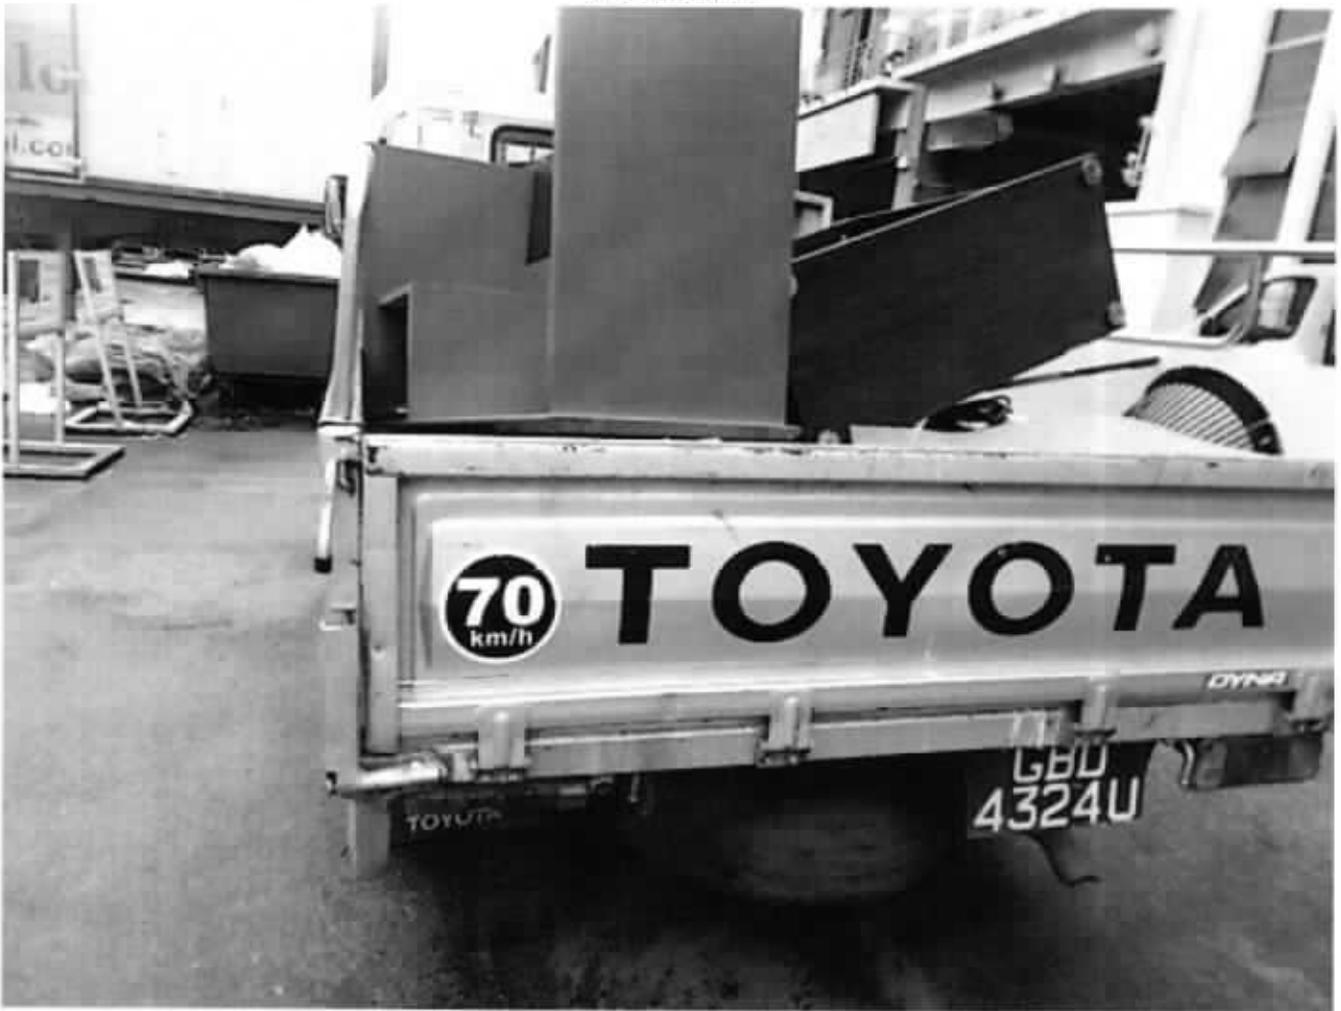
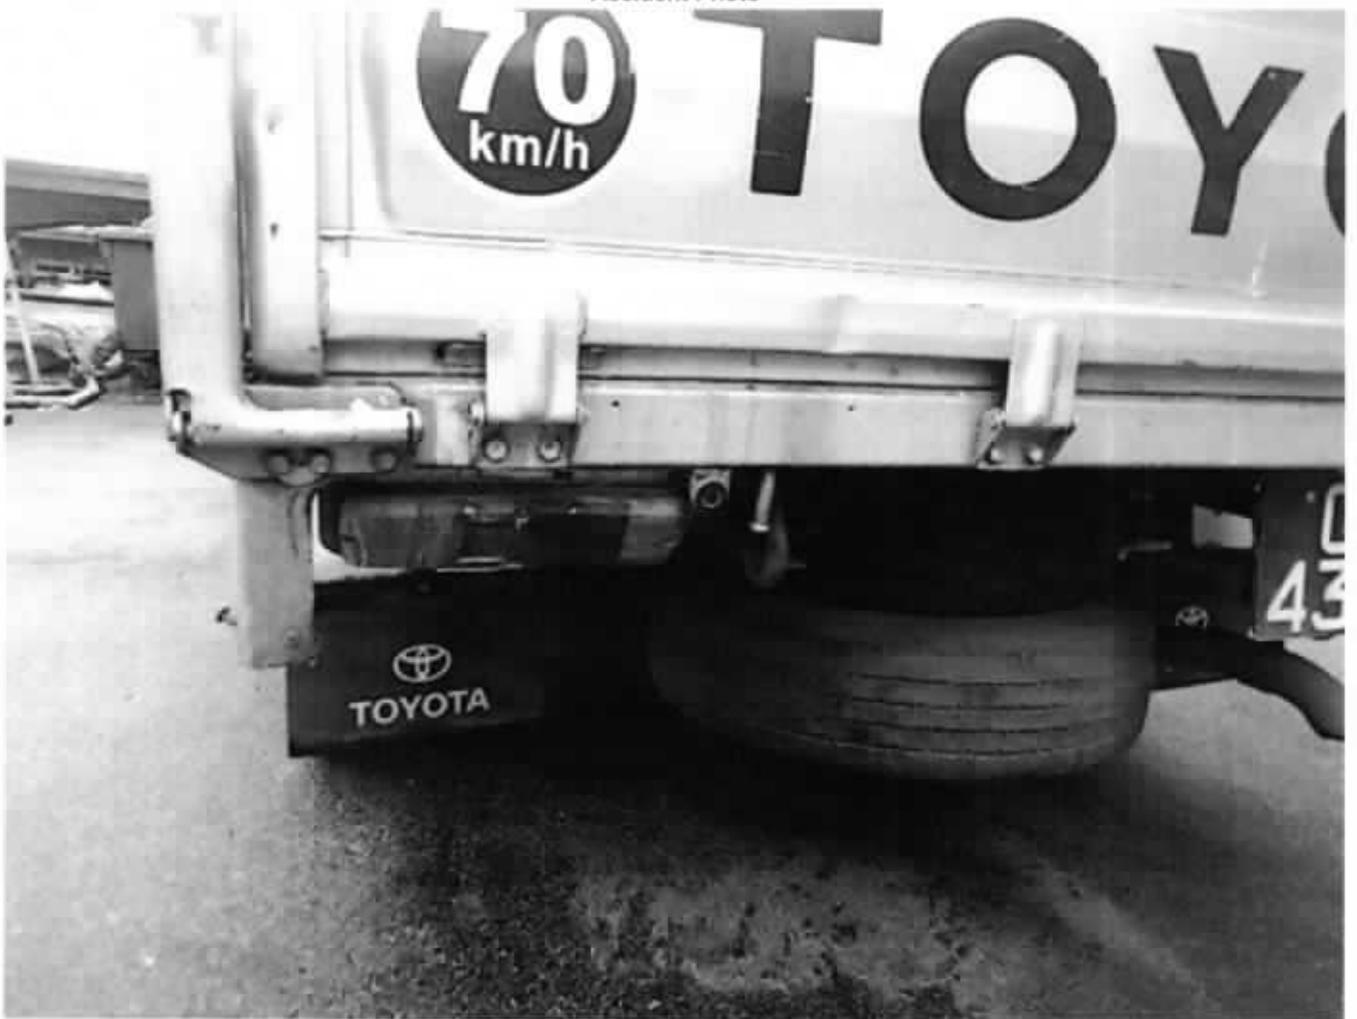
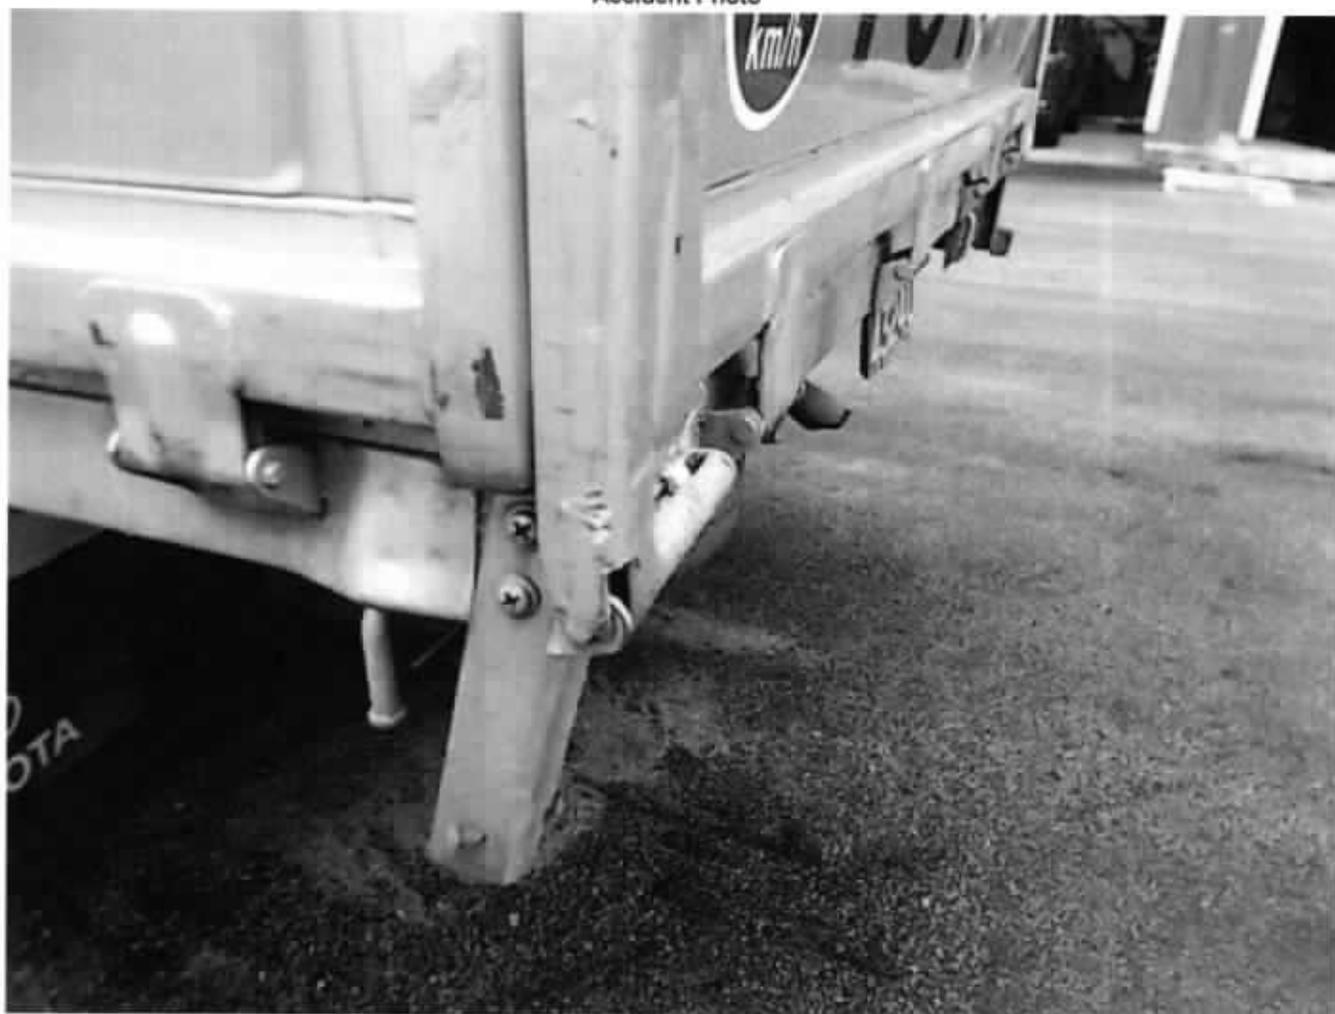
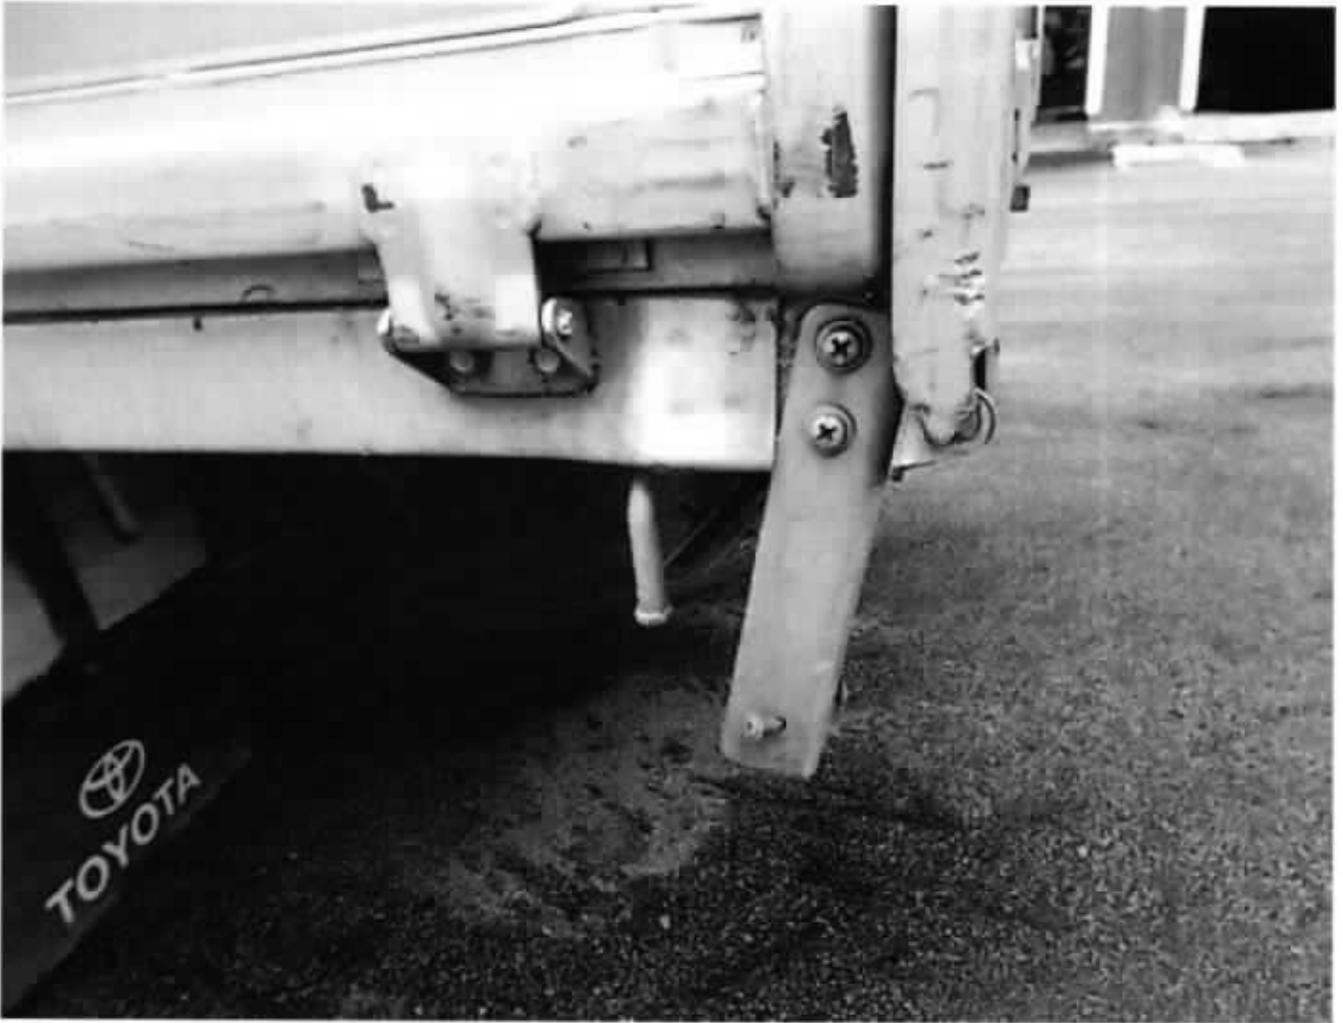
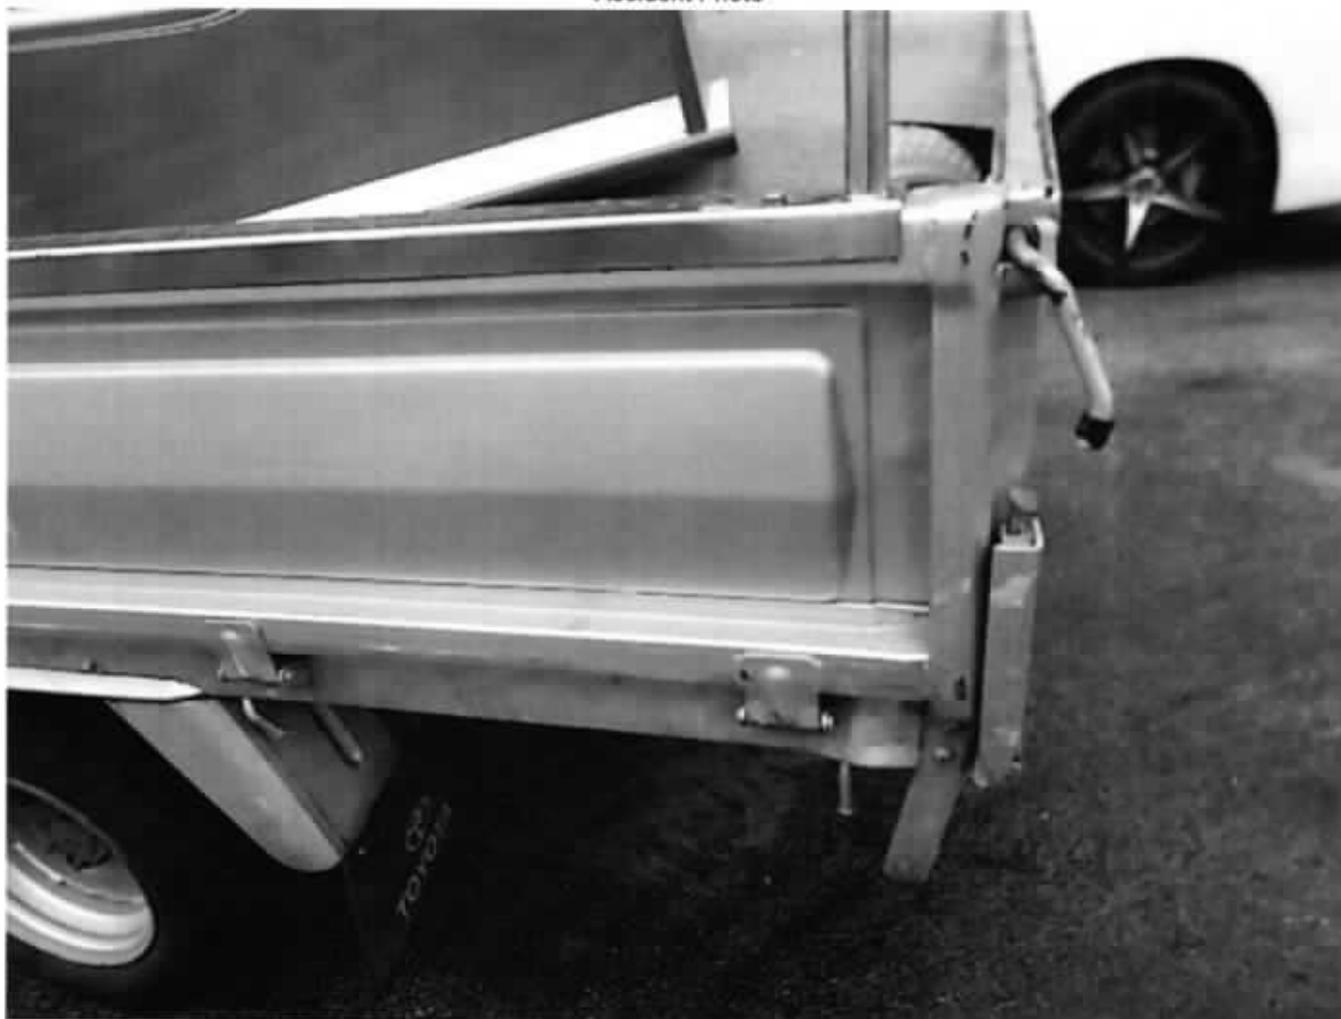
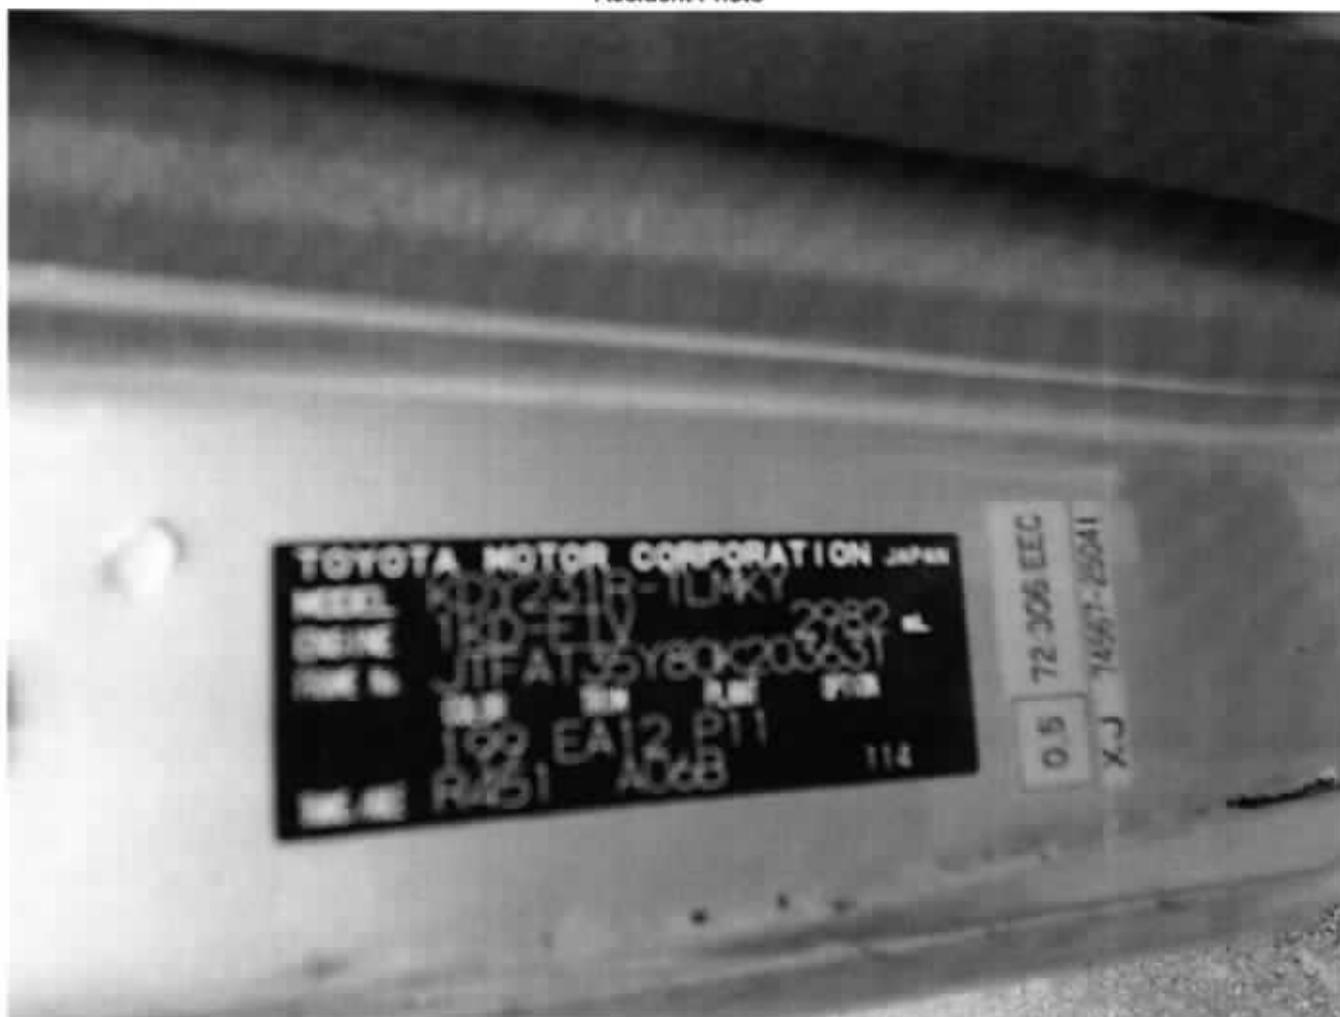
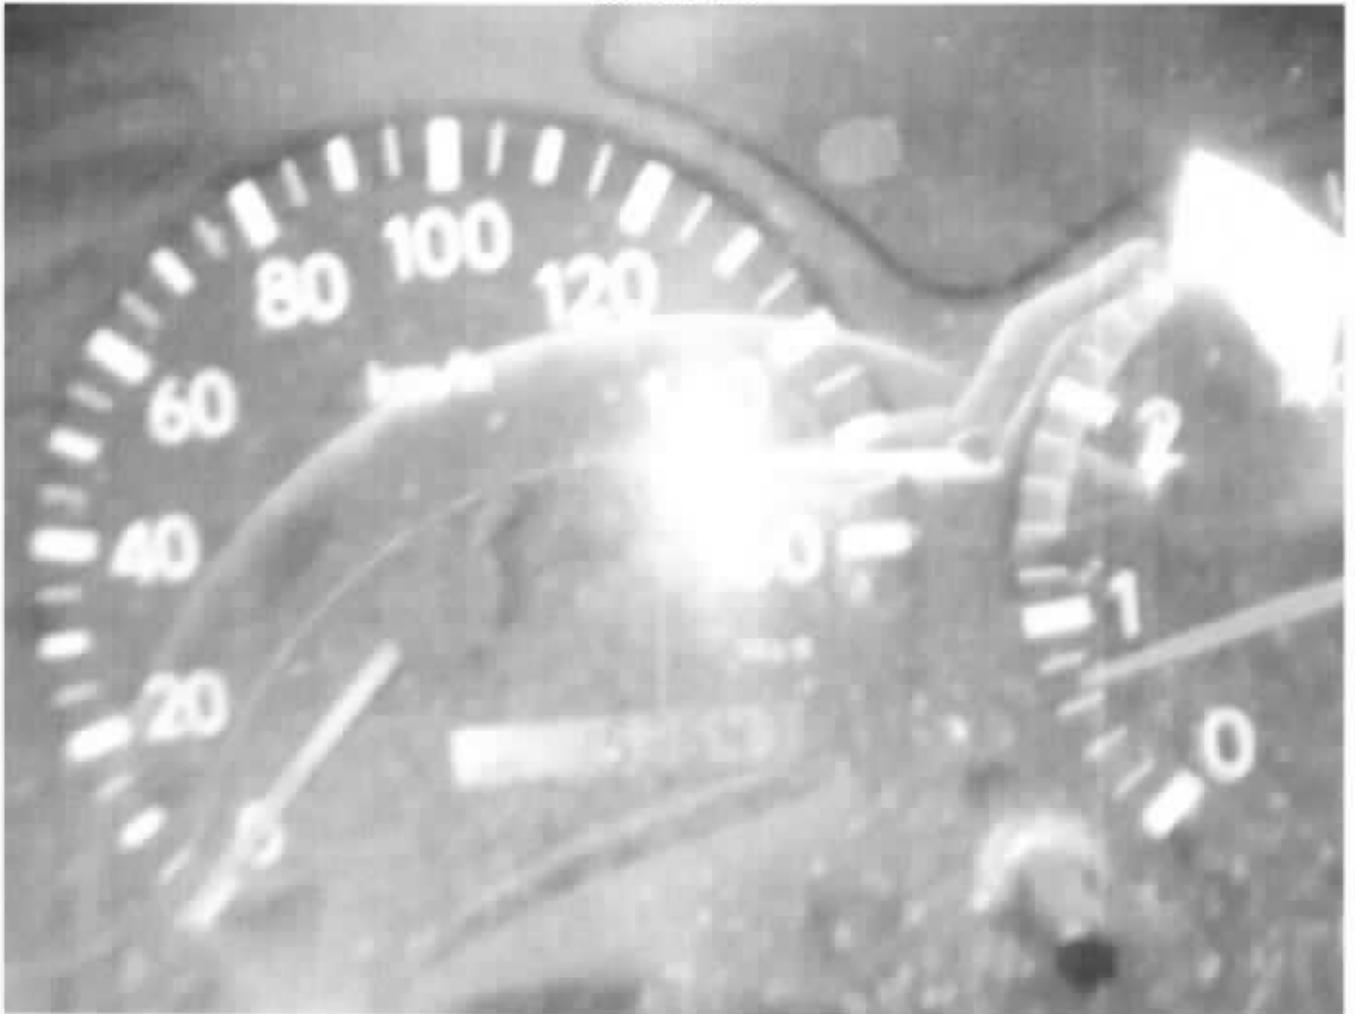
The vehicle sustained damage at the rear portion.
For details, refer to assessment for repairs and photographs attached.

The impact was confined to the rear portion of the vehicle.
The damages appeared to be consistent as per the accident report statement.
Please refer the attached schedule and photographs for details.

On the above mentioned date and time, I was driving along Braddel Road in the middle lane of a 3 lane road towards Bartley Road. I then felt an impact coming from the rear of my lorry. I drove my lorry to the road shoulder and stopped my lorry. I then discovered that a lady rider was laying down on the road and a motorcycle laying flat on the road just slightly behind her. I assisted to carry her motorcycle to the road shoulder while other road users were helping her with her condition. One pedestrian on an overhead bridge approached me and informed that he saw the lady rider colliding into the back of my lorry. My nephew assisted to call for ambulance. The rider was conveyed to hospital conscious. MY vehicle sustained some scratches on the rear left of my vehicle and my rear left tail lamp is damaged.

Our assessment of the repair costs to pre-accident condition was S\$3,100.00 nett at lump sum basis. (Subject to GST if applicable)
Under normal circumstances, estimated period required for repairs : Five (05) working days.

The repairer has agreed to undertake repair the vehicle at a lump sum basis of **\$3,100.00** nett corresponding to replacement of parts, spray painting and labour charges. We now revert for your decision on the above claim.
