ACCIDENT INVOLVING SKE 7014 H / SME 7814 S ON 6/11/19 ALONG CHOA CHU KANG LOOP

VEHICLE DAMAGE INSPECTION REPORT

Our File No: CS3/AIG19019896/GCF3E2

Vehicle No : SKE7014H

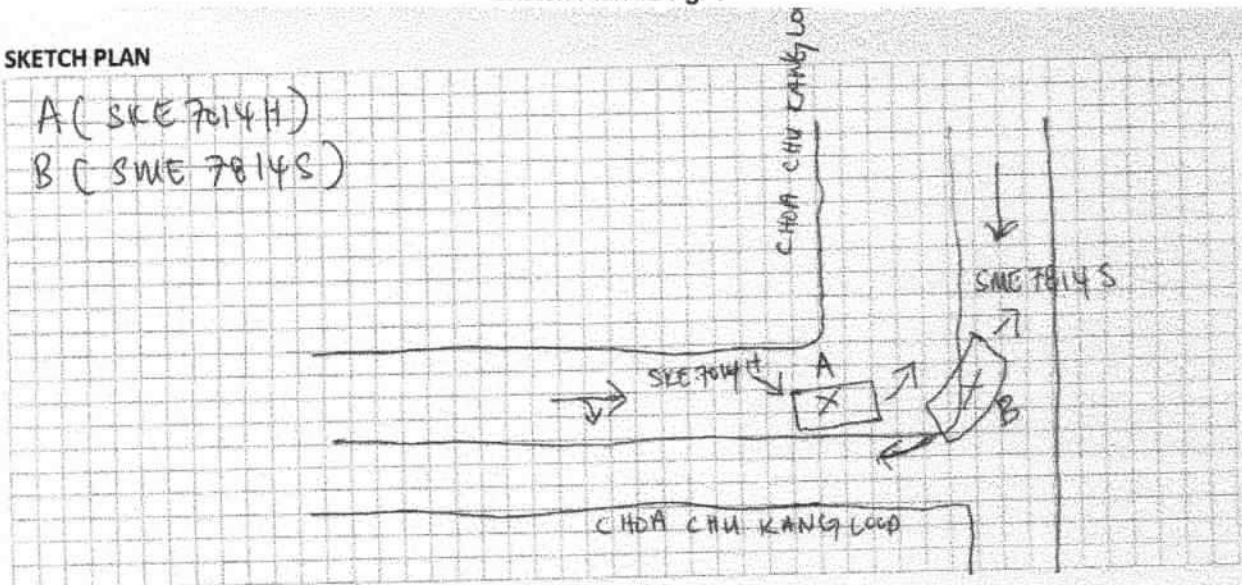
SKETCH PLAN

A (SKE7014H)
B (SME7814S)

At 1pm, I was going straight follow my lane, out of sudden SME7814S he cut ~~out~~ of the lane cut and came to my lane and know my front ~~see~~ SKE7014H bumper. front bumper.
