CS/ALC/19019967/Alsd-302

Vehicle No	: FBL8813G	Accident Date	: 07/11/2019
Make	: YAMAHA MT-10	Policy No.	: 1800023006
Assignment Date	: 12/11/2019	Excess	: S\$1,300.00
Date of Inspection	: 11/11/2019	Est. Duration of Repair	: 4 days
Inspection At	: Bike Production (HQ) No 610 Serangoon Road Singapore 218216

**ASSESSMENT FOR REPAIR: YAMAHA MT-10 SP - FBL8813G**

## VEHICLE DAMAGE INSPECTION REPORT

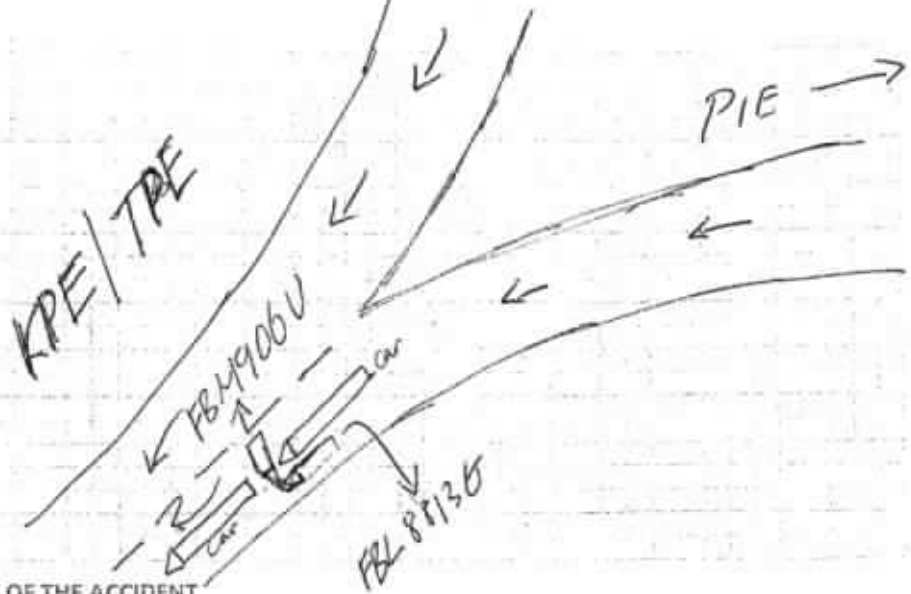
SKETCH PLAN

On 7/11/2019 at about 1840hrs while traveling on KPE towards TPE at the entrance from PIE(Changi). While travelling at about 40km when suddenly after passing one vehicle, one motorbike, FBM906U then came out of the front of the vehicle which I immediately engaged e-brake however was unable to stop in time, I tried to avoid the biker by swerving left however he then hit onto the right front portion of my motorbike causing damage to my radiator and front fork. We both stopped and exchanged particulars for insurance claims. I went to see a doctor on 8/11/2019 at Bok Family Clinic Pte Ltd and was given 3 days MC for pain on right leg area(slight swelling). I will be proceeding with insurance claims.

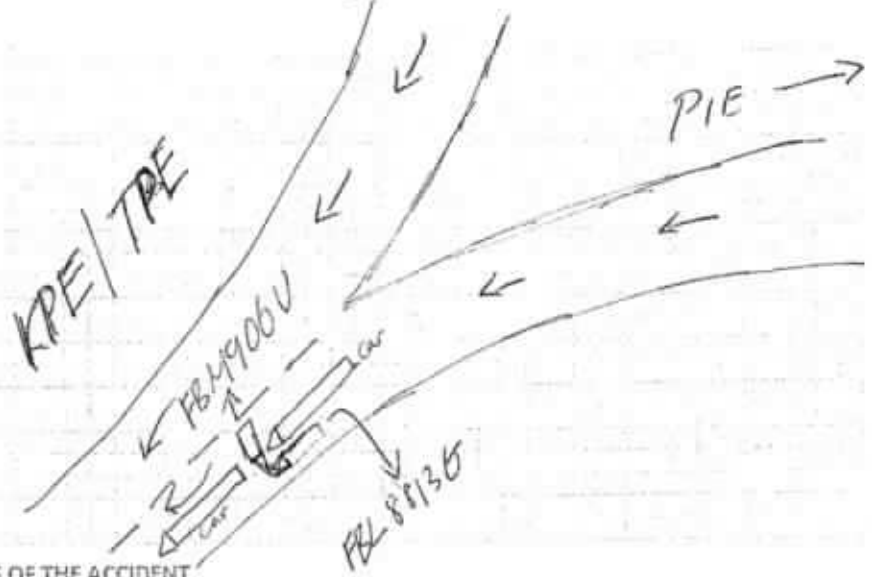
SKETCH PLAN

On 7/11/2019 at about 1840hrs while traveling on KPE towards TPE at the entrance from PIE(Changi). While travelling at about 40km when suddenly after passing one vehicle, one motorbike, FBM906U then came out of the front of the vehicle which I immediately engaged e-brake however was unable to stop in time, I tried to avoid the biker by swerving left however he then hit onto the right front portion of my motorbike causing damage to my radiator and front fork. We both stopped and exchanged particulars for insurance claims. I went to see a doctor on 8/11/2019 at Bok Family Clinic Pte Ltd and was given 3 days MC for pain on right leg area(slight swelling). I will be proceeding with insurance claims.
