To Inspect Vehicle No: SLL 6480C

SJQ 51254 NPA/FWD19020094 D.O.A: 11/11/2019

From: venessa.chan@fwd.com
Sent: Wednesday, 13 November 2019 9:54 AM
To: admin-d@lkkauto.com; admin-a@lkkauto.com
Cc: motorclaims.sg@fwd.com; eileen.bay@fwd.com
Subject: PRE-REPAIR SURVEY --- YOUR REF: SJQ 5125 H --- ACCIDENT INVOLVING SLL 6480 C AND SJQ 5125 H ON 11 NOVEMBER 2019 ALONG CTE TOWARDS MOULMEIN ROAD INSIDE CAIRNHILL TUNNEL AT ABOUT 1730 HOURS

VEHICLE DAMAGE INSPECTION REPORT

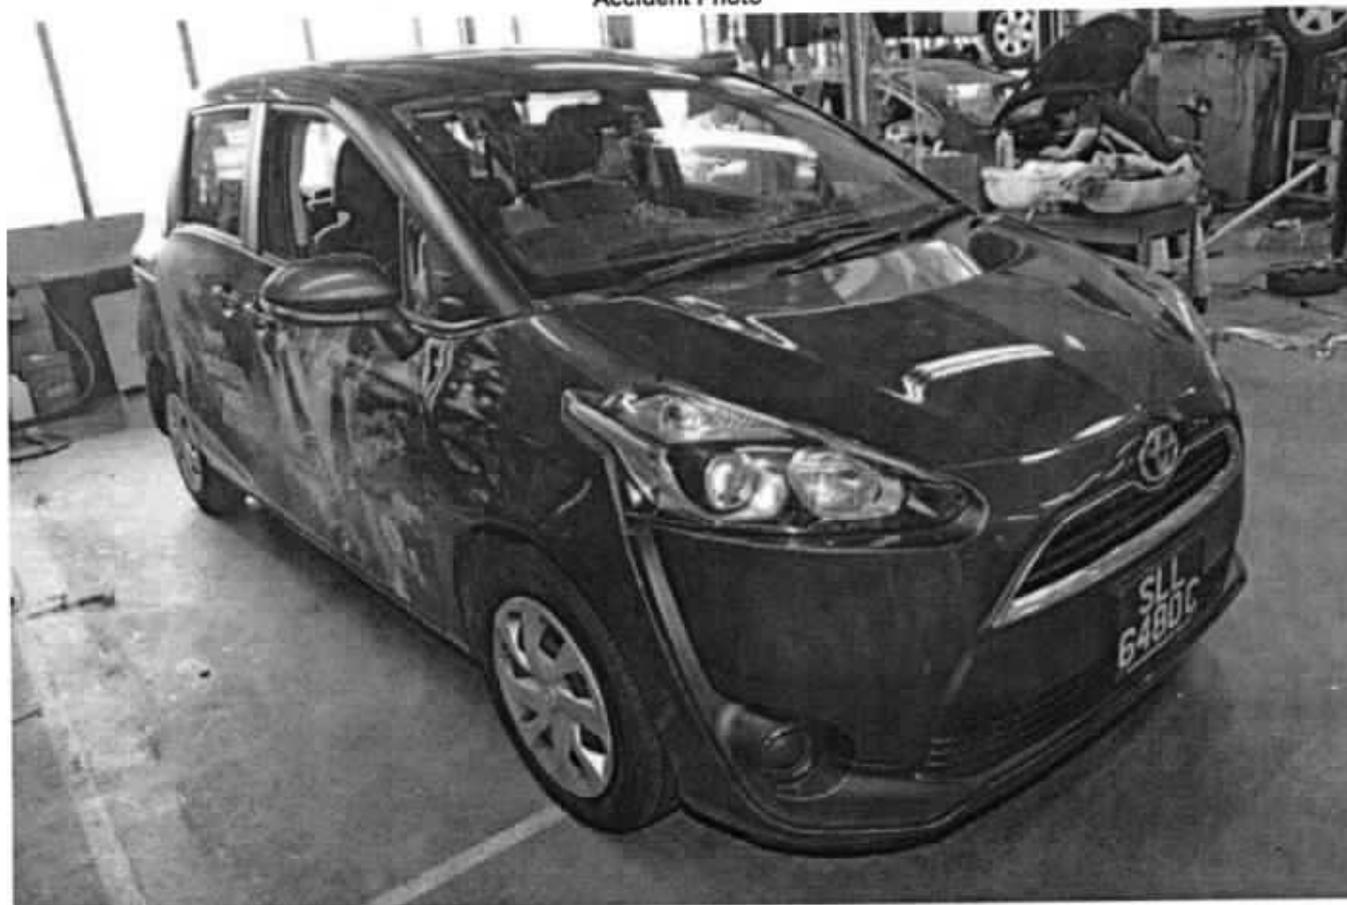
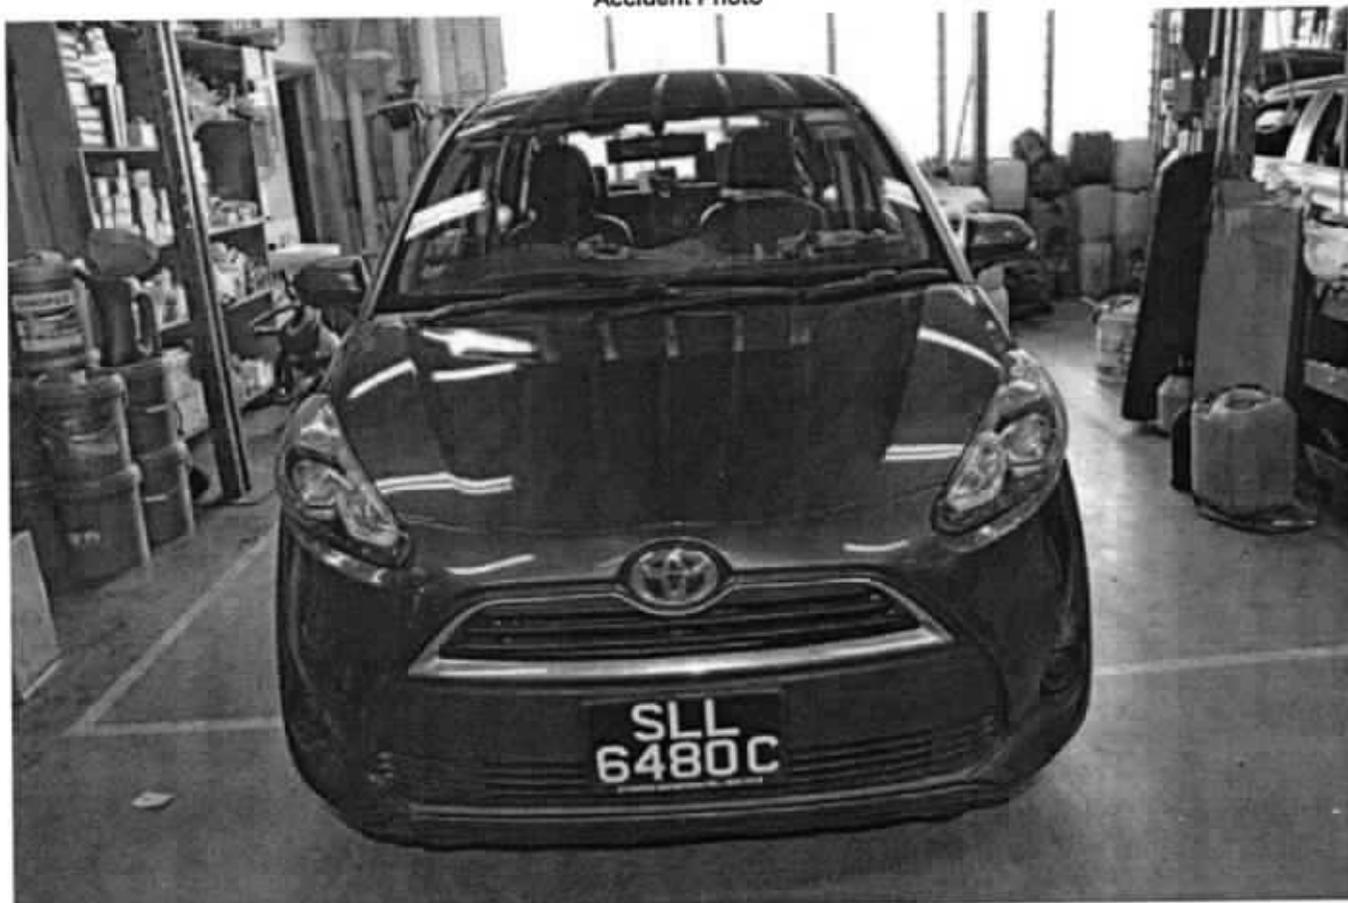
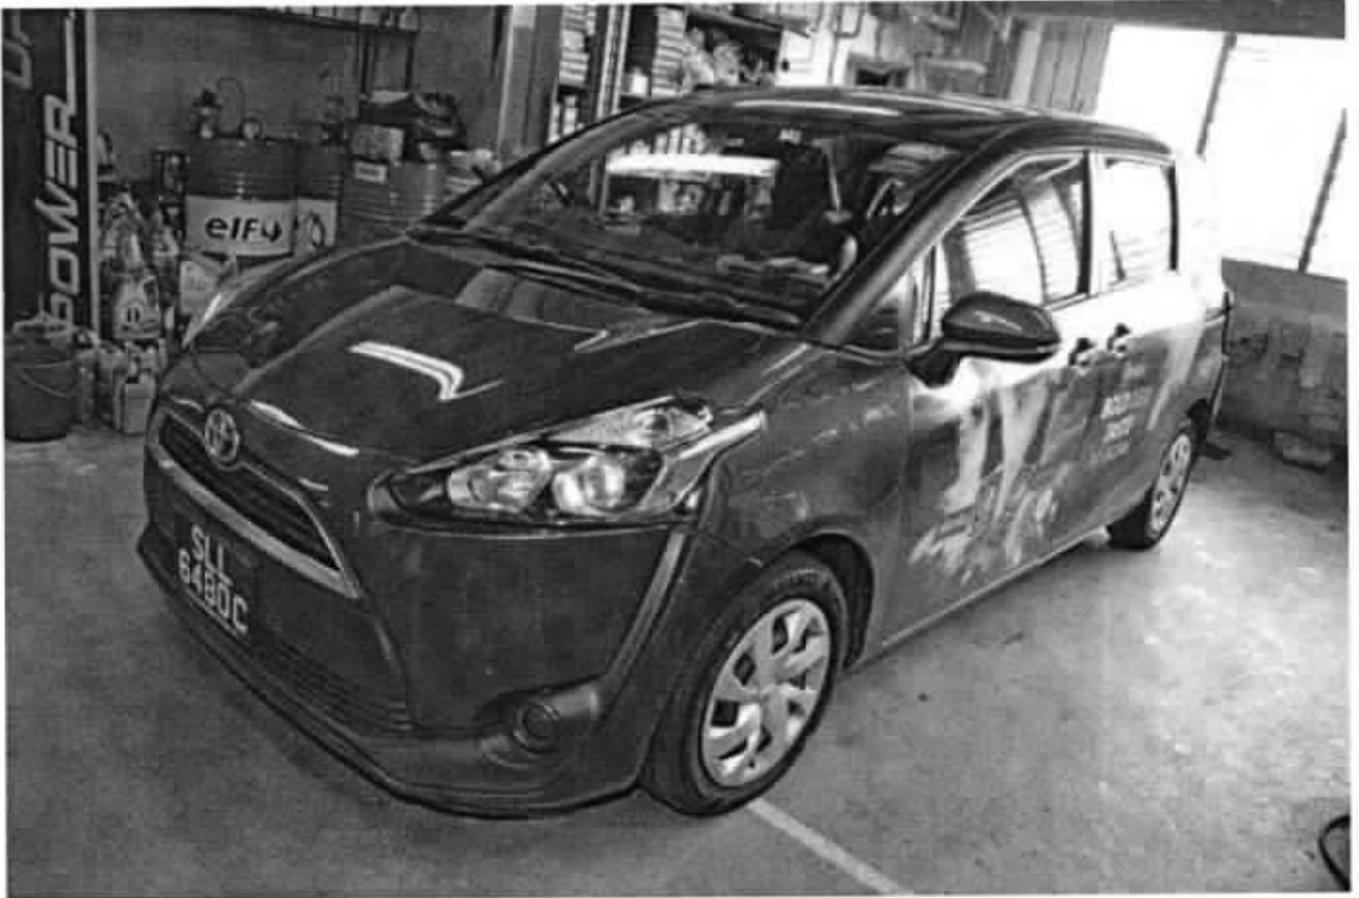
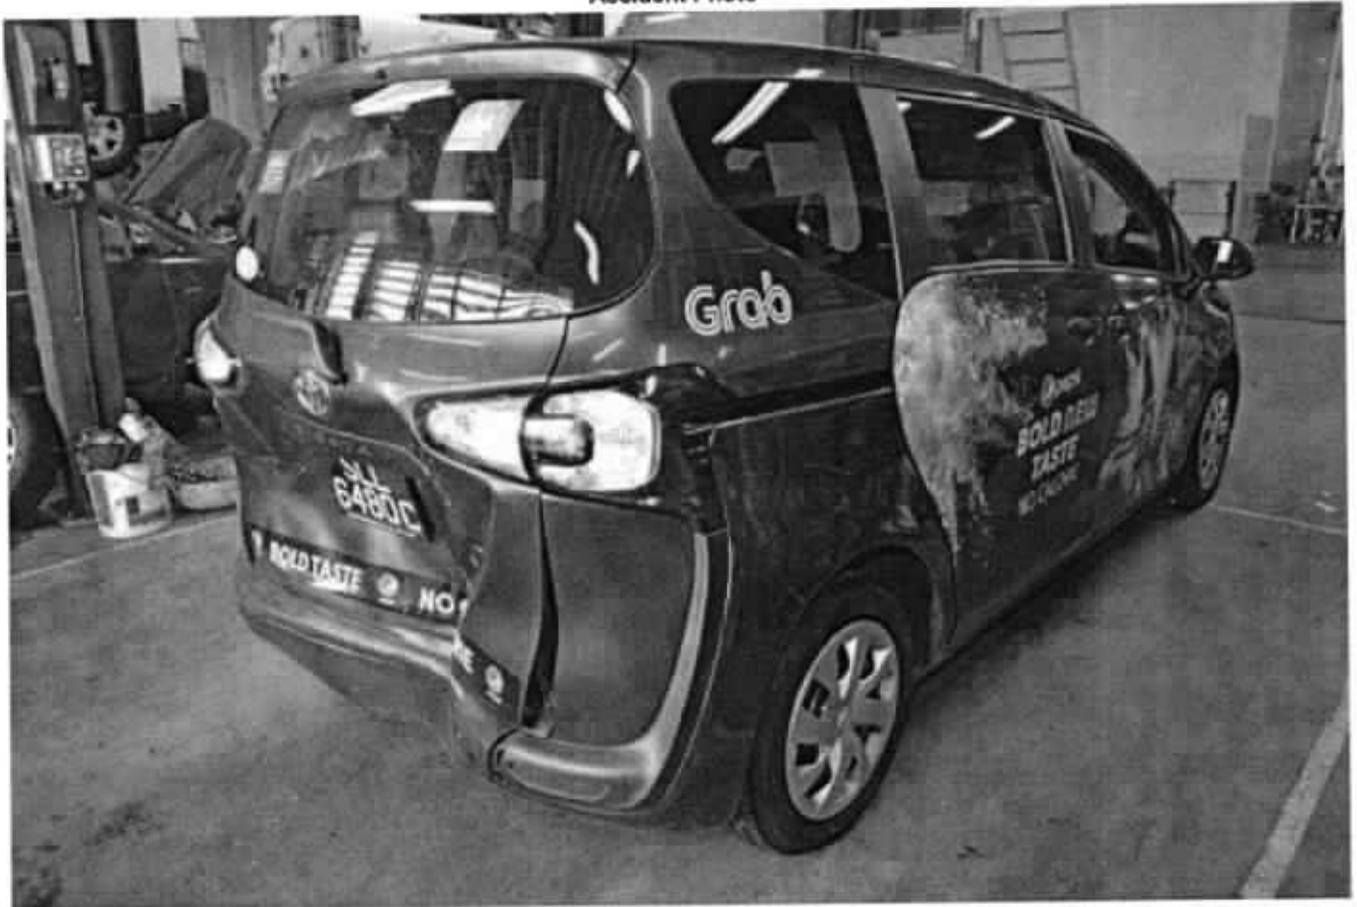
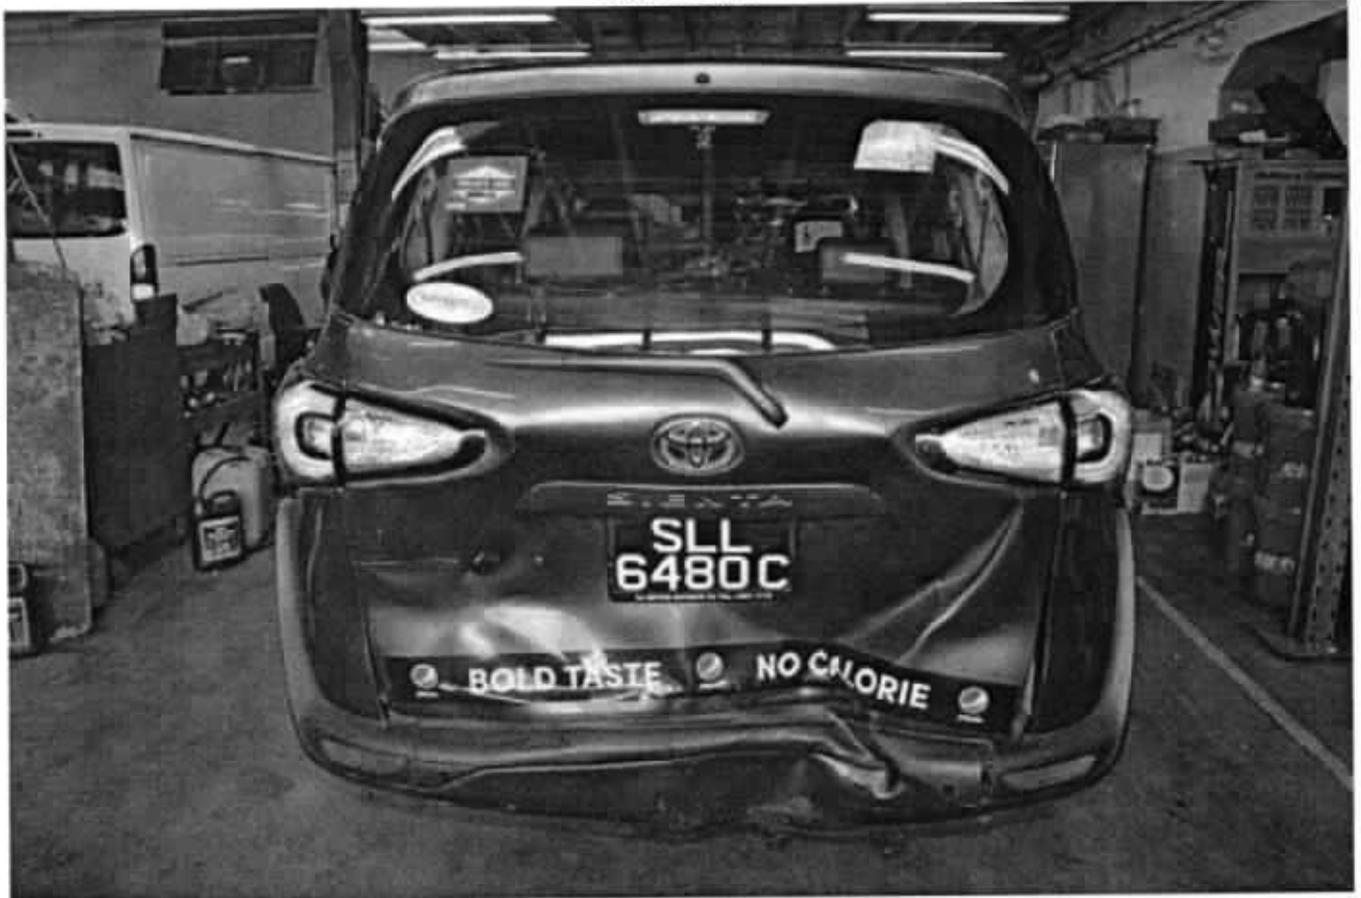
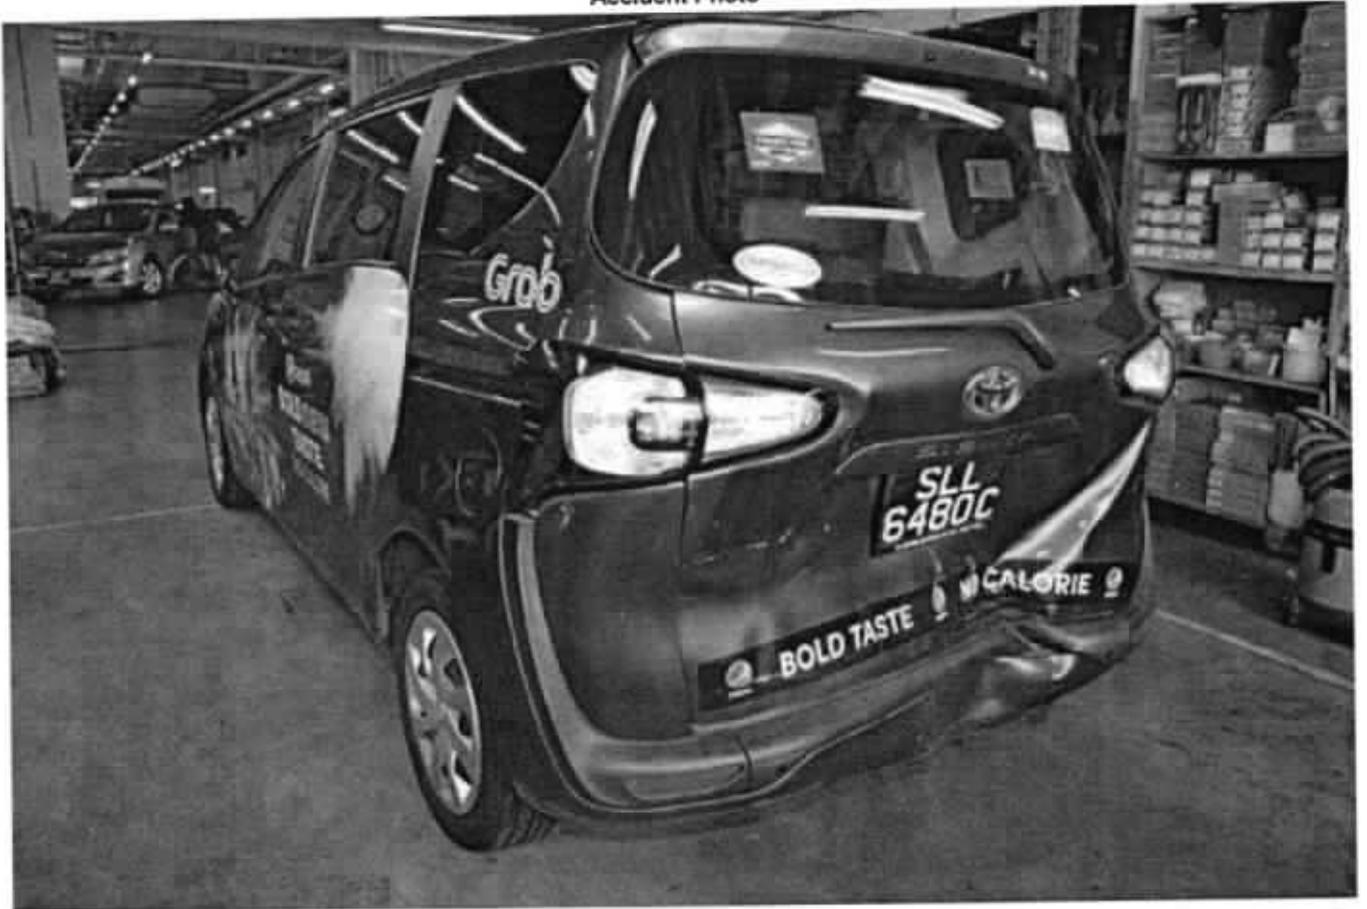
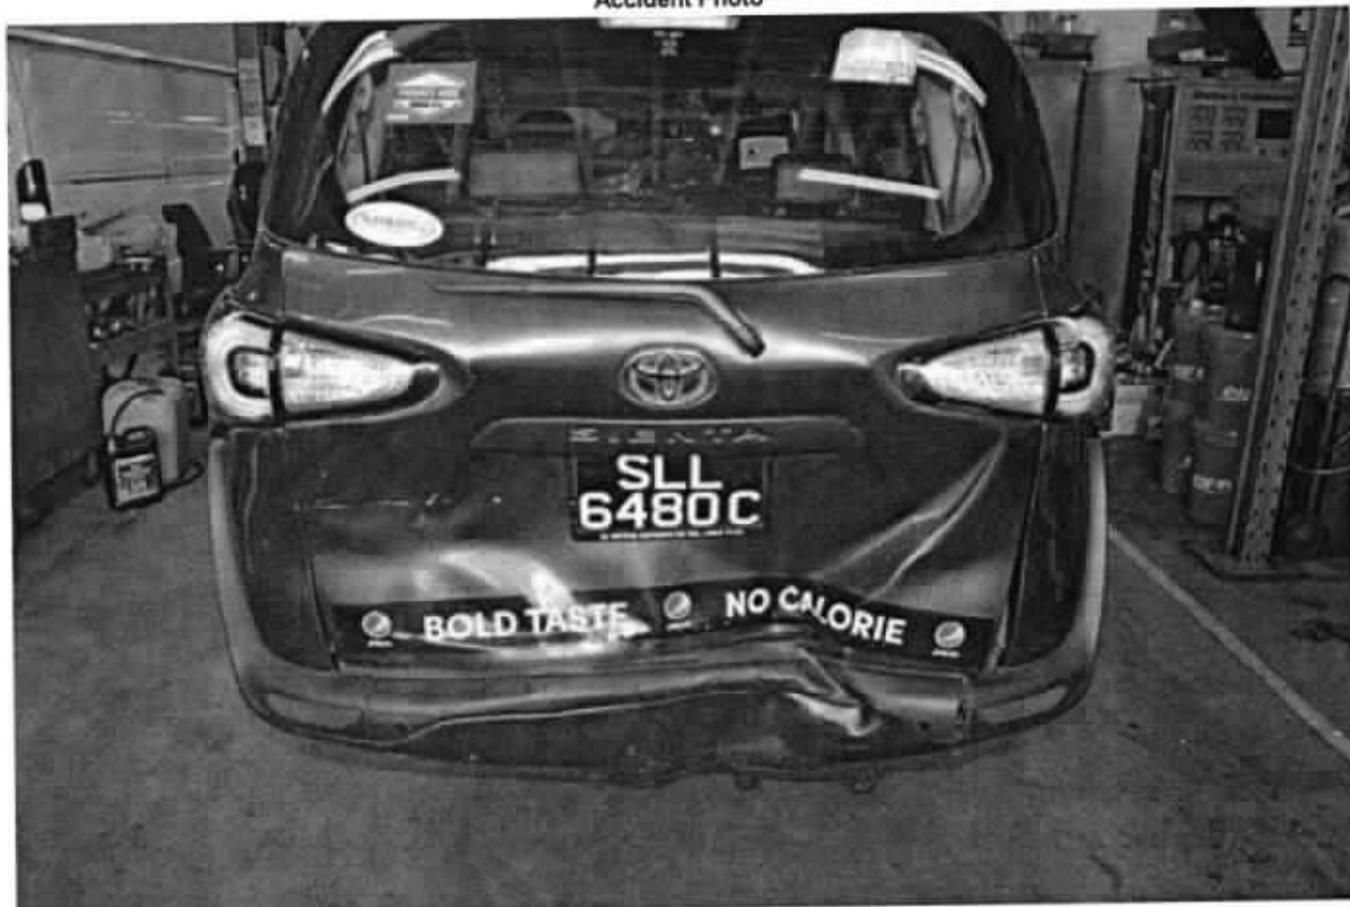
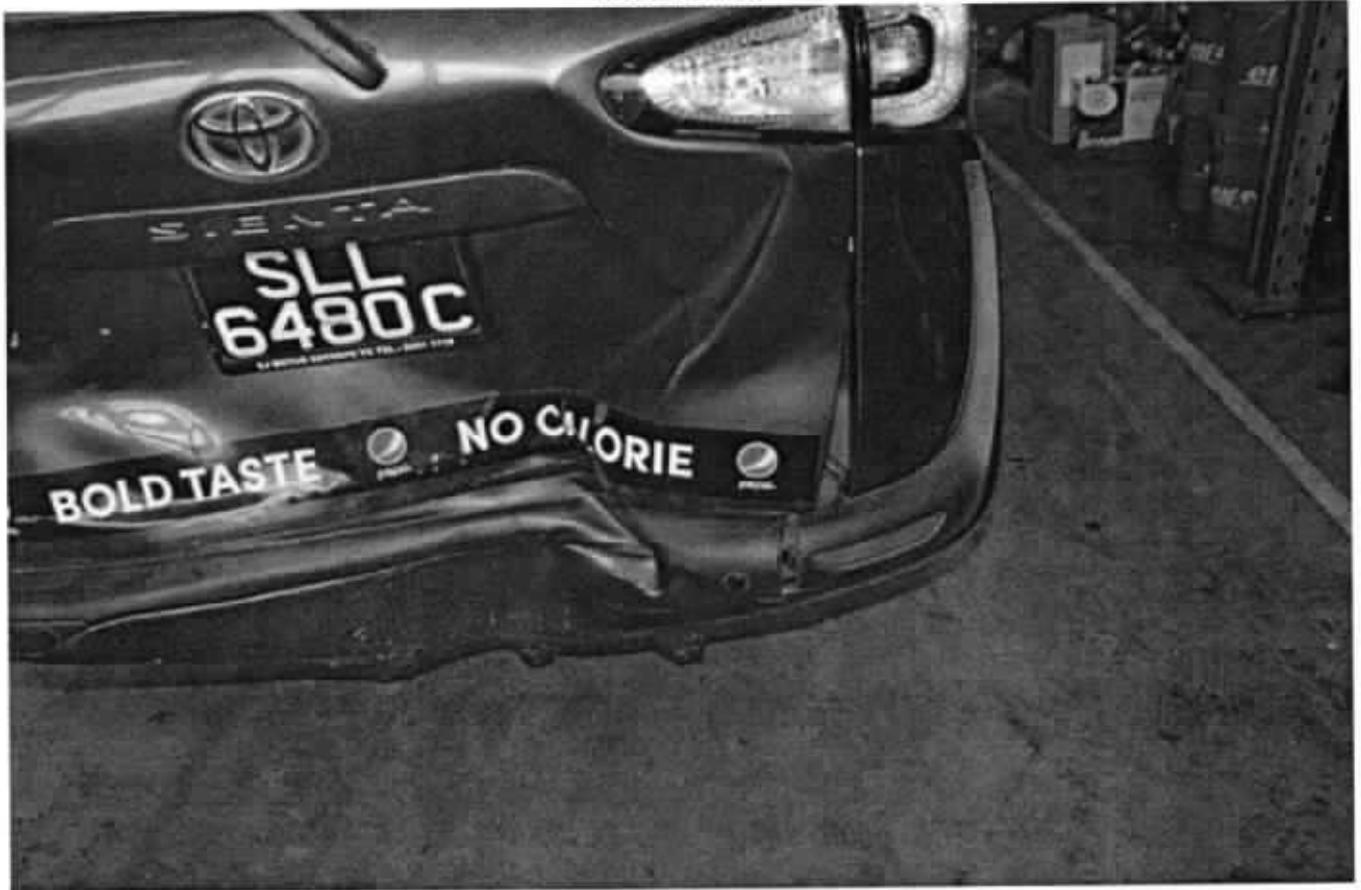
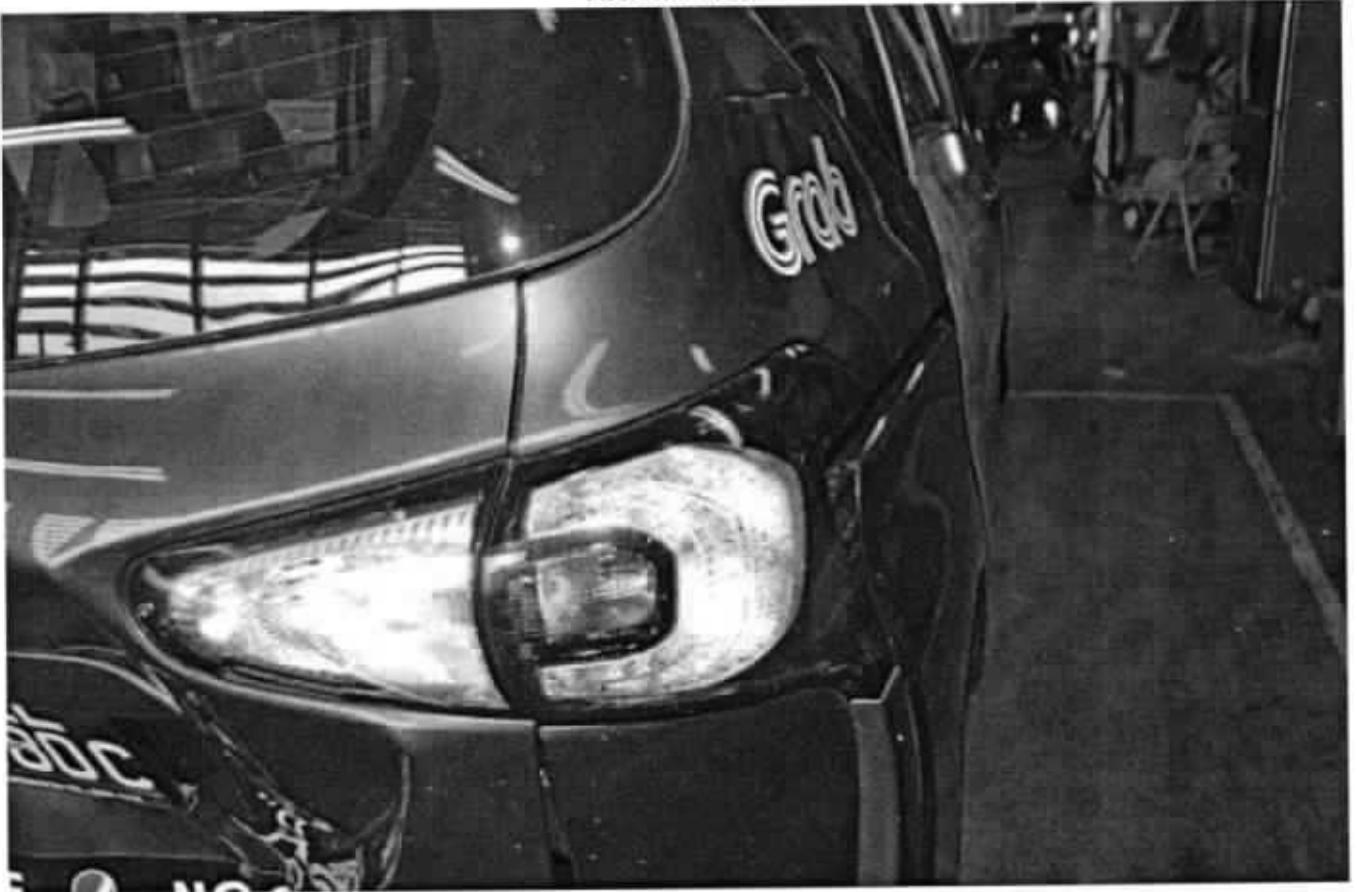
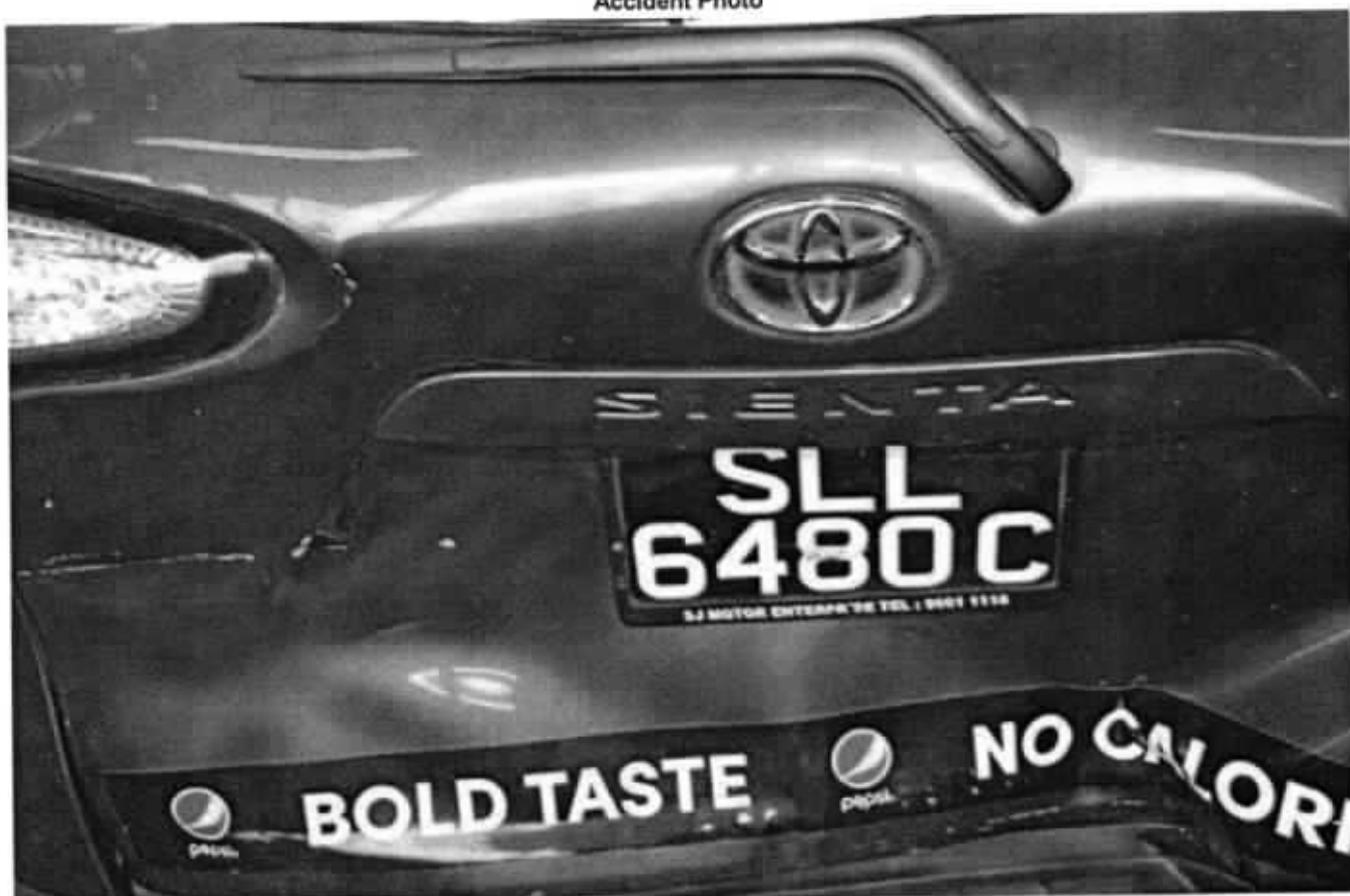
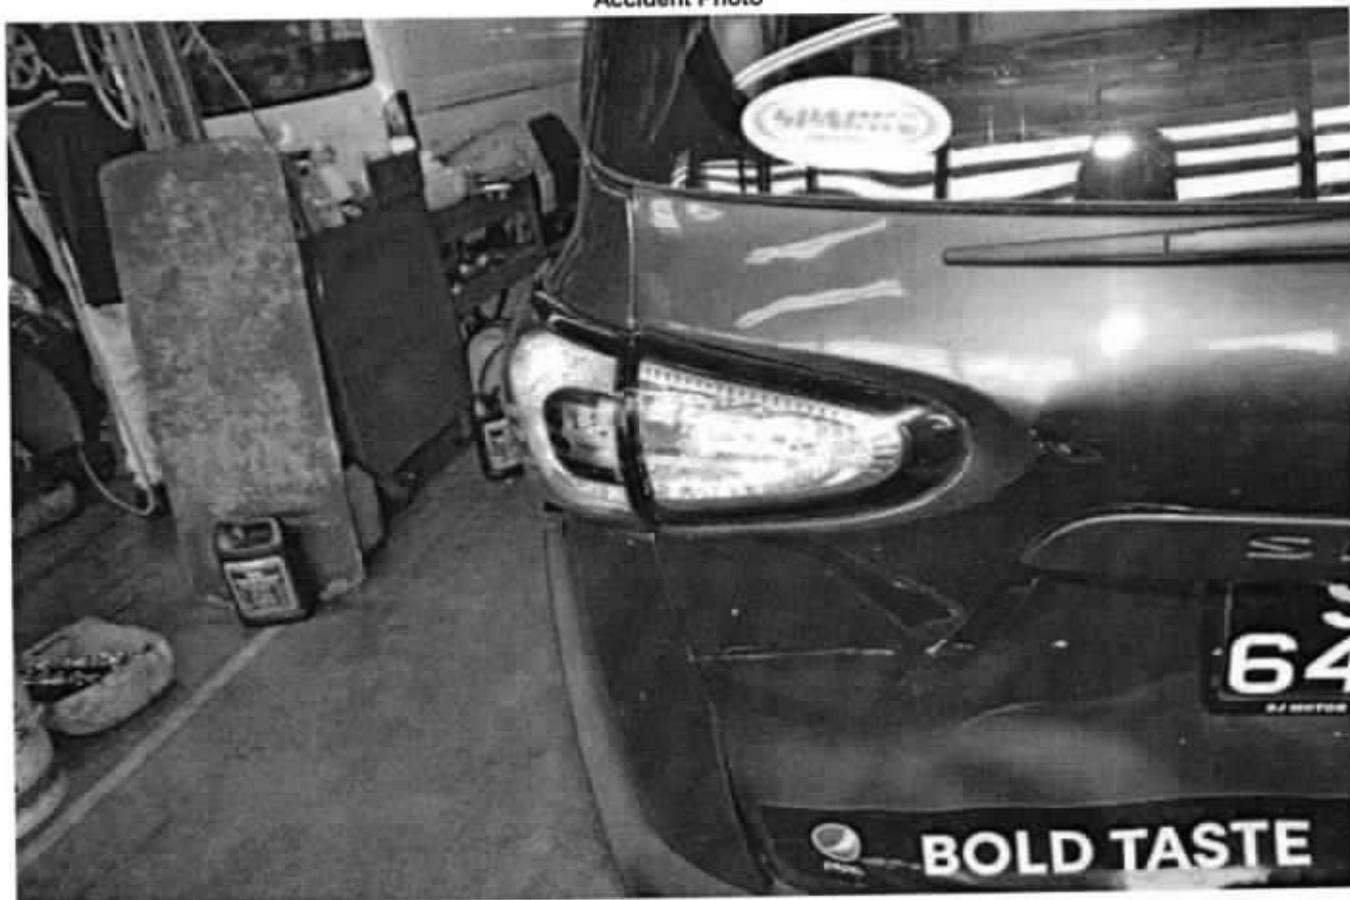
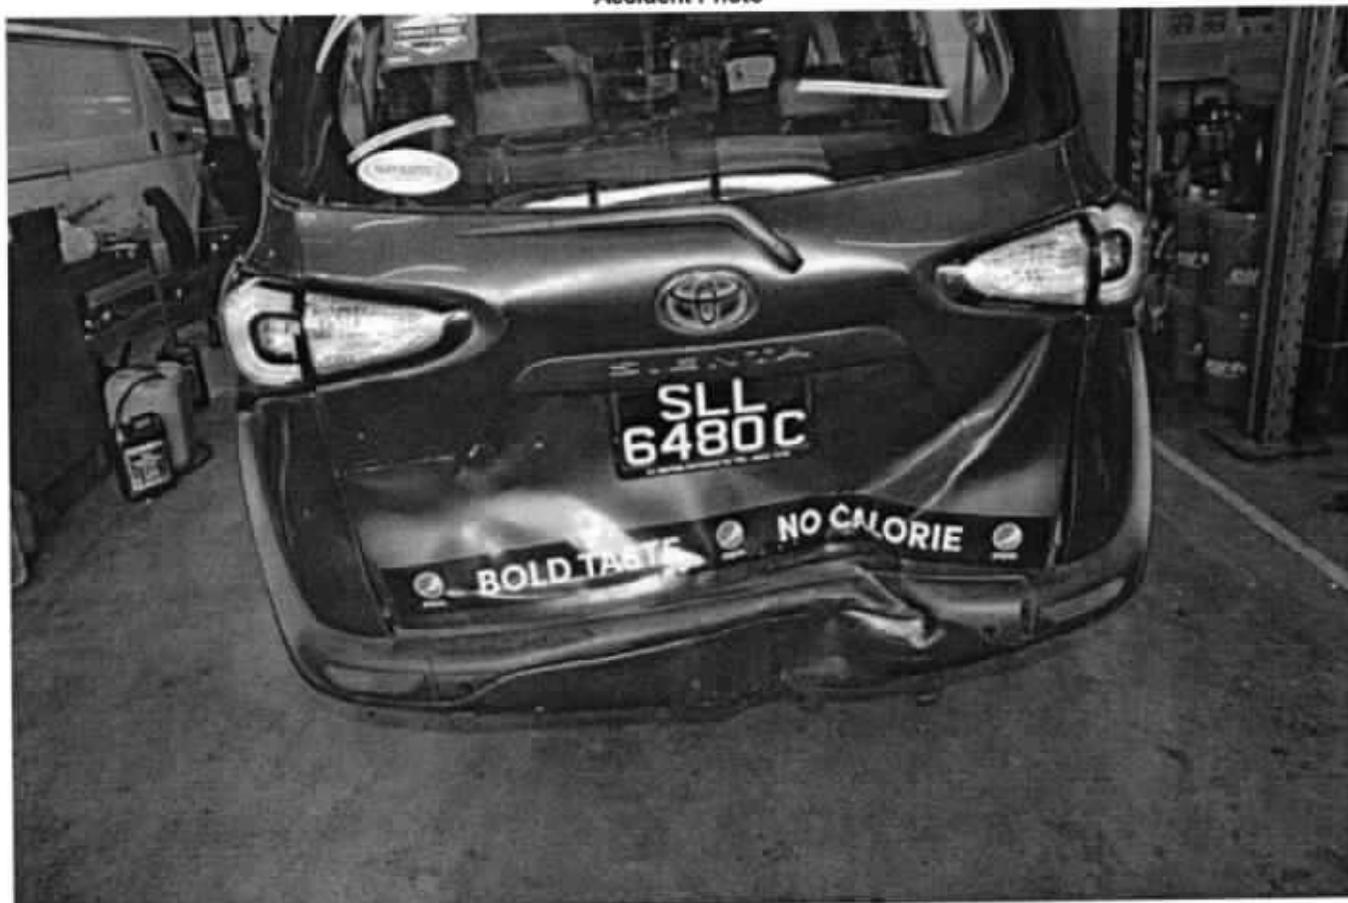
Accident Photo

The UIC / Chassis frame / Body Structure affected due to collision.

No.	Qty	Part No.	Particulars	Condition	Repairer's	Amount
1	1		*IN CAR CAMERA (REAR)	Shorted	500.00 FS	*280.00 FS
2	1		*REAR TAIL GATE ADVERTISEMENT STICKER	Necessary	350.00 FS	*120.00 FS
3	1		*REAR NO PLATE	Cracked	70.00 FS	*45.00 FS
4	1		*REAR END PANEL SEAL	Necessary	250.00 FS	*30.00 FS
5	1		*REAR WINDSCREEN GLASS INNER SEAL	Necessary	60.00 FS	*30.00 FS
6	1		*REAR WINDSCREEN GLASS INNER GUM	Necessary	60.00 FS	*40.00 FS
7	1		*BATTERY	Serviceable	380.00 FS	*- FS
8	1		*TAIL GATE	Bent	1,312.00 FL	*1,086.00 FL
9	1		*TAIL GATE INNER LOCK	Dented	448.00 FL	*265.00 FL
10	1		*TAIL GATE INNER LOCK CATCH	Distorted	64.00 FL	*64.00 FL
11	1		*TAIL GATE INNER TRIMBOARD	Buckled	288.00 FL	*288.00 FL
12	1		*TAIL GATE OUTER MOLDING	Warped	281.72 FL	*167.00 FL
13	1		*TAIL GATE TOYOTA LOGO	Necessary	80.00 FL	*80.00 FL
14	1		*TAIL GATE WINDSCREEN GLASS MOLDING	Necessary	96.00 FL	*96.00 FL
15	1		*TAIL GATE BOTTOM HOLDER	Dented	55.97 FL	*55.97 FL

16	2		*TAIL GATE REFLECTOR	O/S Cracked / N/S Cut	544.00 FL	*544.00 FL
17	2		*TAIL LAMP	O/S Cut / N/S Mtg Cracked	1,254.00 FL	*850.00 FL
18	1		*REAR WEATHER STRIP	Dented / Distorted	432.00 FL	*432.00 FL
19	1		*REAR BUMPER GARNISH (TOP)	Buckled	288.00 FL	*288.00 FL
20	1		*REAR BUMPER FASCIA	Bent	898.76 FL	*485.00 FL
21	1		*REAR BUMPER SIDE RETAINER	N/S Distorted	160.00 FL	*80.00 FL
22	2		*REAR BUMPER SIDE GARNISH	Dented / Cut	352.00 FL	*352.00 FL
23	2		*REAR BUMPER REFLECTOR	Serviceable	160.00 FL	*- FL
24	1		*REAR BUMPER TOW BAR COVER	Missing	57.60 FL	*57.60 FL
25	1		*REAR BUMPER SIDE EXTANSION	Bent	148.50 FL	*148.50 FL
26	1		*REAR LOCK SENSOR	Dented	556.80 FL	*161.60 FL
27	1		*REAR END PANEL (INNER)	Bent	608.10 FL	*608.10 FL
28	1		*REAR END PANEL (OUTER)	Bent	448.00 FL	*448.00 FL
29	1		*REAR END PANEL GARNISH	Buckled	166.40 FL	*166.40 FL
30	1		*REAR FENDER INNER GARNISH	N/S Serviceable / O/S Cracked	1,792.00 FL	*607.90 FL

31	1		*REAR WIPER MOTOR	Jammed	736.00 FL	*655.00 FL
32	1		*REAR EXHAUST BOX	Repair	768.00 FL	*- FL
33	1		*REAR TOOLS BOX	Dented	576.00 FL	*322.20 FL
34	10		*REAR TOOLS BOX CLIP	Necessary	64.00 FL	*64.00 FL
35	1		*REAR FLOOR PANEL	Bent / Buckled	816.00 FL	*778.70 FL
36	1		*O/S REAR SPARE TYRE BOARD	Dented	550.80 FL	*378.00 FL

No.	Qty	Part No.	Particulars	Condition	Repairer's	Amount
37	1		*N/S REAR SPARE TYRE BOARD	Dented	550.80 FL	*378.00 FL
38	1		*REAR SPARE TYRE HOLDING	Repair	58.61 FL	*- FL
39	2		*REAR NO. PLATE LAMP	Serviceable	179.20 FL	*- FL
40	2		*REAR REVERSE SENSOR	Shorted	896.00 FS	*200.00 FS

No	Particulars	Lab.Type	Repairer's	Amount
Labour Items				
1	LABOUR CHARGES	New	1,600.00	1,300.00
2	TO PUTTY AND SPRAY PAINTING	New	1,200.00	1,000.00
3	RE-SEAL ANTI-RUST	New	200.00	120.00
4	TO TRANSFER TAIL GATE	New	120.00	60.00
5	TO CHECK, REPLACE, REPAIR WIRING	New	80.00	20.00
6	TO REMOVE AND REFIX REAR WINDSCREEN GLASS	New	160.00	120.00
7	TO REMOVE AND REFIX REAR IN CAR CAMERA	New	120.00	50.00
8	REMOVE AND REFIX EXHAUST BOX	New	120.00	60.00
9	REMOVE AND REFIX REAR GARNISH, CARPET, ETC	New	220.00	120.00
Gross Labour Cost (S\$)			3,820.00	2,850.00
