VEHICLE DAMAGE INSPECTION REPORT

Our File No: CS3/AIG19020294/GCD3E2

Vehicle No : SKW8627M

Make & Model: MERCEDES-BENZ C180K, 1.8 (A)

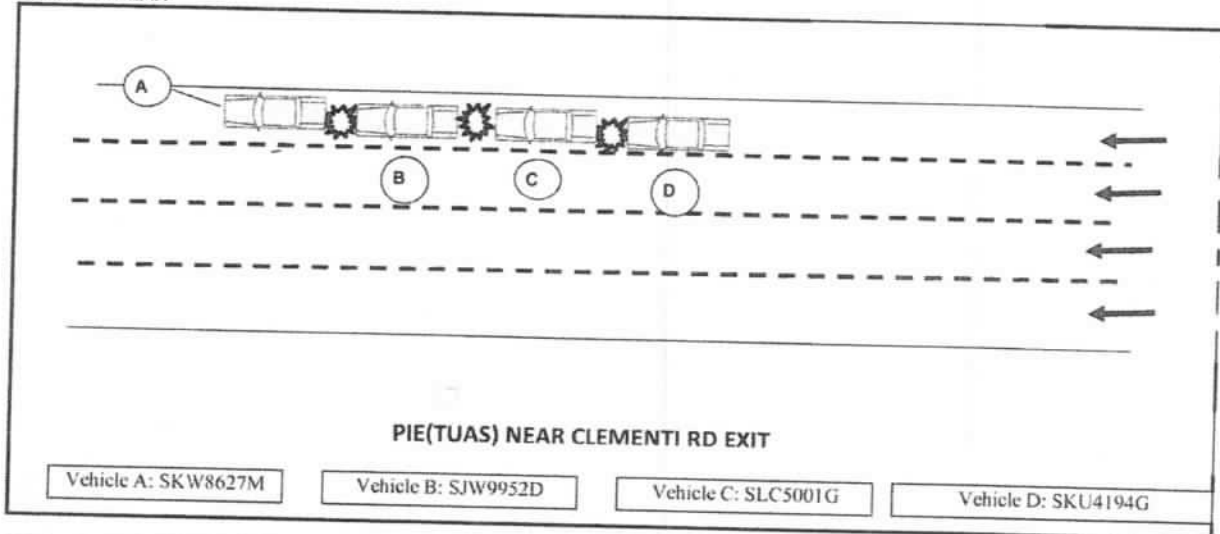
SKETCH PLAN

MY VEHICLE WAS TRAVELLING ON THE RIGHTMOST LANE OF PIE(TUAS) NEAR CLEMENTI RD EXIT. VEHICLES IN FRONT OF ME JAM BRAKED. I ALSO E-BRAKED. SUDDENLY, I FELT AN IMPACT ON MY VEHICLE REAR PORTION AND VEHICLE B HAD HIT ONTO MY VEHICLE. UPON ALIGHT, IT WAS A CHAIN COLLISION INVOLVING FOUR VEHICLES. NO ONE WAS INJURED.
