Veh No: SLB 9754X Yr Regn: 28/4/16
Type: M.Car / M.Cycle / Bus / Van / Lorry / Taxi / Prime Mover / Truck / Trailer or Make: Subaru Forester c.c. 1995
Colour: Grey A/C: Insured / Std / NI / NA Sp.Reading: N/A T/Radio: Insured / Std / NI / NA

Preliminary Advice

Vehicle No	: SLB9754X	Accident Date	: 24/10/2019
Make	: SUBARU FORESTER	Policy No.	: 80455447
Assignment Date	: 20/11/2019	Excess	: S\$700.00
Date of Inspection	: 20/11/2019	Est. Duration of Repair	: 0.00
Inspection At	: MOTOR IMAGE ENTERPRISES PTE LTD (HQ) 19 LORONG 8 TOA PAYOH SINGAPORE 319255

VEHICLE DAMAGE INSPECTION REPORT

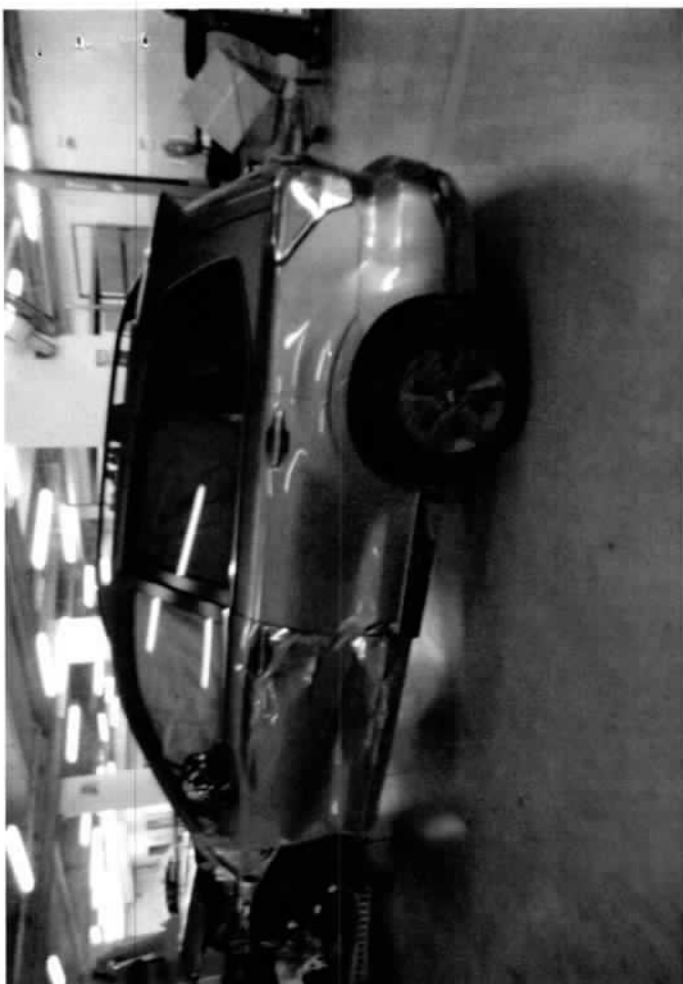
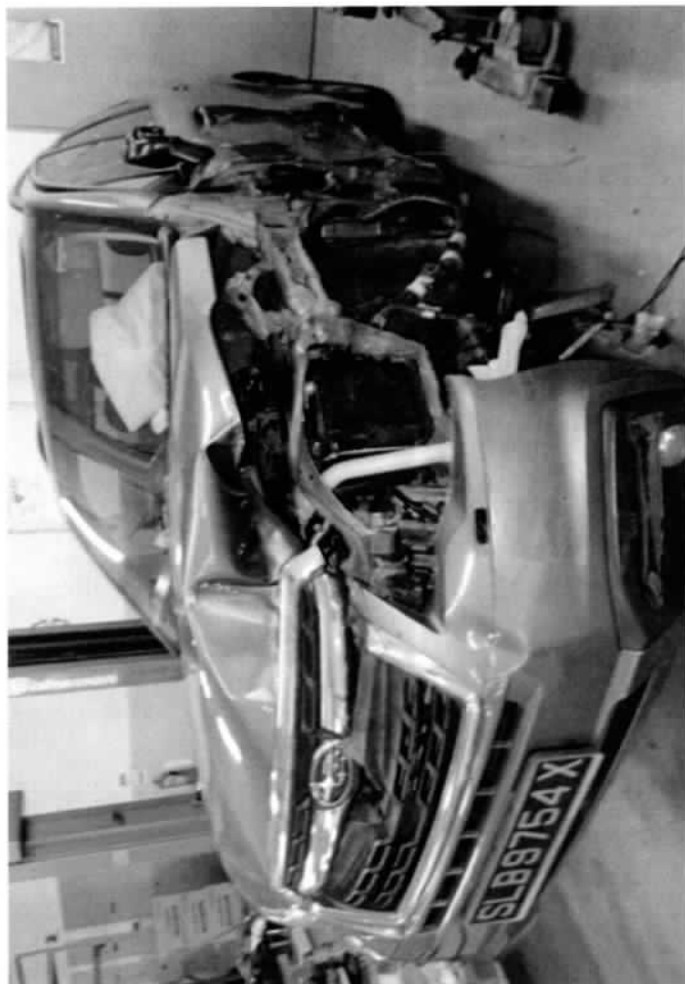
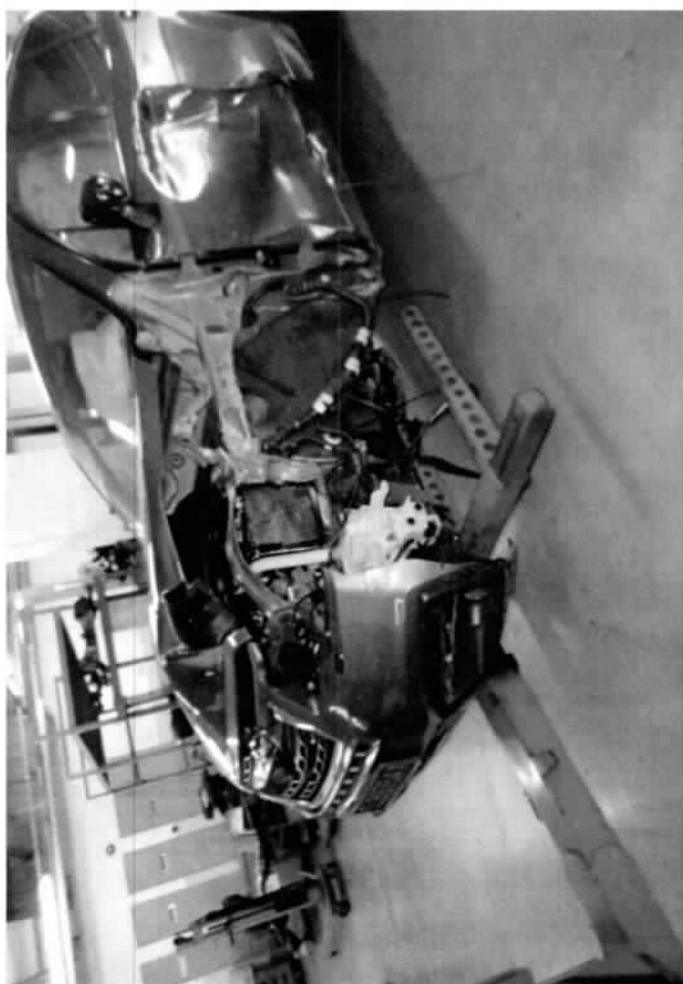
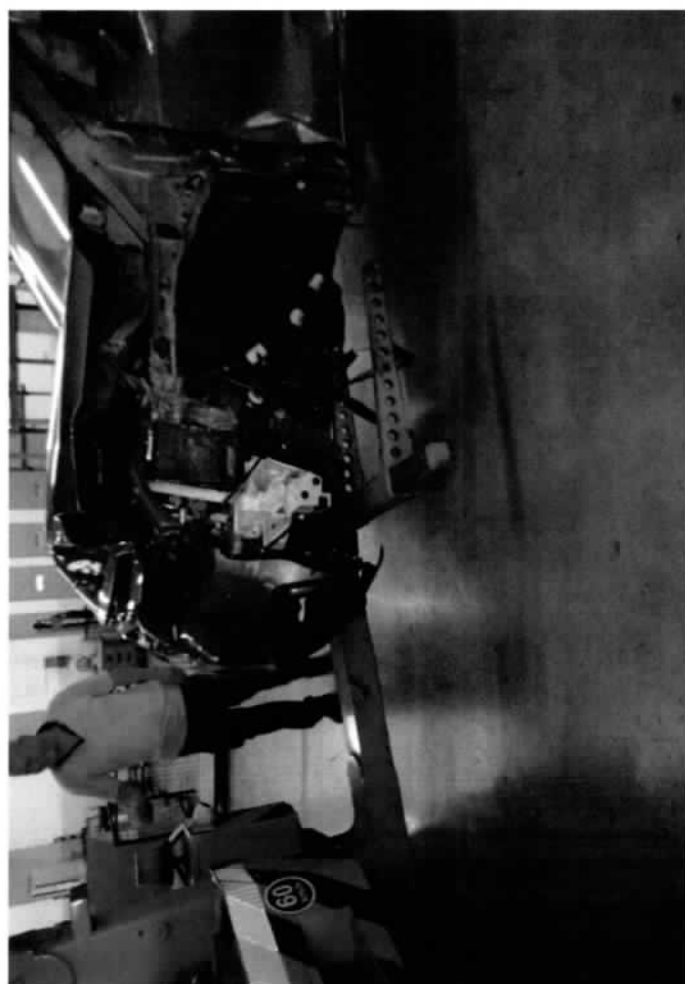
The vehicle sustained impact / damages front o/s & n/s portion and parts claimed are consistent to the accident.

Based on our assessment, we found damages to the front left side of the chassis which leads to the safety of the vehicle being compromised and the entire left portion of vehicle being severely damaged and leading it to be beyond the economic cost of repair. We seek your assistance and endorsement to declare the above mentioned a constructive total loss vehicle.

- (X) The vehicle is not economical for repair.
- () The above survey was conducted on a 'without prejudice' basis.
