Vehicle Reg No. SHD3093X CTPL

Preliminary Advice

Insured Vehicle No : XD853A
TP Vehicle No : SHD3093X
Make : HYUNDAI I40
Date of Inspection : 25/11/2019
Inspection At : ComfortDelGro Engineering Pte Ltd (Loyang)
59 Loyang Drive
Singapore 508969

VEHICLE DAMAGE INSPECTION REPORT

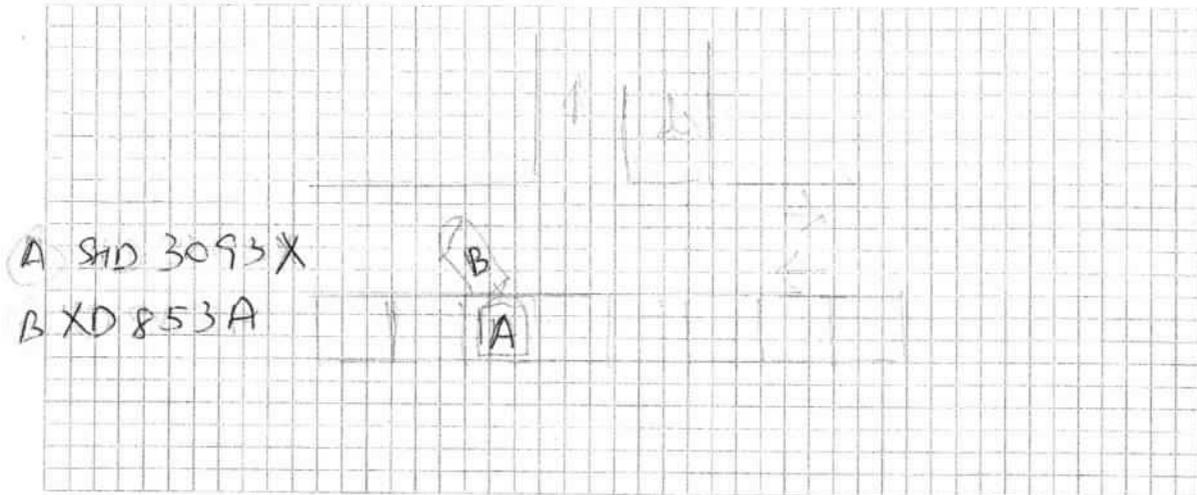
SKETCH PLAN

On 22/11/2019 at about 1630 hrs, I vehicle A was stationary at the Hougang ave 2 block 710 HDB open air Carpark. At that time it was heavy rain and I was in the taxi. Suddenly vehicle B reverse his lorry and collided onto vehicle A left front portion. No one was injured at that time.

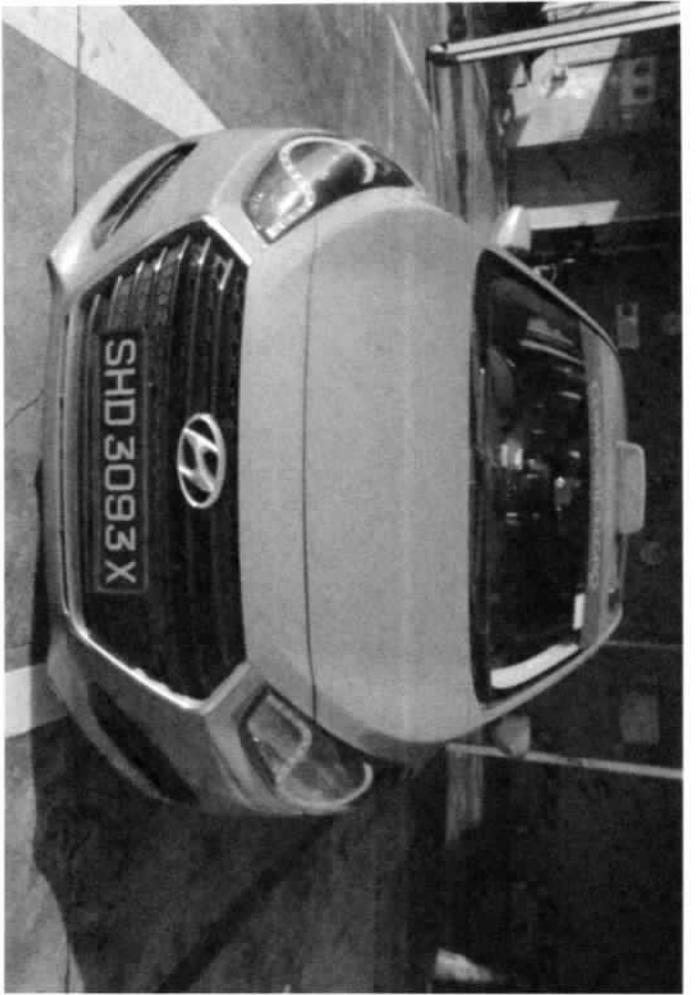
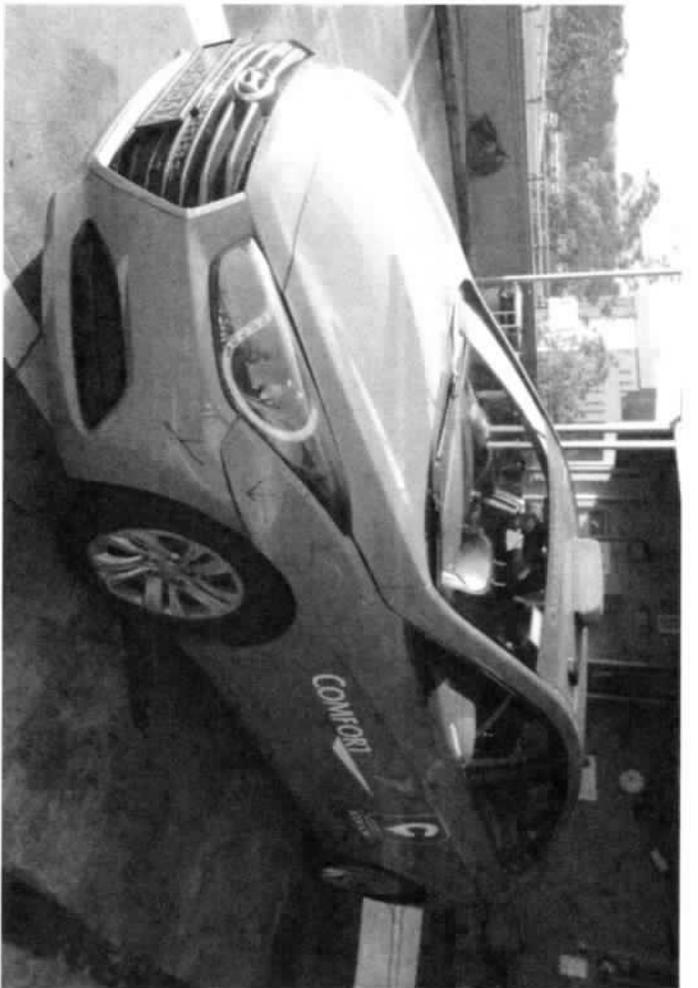
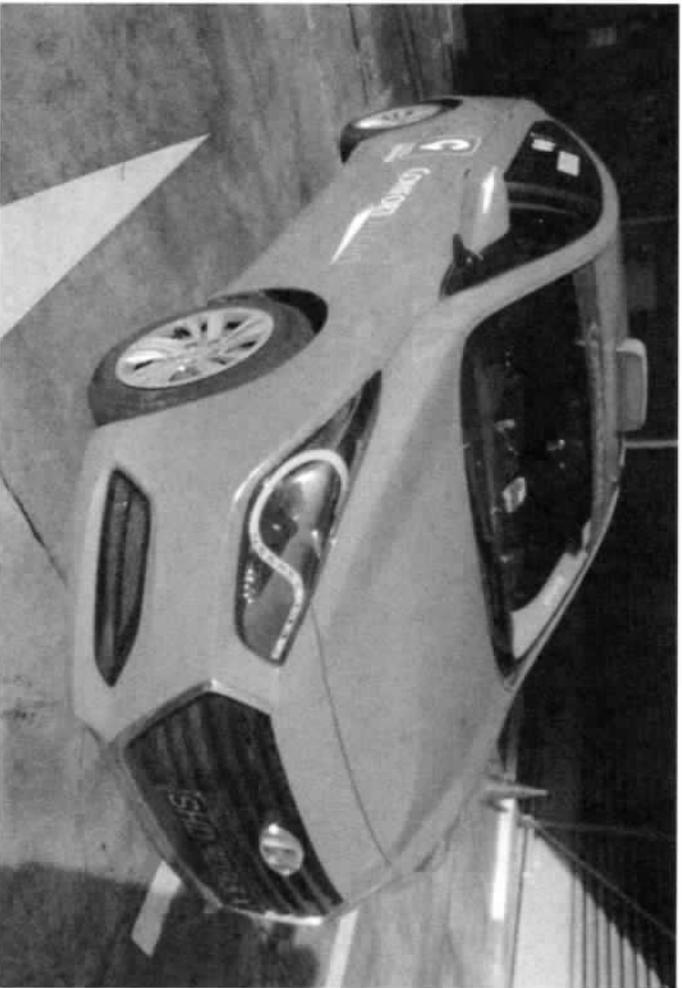
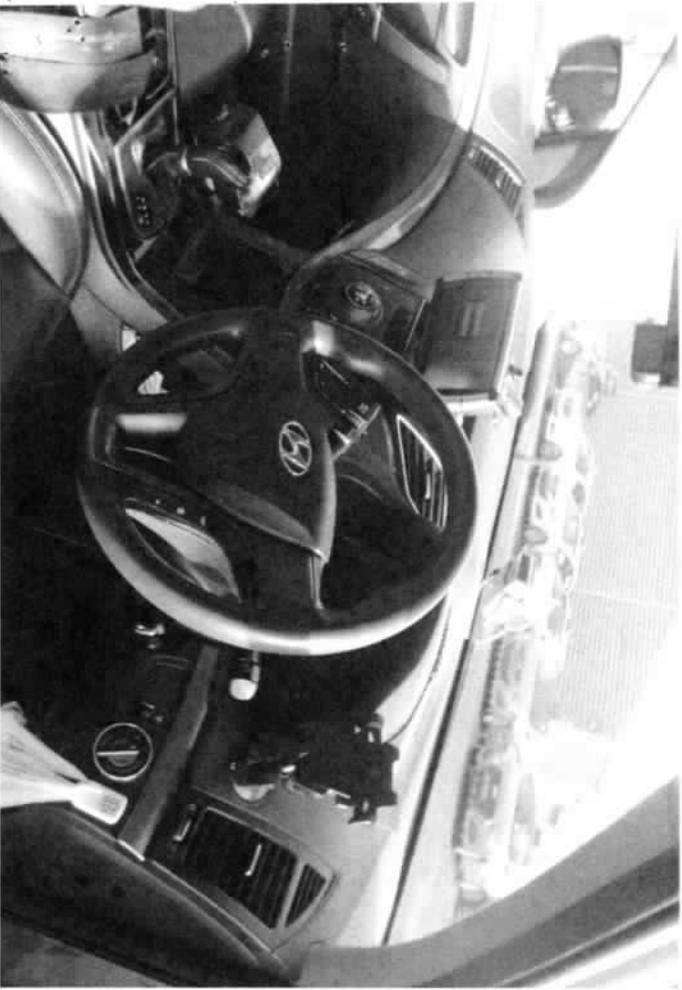
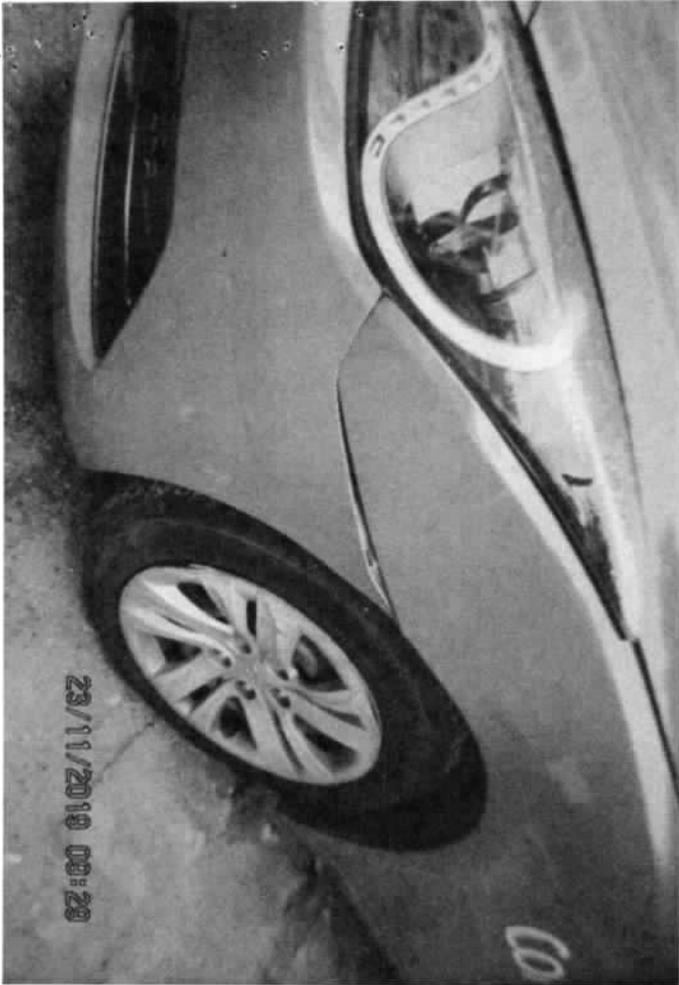
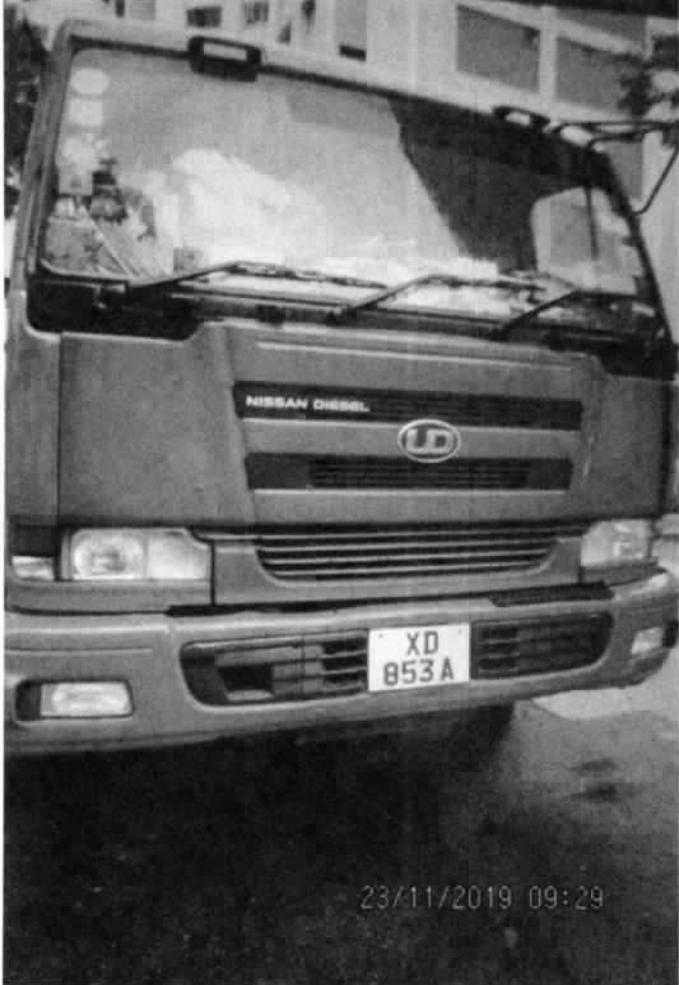
The vehicle sustained impact / damages front n/s & n/s front portion and parts claimed are consistent to the accident.

No.	Qty	Part No.	Particulars	Condition	Repairer's	Amount	
1	1		*FRONT FENDER - LH	Repair	566.30 FL	*- FL	
2	1		*FRONT FENDER SHIELD - LH	Not Necessary	175.90 FL	*- FL	
3	1		*FRONT WHEEL COVER - LH	Deformed	107.10 FL	*107.10 FL	
4	1		*FRONT BUMPER	Repair	1,052.20 FL	*- FL	
5	10		*FRONT BUMPER CLIPS	Not Necessary	22.00 FL	*- FL	
					Sub Total (S\$)	1,923.50	107.10
					- List Item Discount on L Items 20.00/20.00% (S\$)	384.70	21.42
					Total Parts (S\$)	1,538.80	85.68

No	Particulars	Lab.Type	Repairer's	Amount
Labour Items				
1	PANEL BEATING	New	600.00	560.00
2	SPRAY PAINTING	New	500.00	400.00
3	TUFF KOTE	New	100.00	0.00
4	WIRING CHARGE	New	100.00	0.00
5	FRONT WHEEL ALIGNMENT	New	100.00	0.00
Gross Labour Cost (S\$)			1,400.00	960.00
