25/CT119021083/ EV d3b

SLX 5089 T

BMW 318i

VEHICLE DAMAGE INSPECTION REPORT

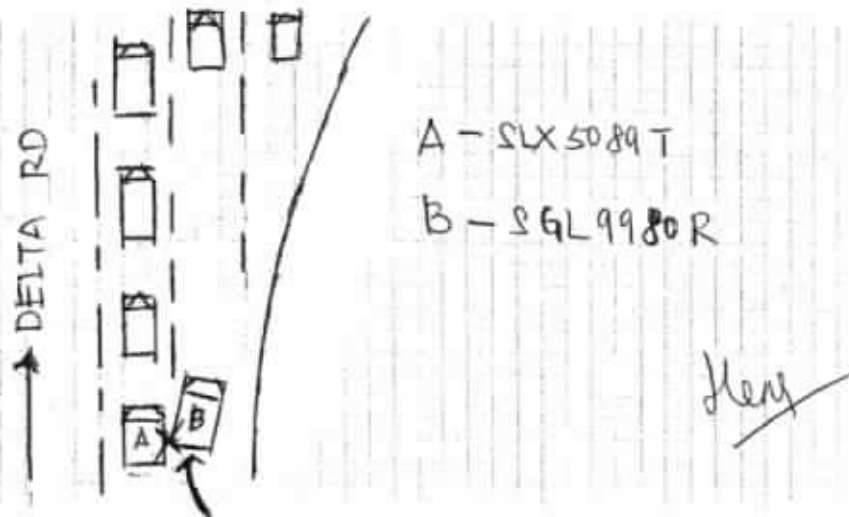
SKETCH PLAN

On 27/11/19 at about 9.25 am, my vehicle stopped at Delta Road traffic light junction as the traffic light was Red. Suddenly I heard a loud bang on the right side of my car. I came out of the car and notice a few marks/dents on the right side of my car. The other vehicle driver and I then drove our cars to another side road to exchange particulars, and she admitted that she has just hit my car.
