Your Ref: Honda Engine
(number K20A5824384)
Our Ref : CI/TP19021208/D

INSPECTION REPORT OF A HONDA ENGINE WITH NUMBER K20A5824384

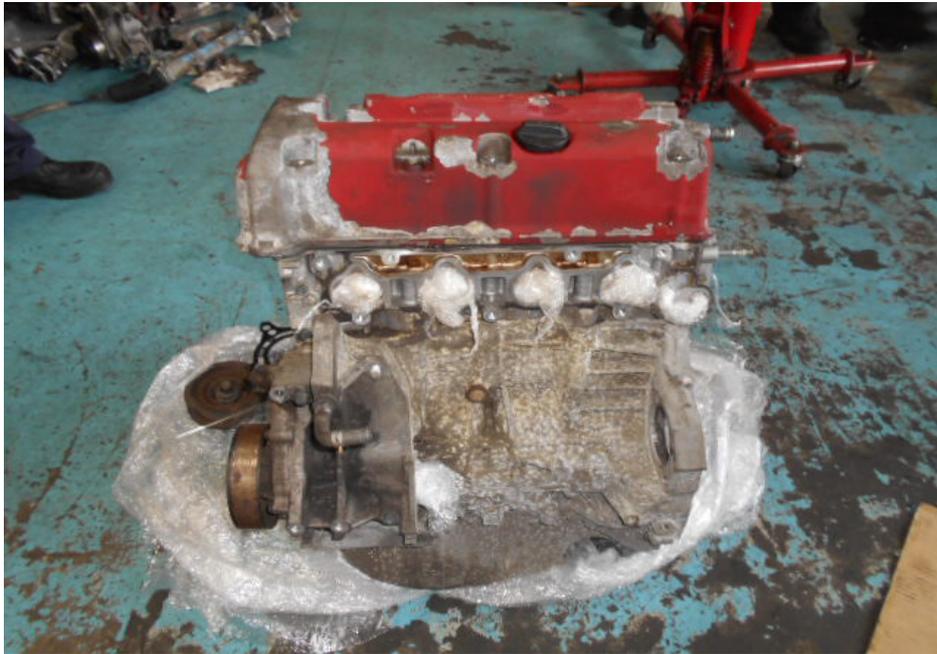
Photo 1 shows a general view of the Honda engine that I had inspected. The Honda engine was observed to be a used engine and was not fitted on any motor car. It was also observed to be a complete assembly with all mechanical parts still intact, within the engine housing.

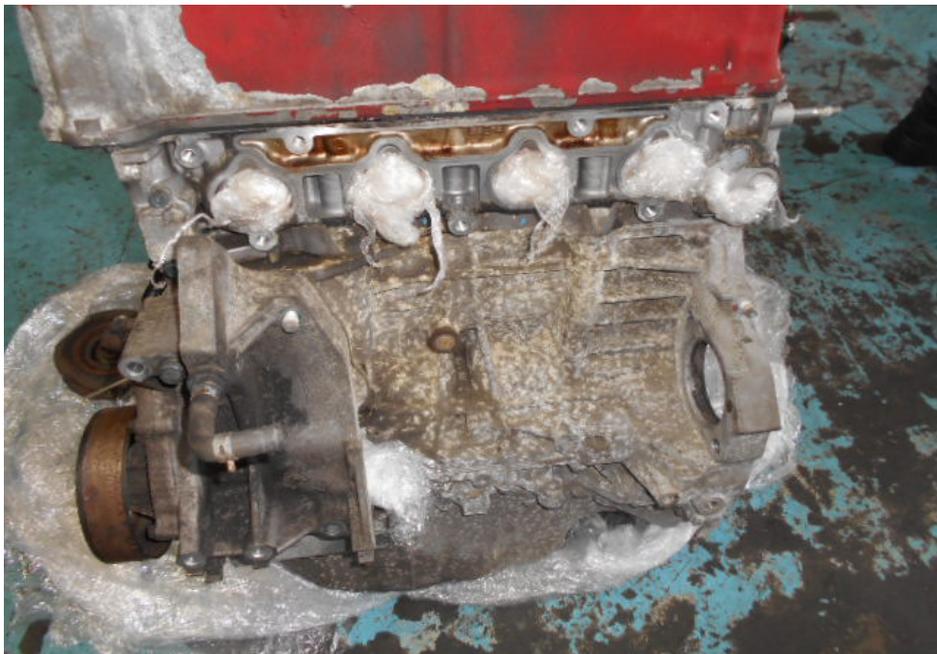
Photo 2 shows a closer view of the Honda engine that I had inspected. My visual examination of the engine housing revealed the housing to be of serviceable/satisfactory condition. There was no crack and/or hole observed on the engine housing.

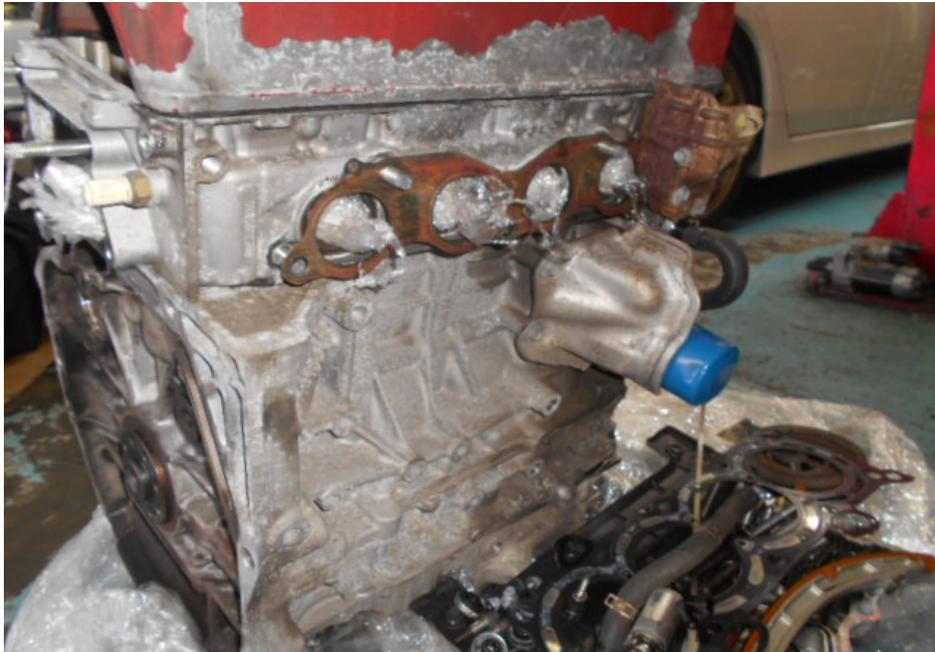
Photo 3 shows a closer view of the Honda engine that I had inspected. My visual examination of the engine housing revealed the housing to be of serviceable/satisfactory condition. There was no crack and/or hole observed on the engine housing.

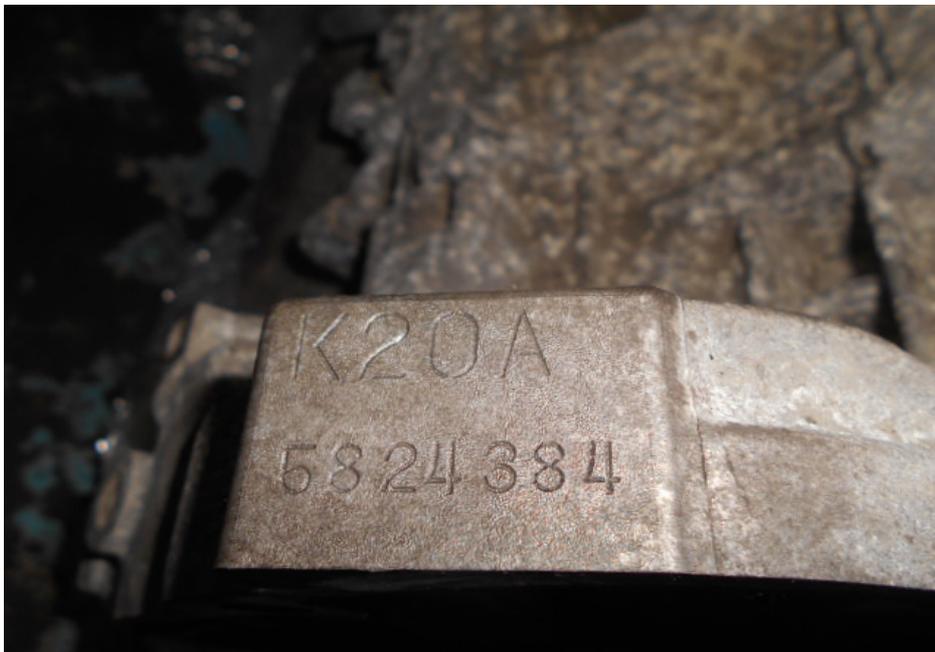
Photo 4 shows the engine number engraved on the housing of the Honda engine that I had inspected. The engine number was K20A5824384.

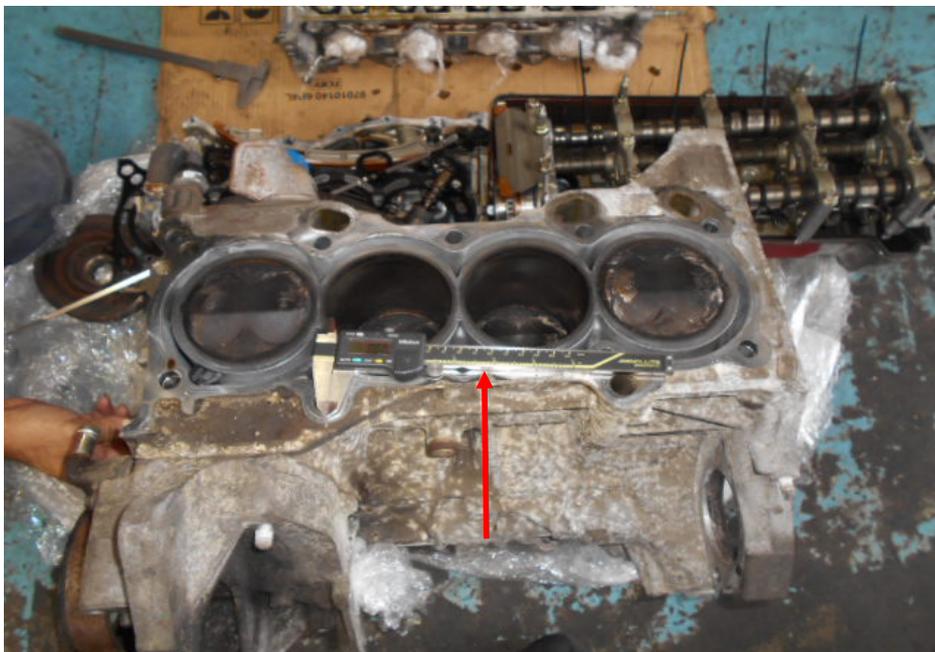
Photo 6 shows the bottom block of the Honda engine and the digital Vernier Caliper (arrowed) that was used to measure the bore and stroke measurements of each cylinder, which typically can be used to determine the engine displacement or more commonly referred to as engine cc. The digital Vernier Caliper was calibrated before the start of the measurements.

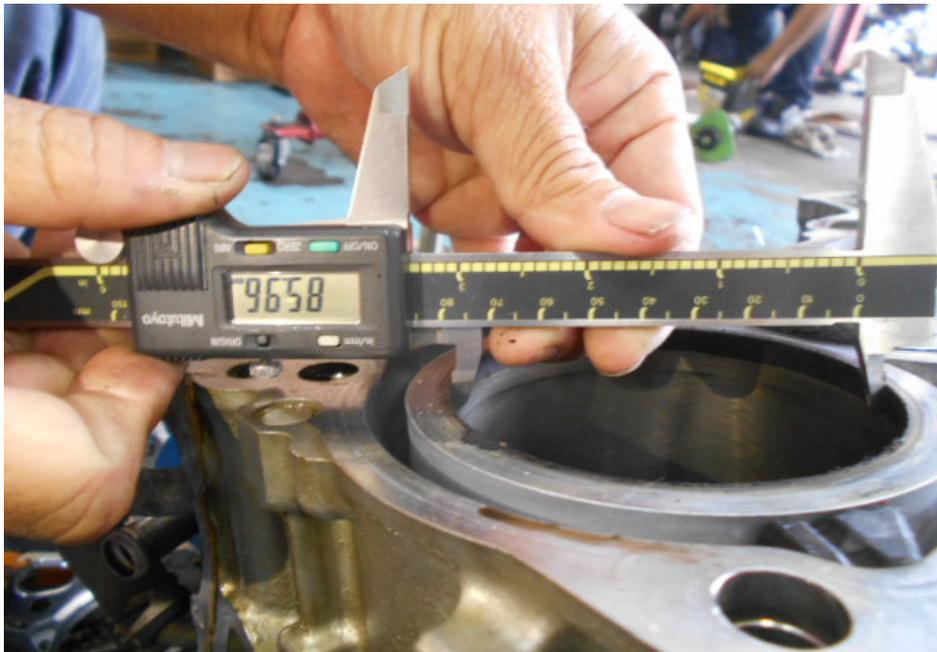
Photo 8 shows the bore measurement of cylinder 1, which was recorded to be 85.96mm.

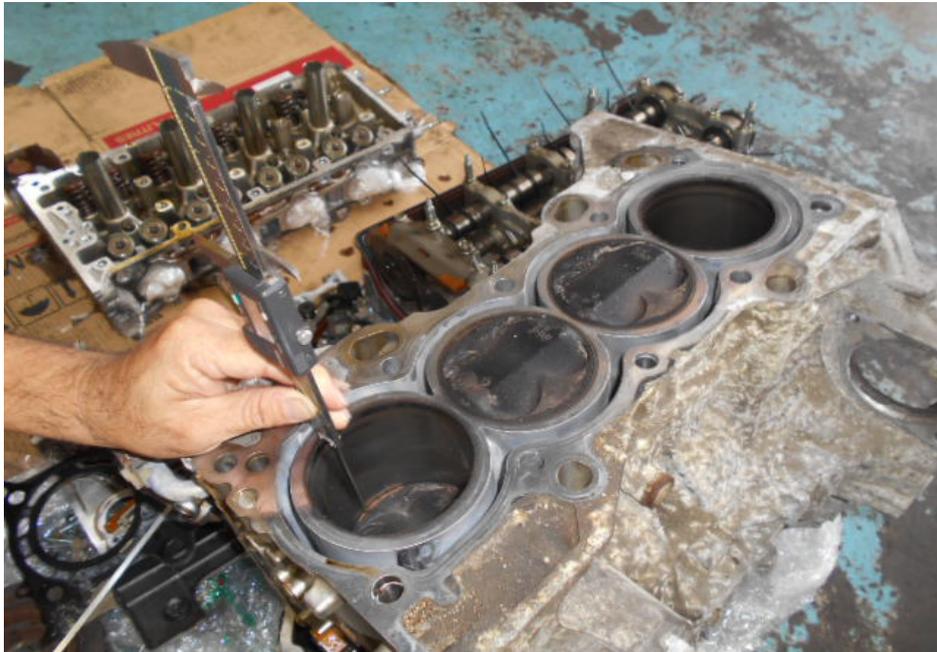
Photo 9 shows measurement being carried out to the stroke of cylinder 1 of the Honda engine. The bore and stroke measurements of the Honda engine were carried out using a digital Vernier Caliper.

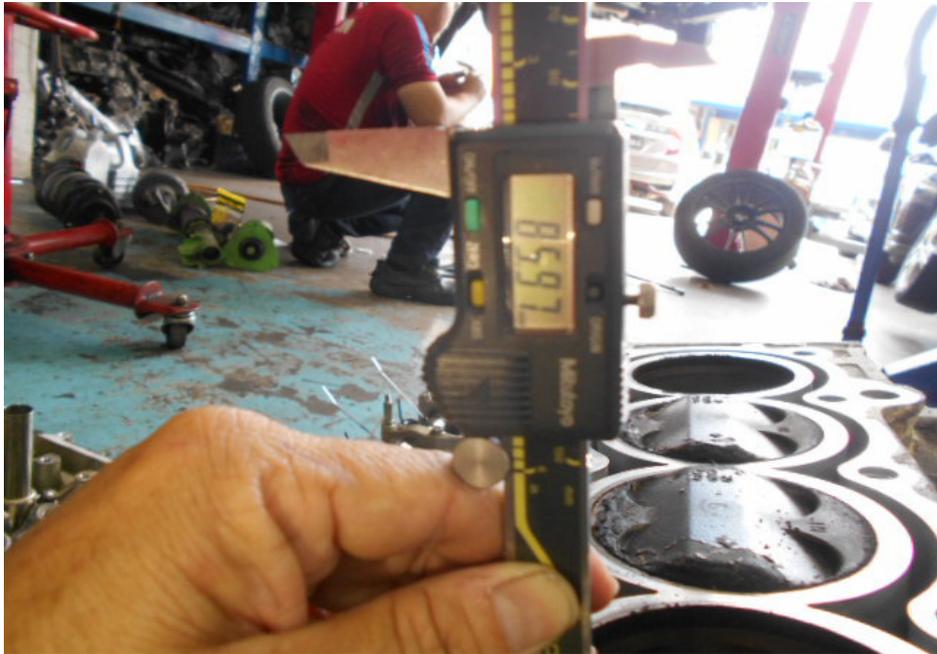
Photo 11 shows the stroke measurement of cylinder 1, which was recorded to be 85.97mm.

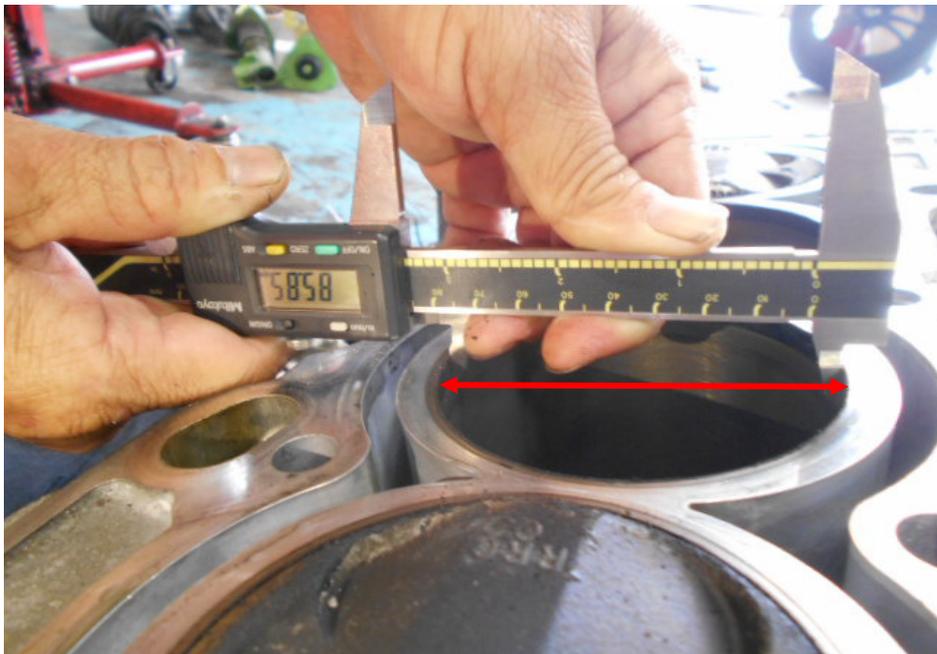
Photo 12 shows measurement being carried out to the bore (arrowed) of cylinder 2 of the Honda engine. The bore measurement of cylinder 2 was recorded to be 85.85mm.

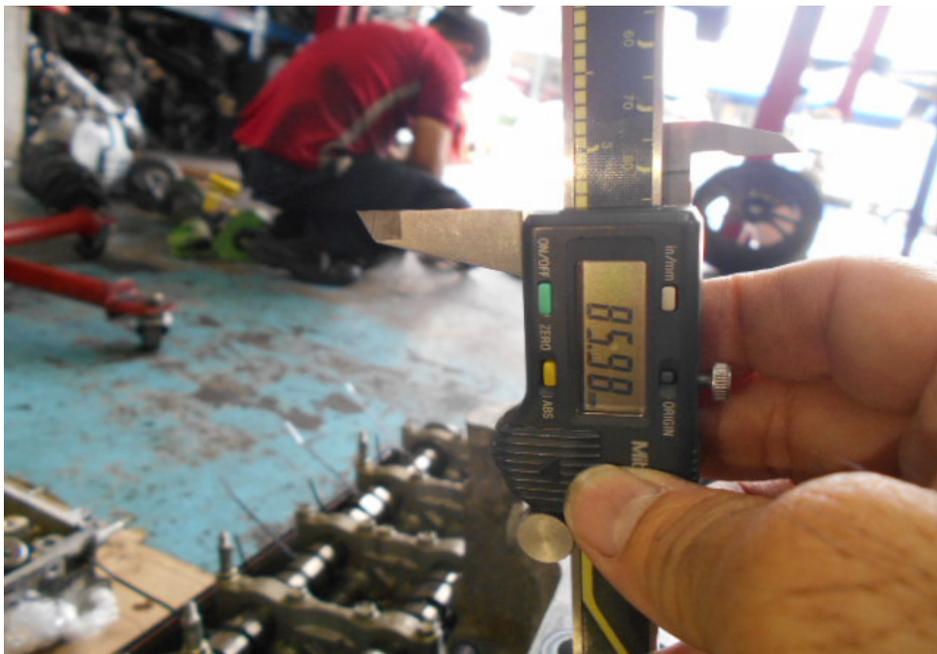
Photo 14 shows the stroke measurement of cylinder 2, which was recorded to be 85.98mm.

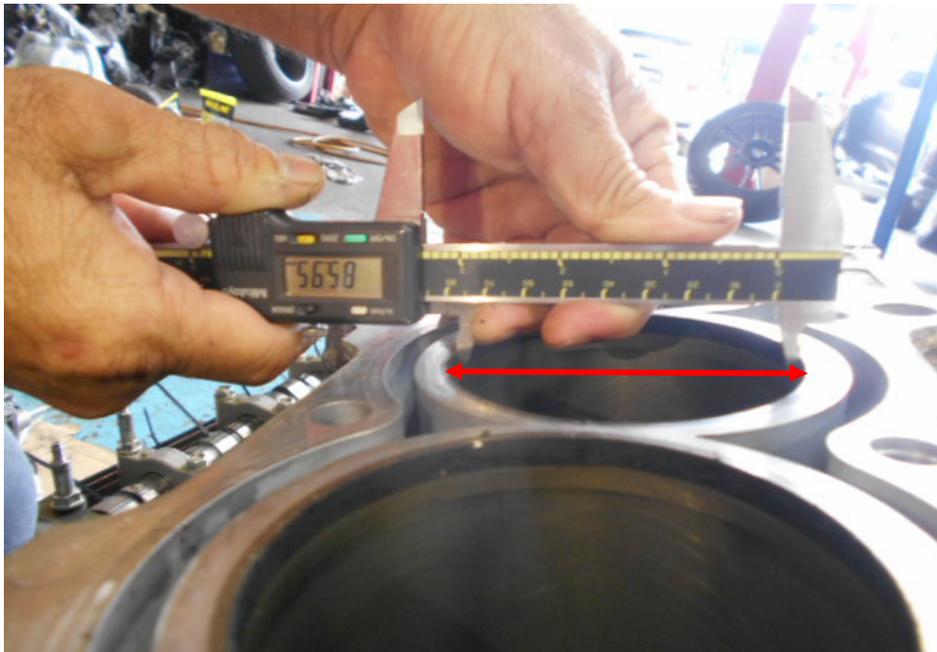
Photo 16 shows measurement being carried out to the bore (arrowed) of cylinder 3 of the Honda engine. The bore measurement of cylinder 3 was recorded to be 85.95mm.

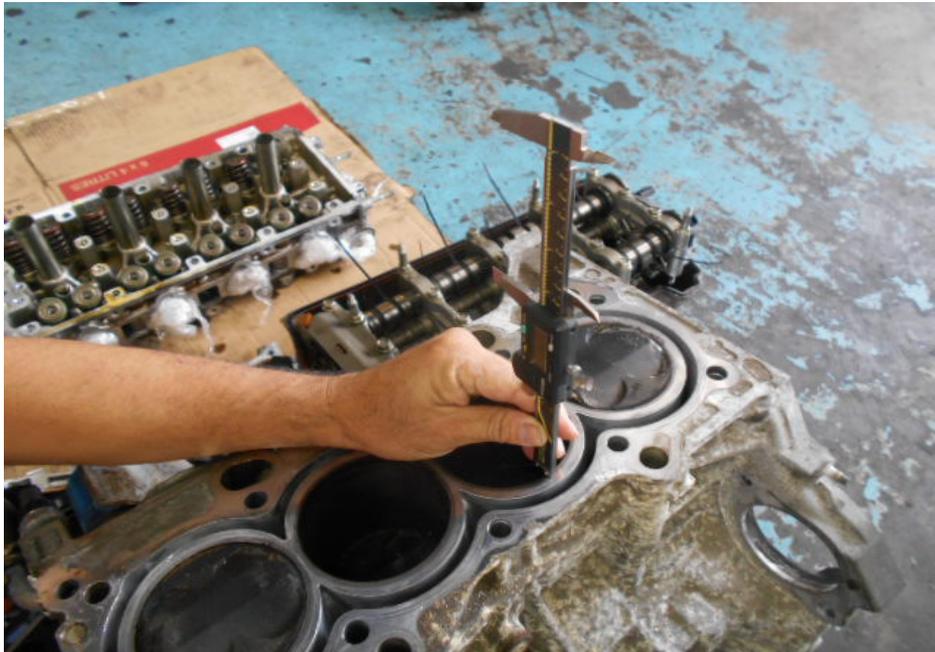
Photo 17 shows measurement of the stroke for cylinder 3 of the Honda engine that I had inspected. The bore and stroke measurements of the Honda engine were carried out using a digital Vernier Caliper that was calibrated before the start of measurements.

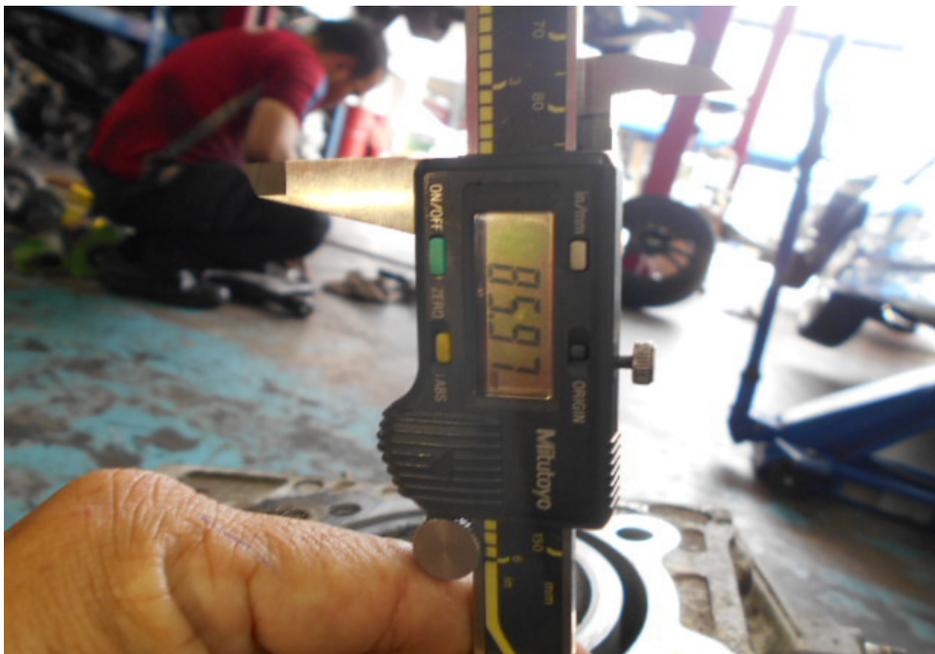
Photo 18 shows the stroke measurement of cylinder 3, which was recorded to be 85.97mm.

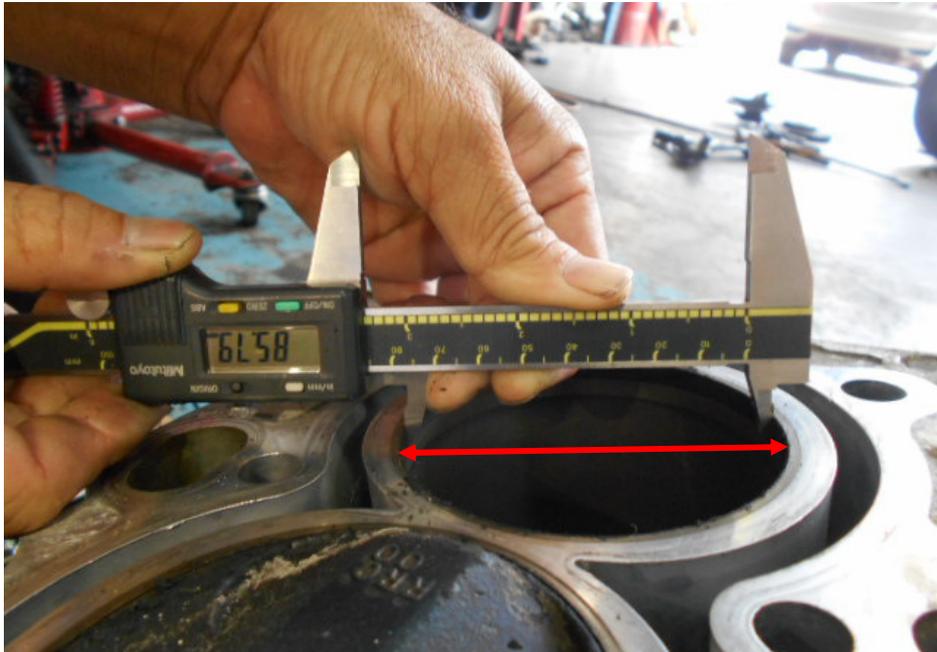
Photo 19 shows measurement being carried out to the bore (arrowed) of cylinder 4 of the Honda engine. The bore and stroke measurements of the Honda engine were carried out using a digital Vernier Caliper. The bore measurement of cylinder 4 was recorded to be 85.79mm.

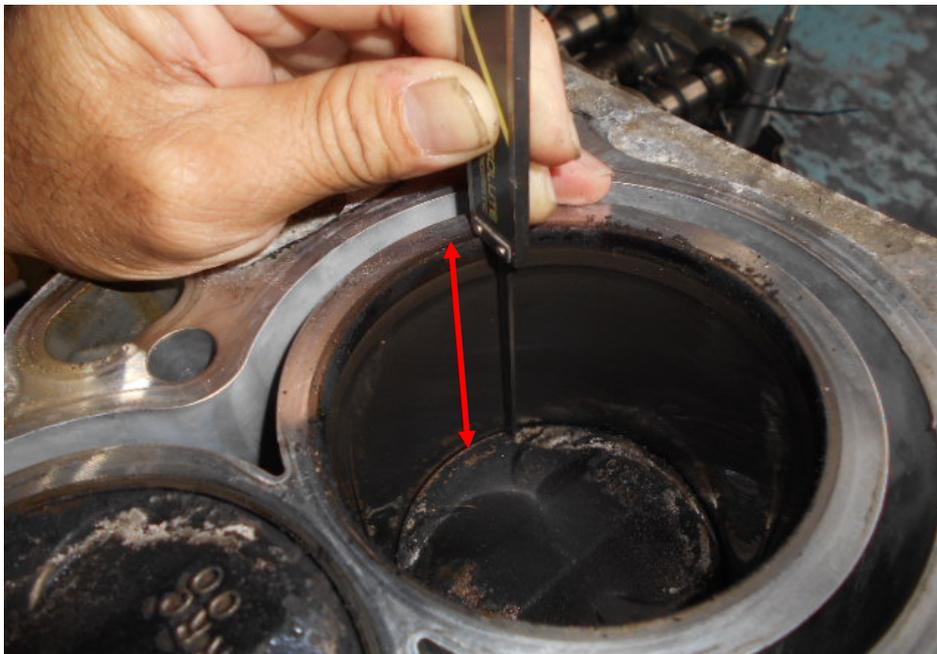
Photo 20 shows measurement being carried out to the stroke (arrowed) of cylinder 4 of the Honda engine. The bore and stroke measurements of the Honda engine were carried out using a digital Vernier Caliper that was calibrated prior to the start of measurements.

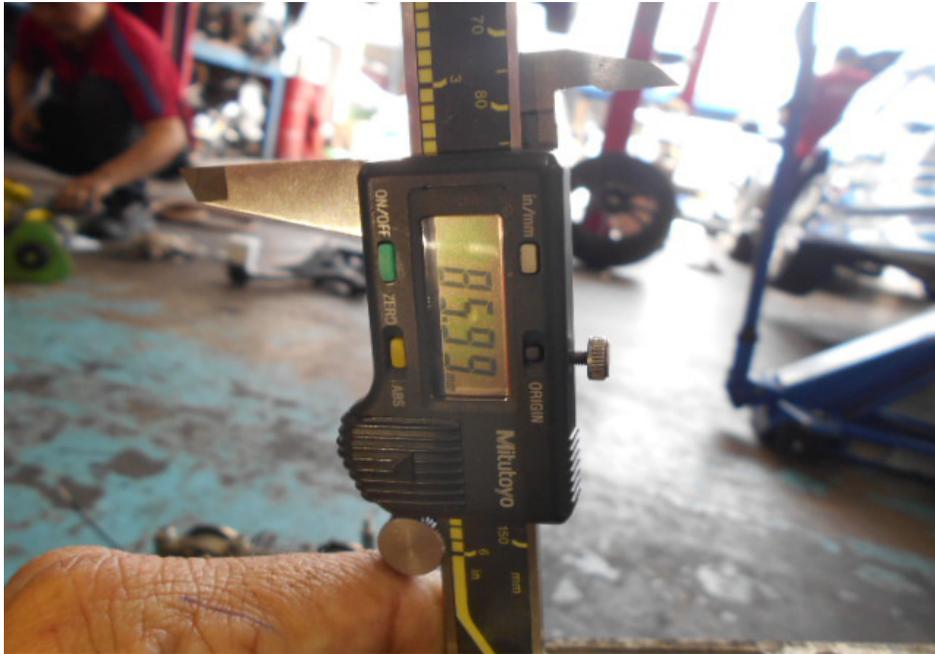
Photo 21 shows the stroke measurement of cylinder 4, which was recorded to be 85.99mm.
