AUTO & GENERAL INSURANCE (S) PL Ref: CS/AGI19021285/Kqd3n2

239	924		Code: AGI	
1.		Policy Particula	ars :- THIRD PARTY CLA	JIM
	Insured Veh.	SKU 857D	Veh. Inspected	SME 86Y
	Policy No.		Coverage (\$)	0.00
	Claim No.	C10004757/KY	Excess (\$)	0.00
	Assign From	IVY RATILLA	Assign Date	02/12/2019

4.		Descr	iption of Damages	TO PARTIE LA
	THE VEHICLE SU	STAINED DAMAGES AT THE	FRONT O/S DOOR.	
	DAMAGES SEE D	ETAILS.		
5.		Gen	eral Information	
	Accident Date	29/11/2019	Inspection Date	11/02/2020
	Survey held at	ALAN'S UNITED AUTO PTE	LTD	
		BLK 7 SIN MING INDUSTRI #01-76 SINGAPORE 575642	AL ESTATE	
5a.		THE RESER	Remarks	The second second
		ON WAS CONDUCTED ON A'CE TO YOUR INSTRUCTIONS		
5b.		Estim	ate Days of Repair

#### ADJUSTMENT ON REPAIR COST FOR VEHICLE NO. SME 86Y

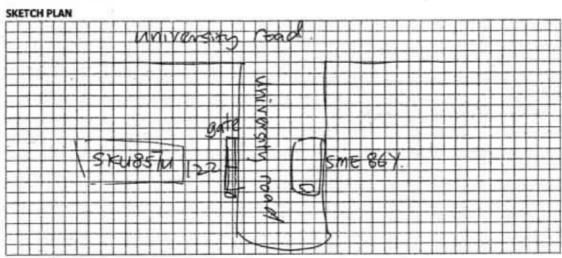
## Sketch Plan Pg. 2

Scratched. A note from Natascha Milsom was left behind, confirming their vehicle reversed into sneed and caused the domages.  Natascha Milsom and Matt Milsom  Neic: F0645014T  Vehicle: Skuf57D  Insurance: BUBGIT NEIJ P10186495R00  Tel: 8860 0095 and 8120 5153
NRIC: F0645014T Veh: Cle: StuffTD Insurance: SUBGIT DIRTY P10186445ROD
Insurance: BUDGET DIKEY PIOIS6495ROD
