The UIC / Chassis frame / Body Structure affected due to collision

Make: Honda Vezel C.C. 1496

## VEHICLE DAMAGE INSPECTION REPORT

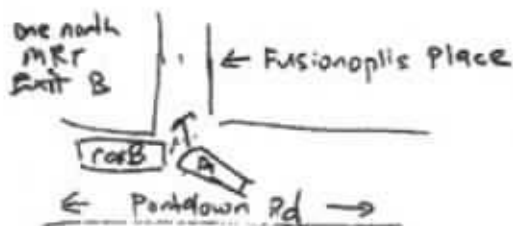
### SKETCH PLAN

I was driving Car A & did a right but didn't ~~note~~ notice that Car B was going straight. Due to that right turn both cars collided.

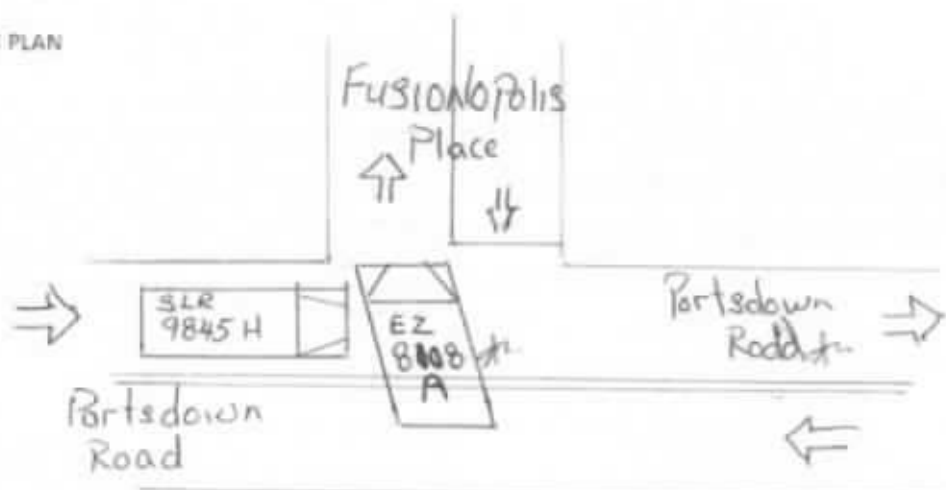
# SKETCH PLAN

On date 25/02/2019 time 10.43. I was driving along Portsmouth Road to send my passenger to her location while I was driving I saw one car EZ 8008 A come from opposite without signal and turn right and hit to my car SLR 9845 H.

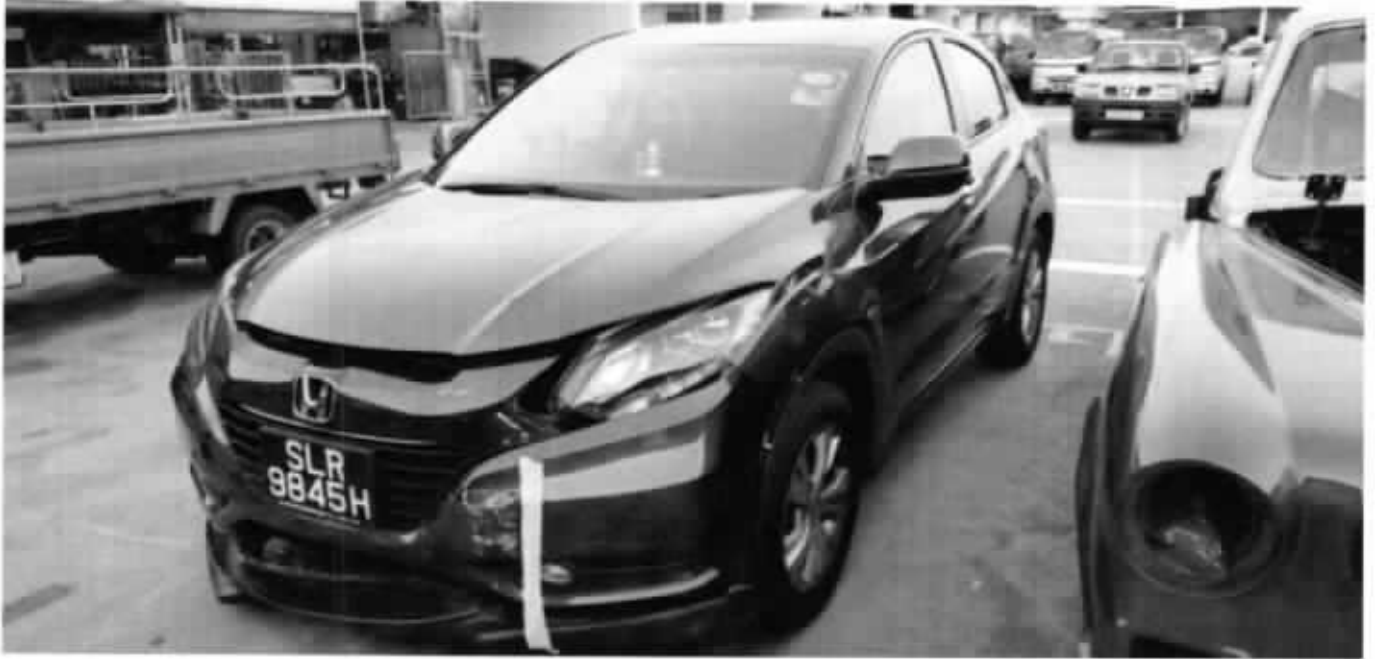
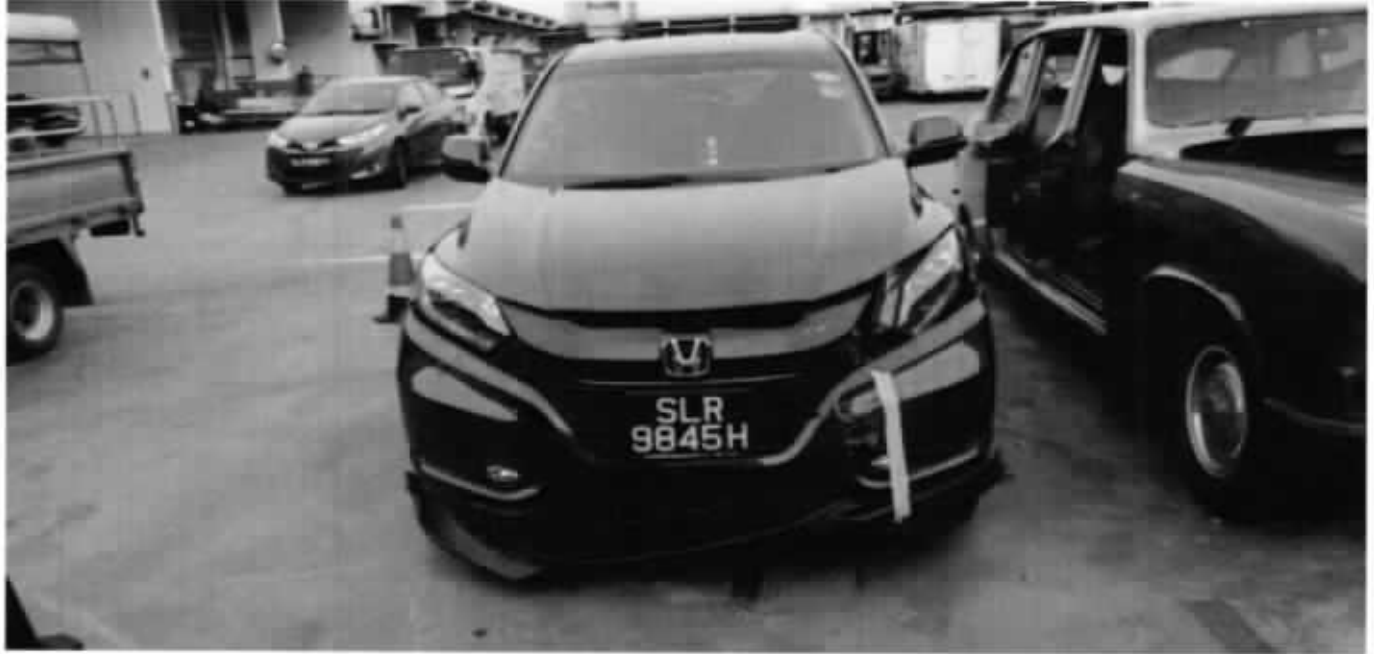
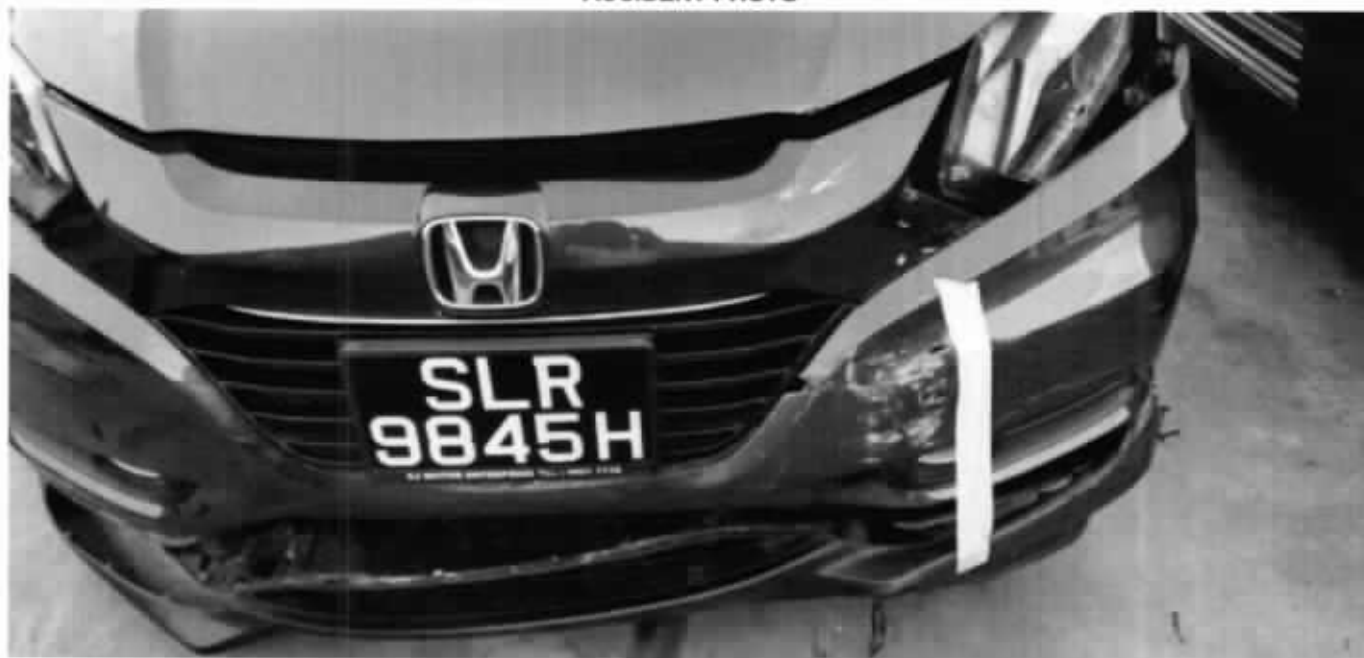
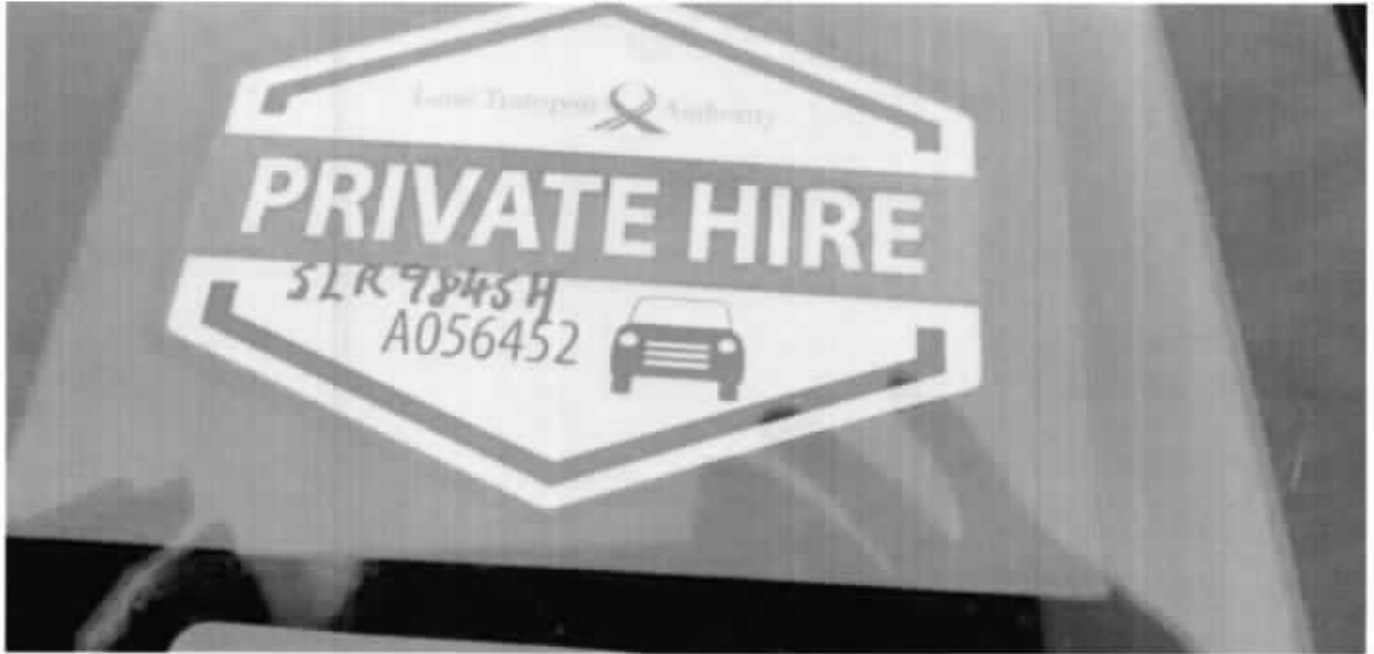
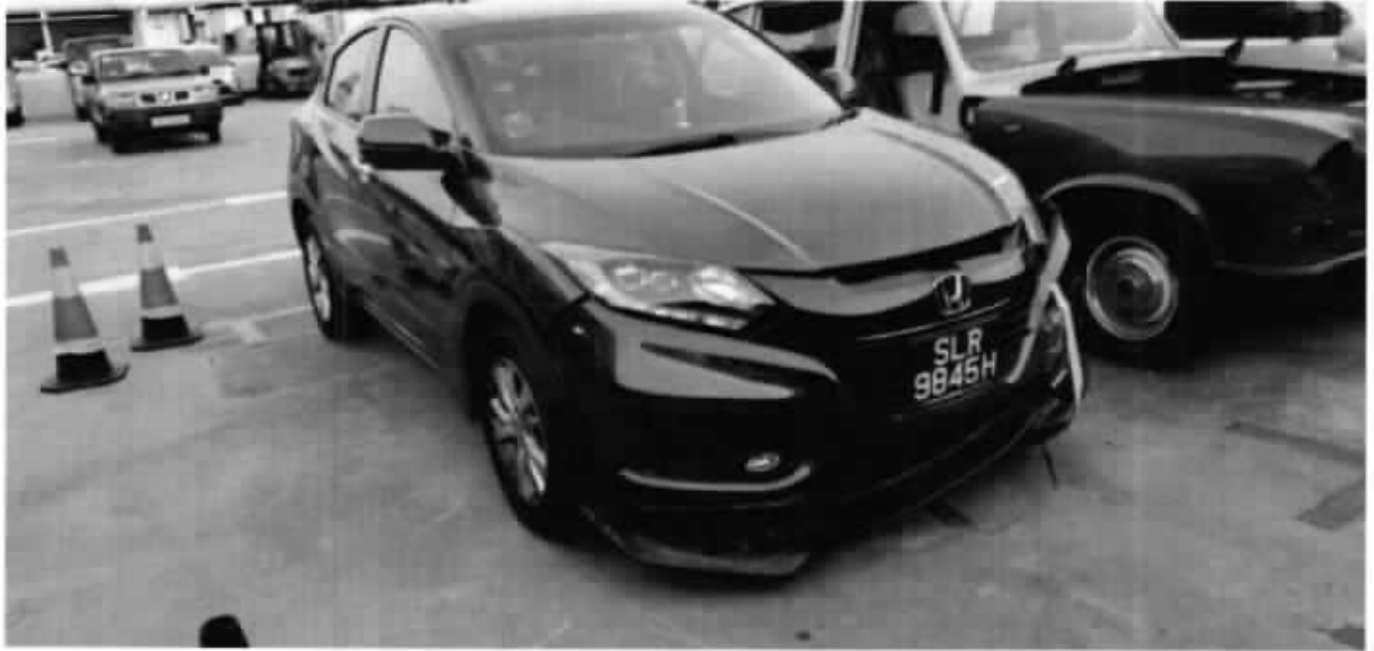
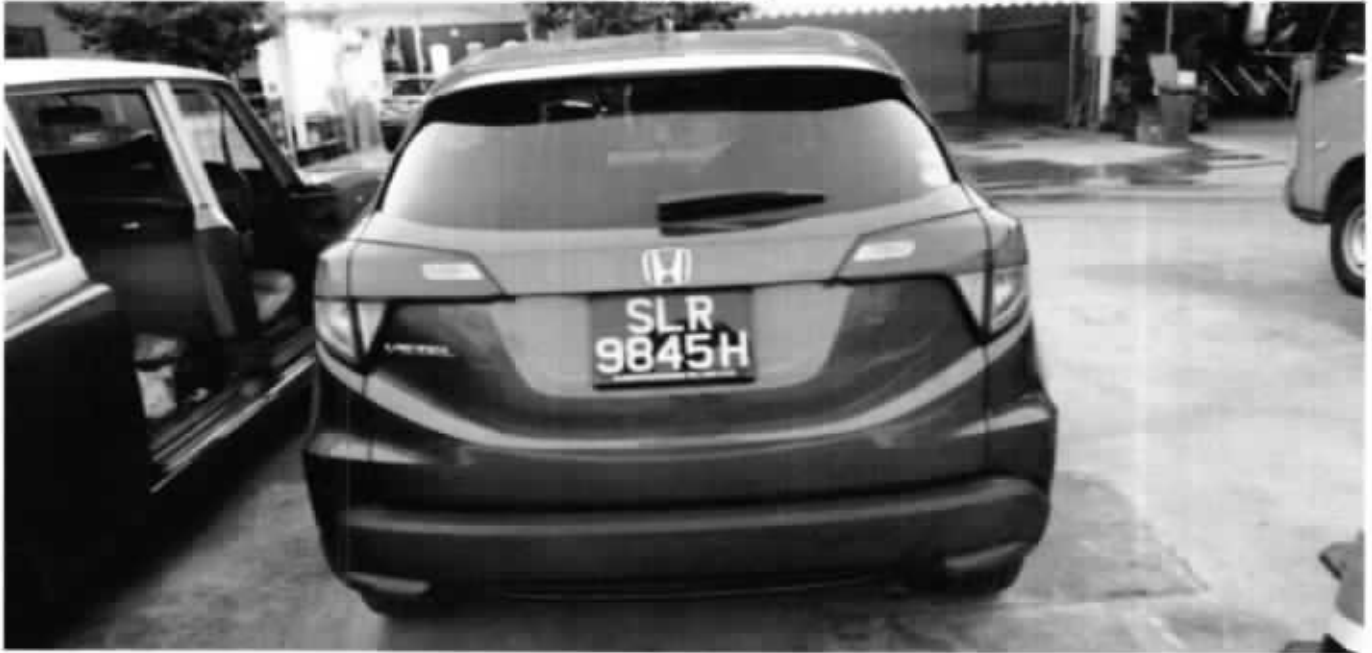
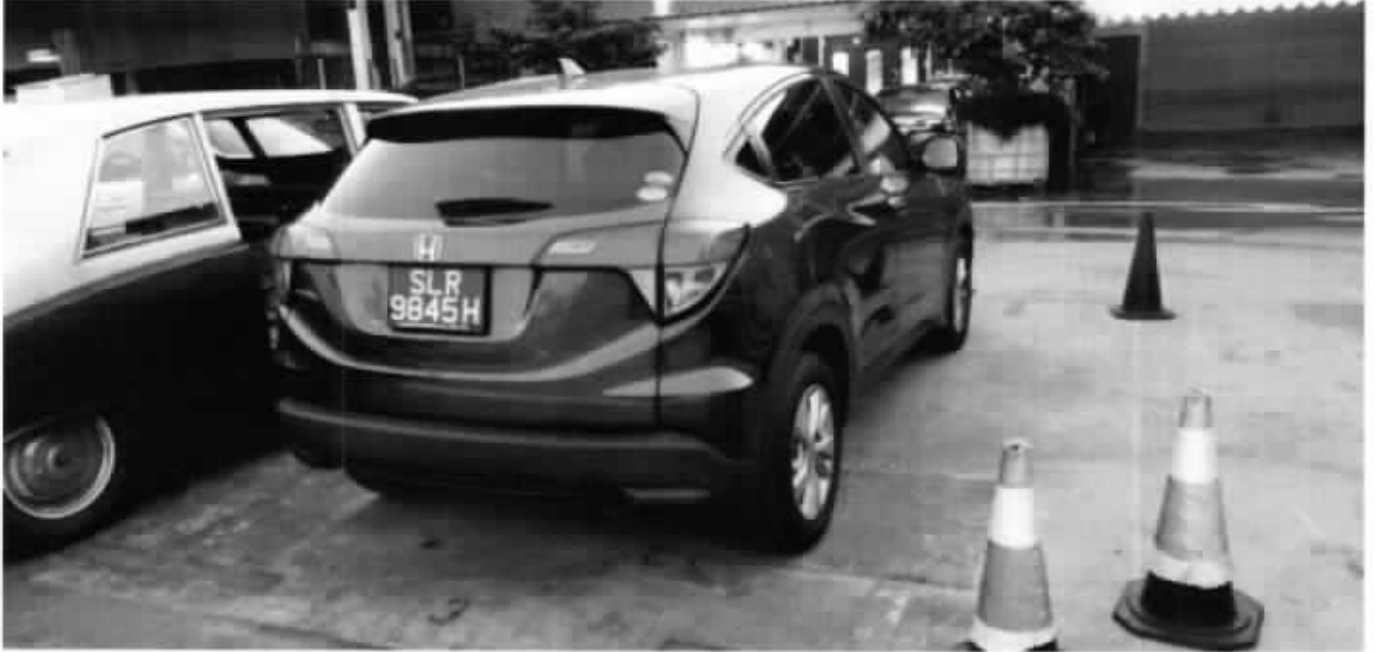
Other parts were also found damaged. (See schedule for details)

The estimate cost of repair submitted by M/s Kok Wang Car Grooming as per schedule attached have been revise and scrutinize. We list the breakdown of our findings and recommendation as per attached.

The repairer has agreed to undertake the repair at a lumpsum of SGD \$10,150.00

Under normal circumstances, the repair of the damaged vehicle should be completed within a reasonable period of 8 working days.
