## ASSIGNMENT

Insured: SLA 1089R

Claims No. MT/1075406-001

### ADJUSTMENT ON REPAIR COST FOR VEHICLE NO. SHC 8640P

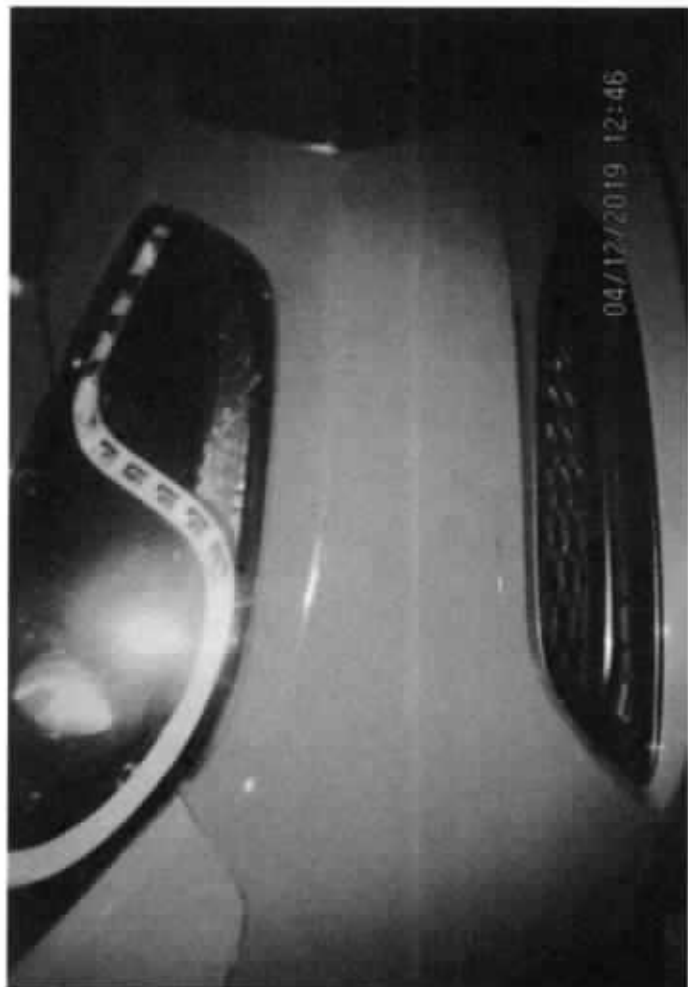
THE VEHICLE SUSTAINED DAMAGES AT THE FRONT PORTION. DAMAGES SEE DETAILS.
---

Qty	Description of Parts	Condition	Estimate By Workshop (\$)	Our Adjusted (\$)
	<b><u>REPLACEMENT OF PARTS</u></b>			
1	FRONT BUMPER COVER	TO REPAIR SEE LABOUR	544.50	-
1	FRONT BUMPER BRACKET TOP (RH)	NOT NECESSARY	22.40	-
1	FRONT BUMPER BRACKET (RH)	NOT NECESSARY	24.60	-
	LESS 20% DISCOUNT		-118.30	-
			473.20	-
	<b><u>LABOUR</u></b>			
	PANEL BEATING. INCLUSIVE OF THE REPAIR OF FRONT BUMPER COVER.		350.00	280.00
	SPRAY PAINTING CHARGE.		250.00	200.00
			600.00	480.00
	<b>GRAND TOTAL</b>		<b>1,073.20</b>	<b>480.00</b>
<b>RECOMMENDED COST OF REPAIRS (CONFIRMED)</b>				<b>480.00</b>
