ACCIDENT VEHICLE INSPECTION REPORT

Report no : 424M1019.PH
Vehicle no : SMC1076E

Make/model : HONDA VEZEL 1.5X CVT
Chassis no : RU11303702
Engine no : L15B5553709
Date of registration : 26 Jun 2018 COE Expiry Date: 25 Jun 2028
Engine capacity : 1496 cc
Odometer reading : 027608 km
Colour : Grey

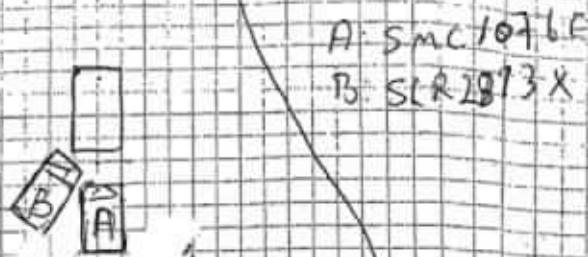
TW PLAN

On 15 Oct 19, 1710H, I ~~was~~ driving along toward Johore
towards immigration check point along middle lane. It was
heavy jam during the incident happened. Suddenly I felt a
jerk at the front of my car and I noticed my car was
collided with the other car on my left.

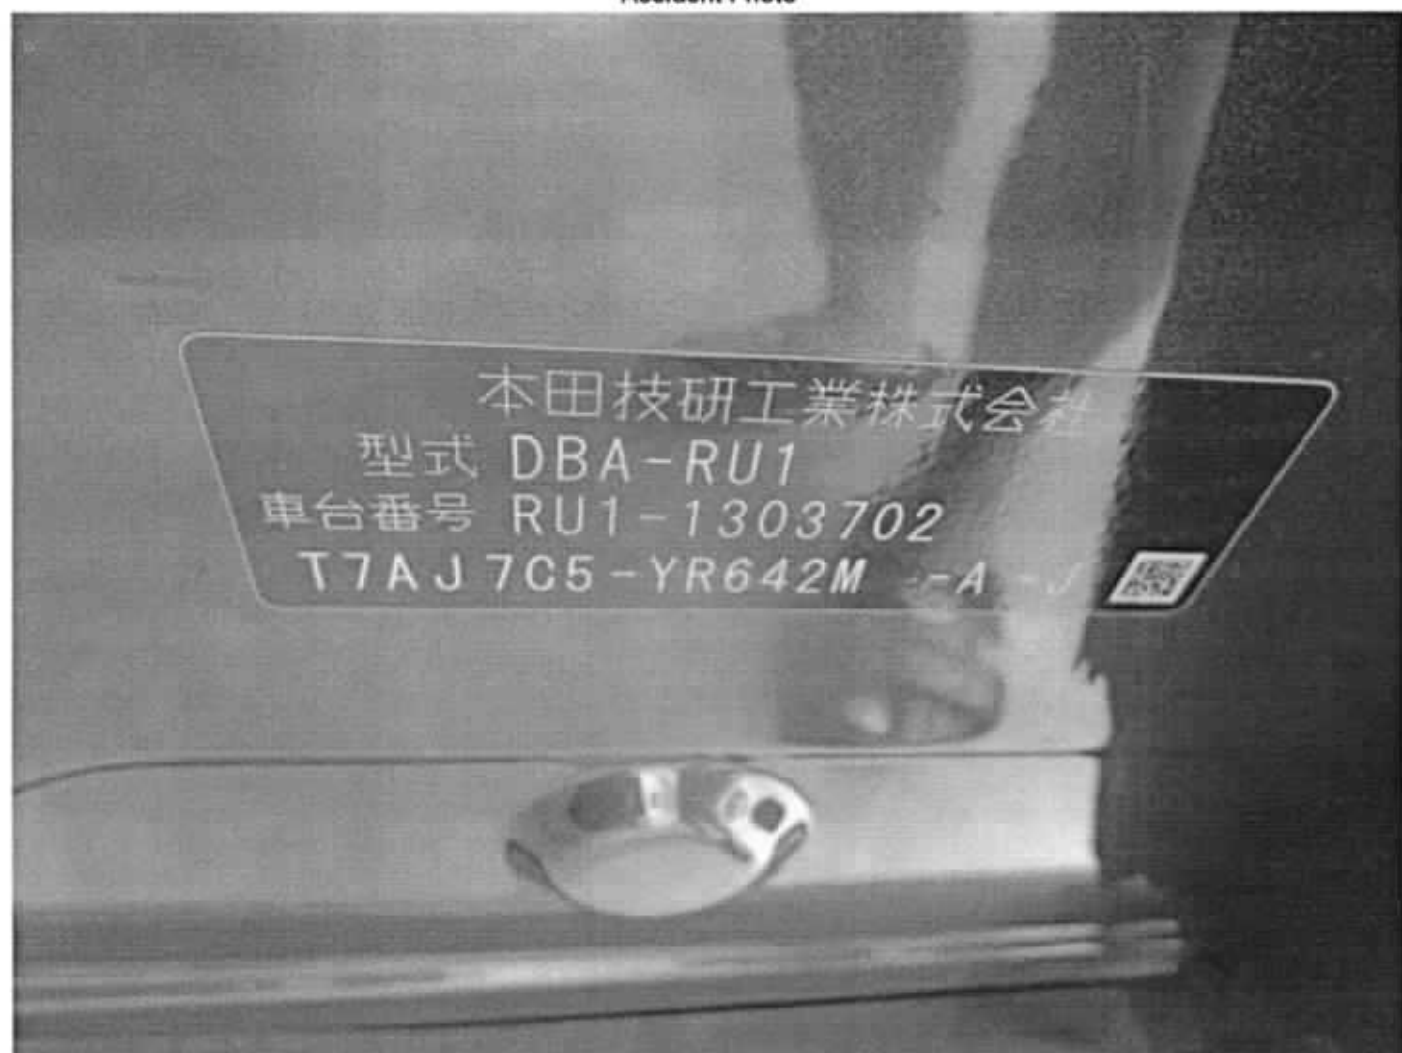
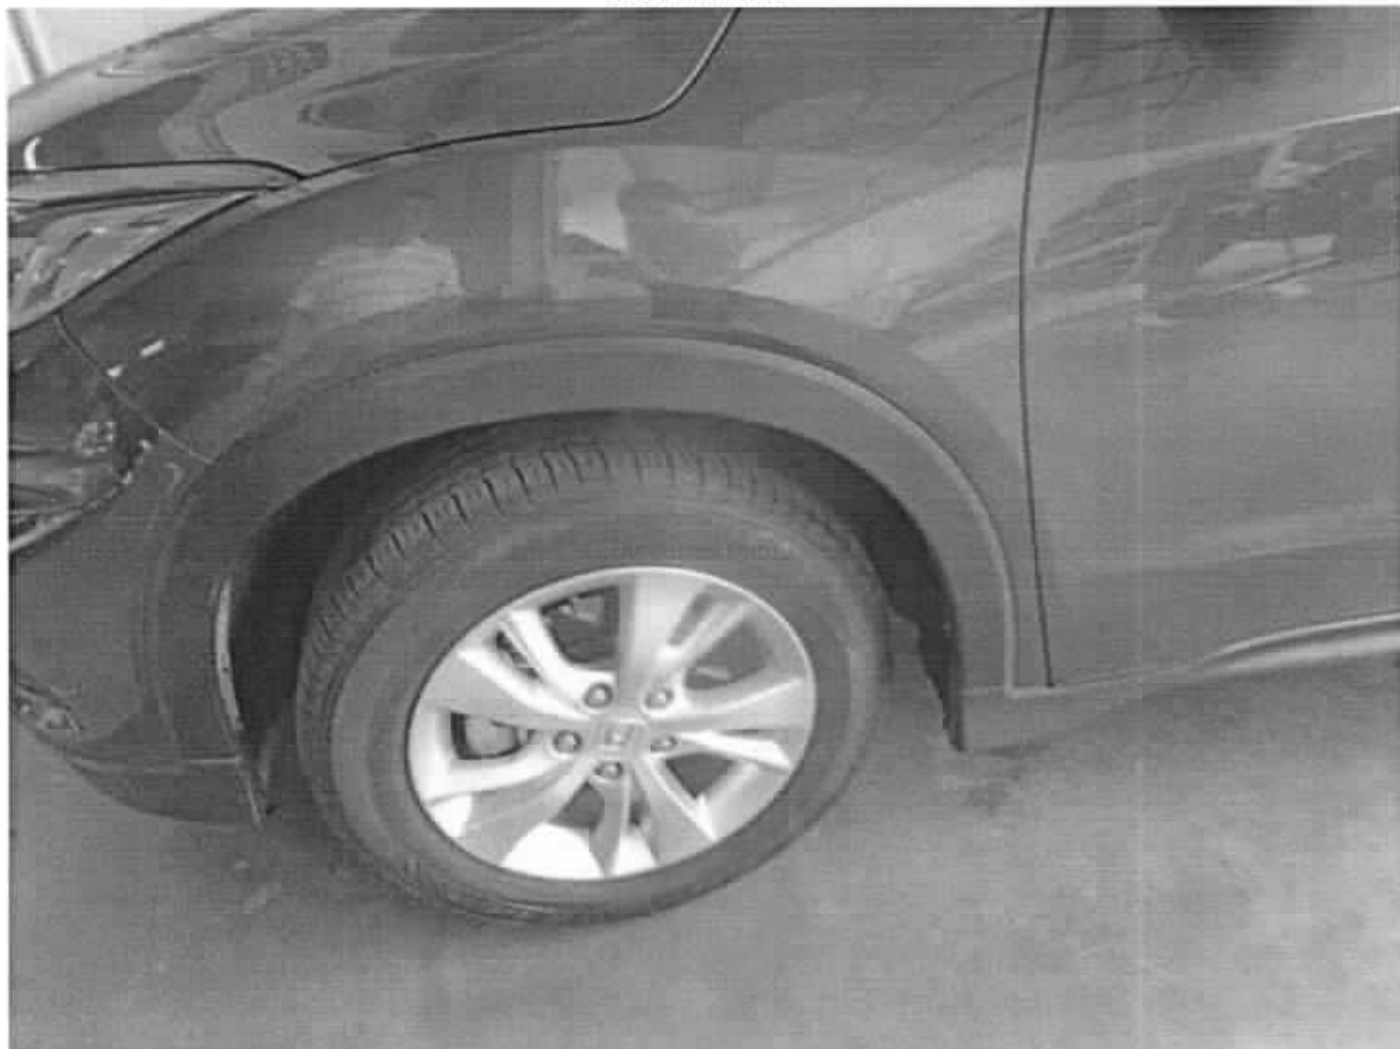
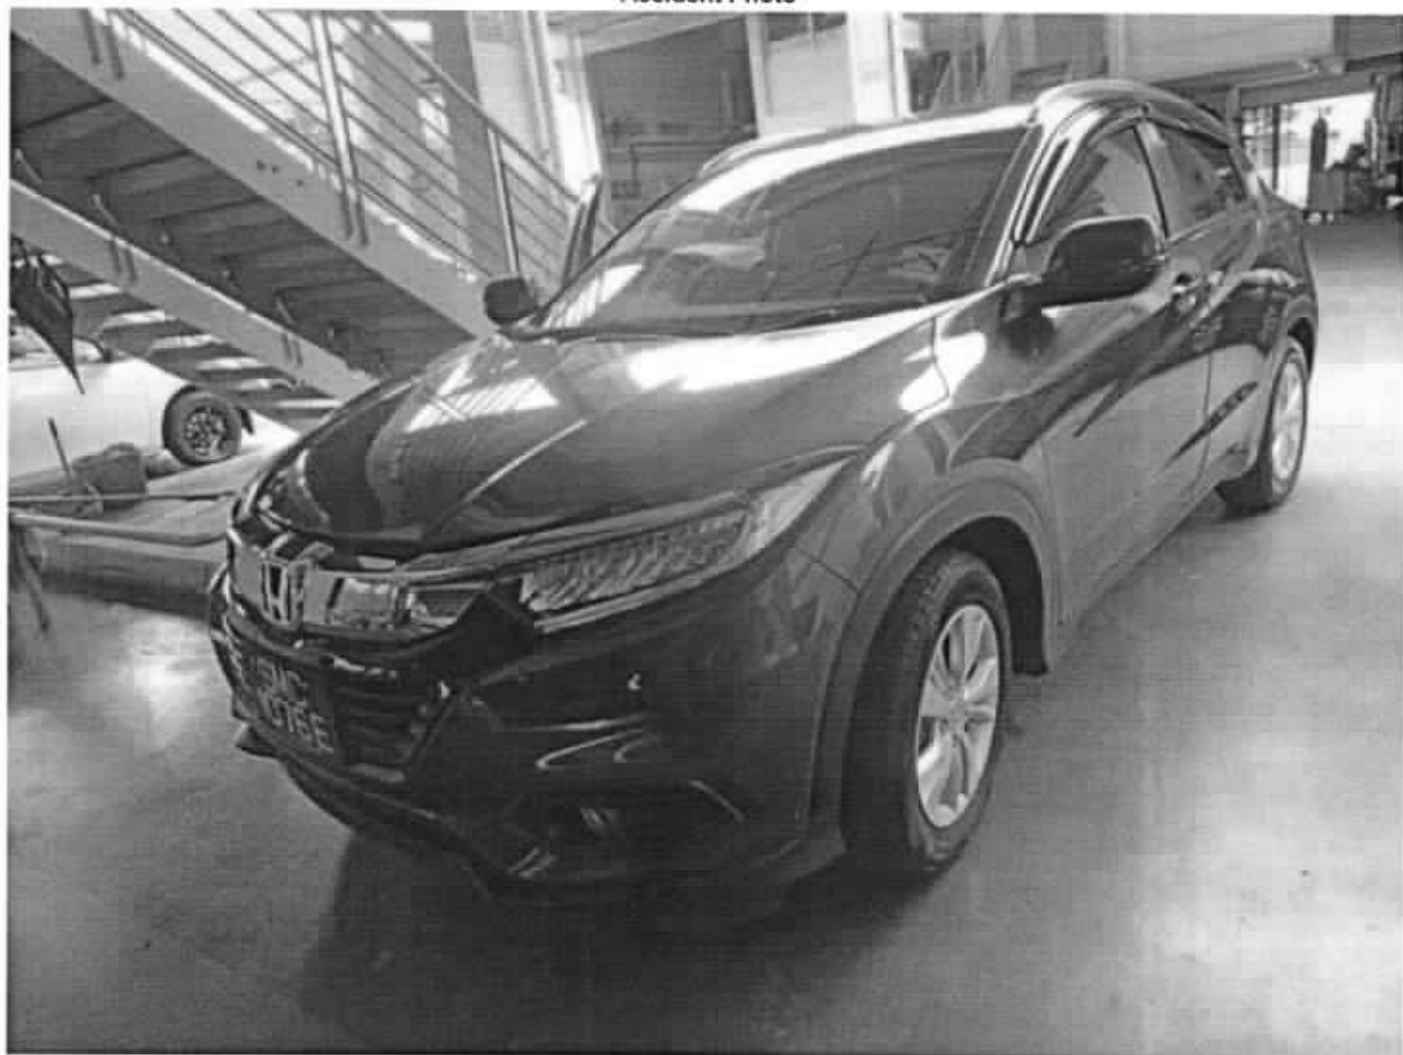
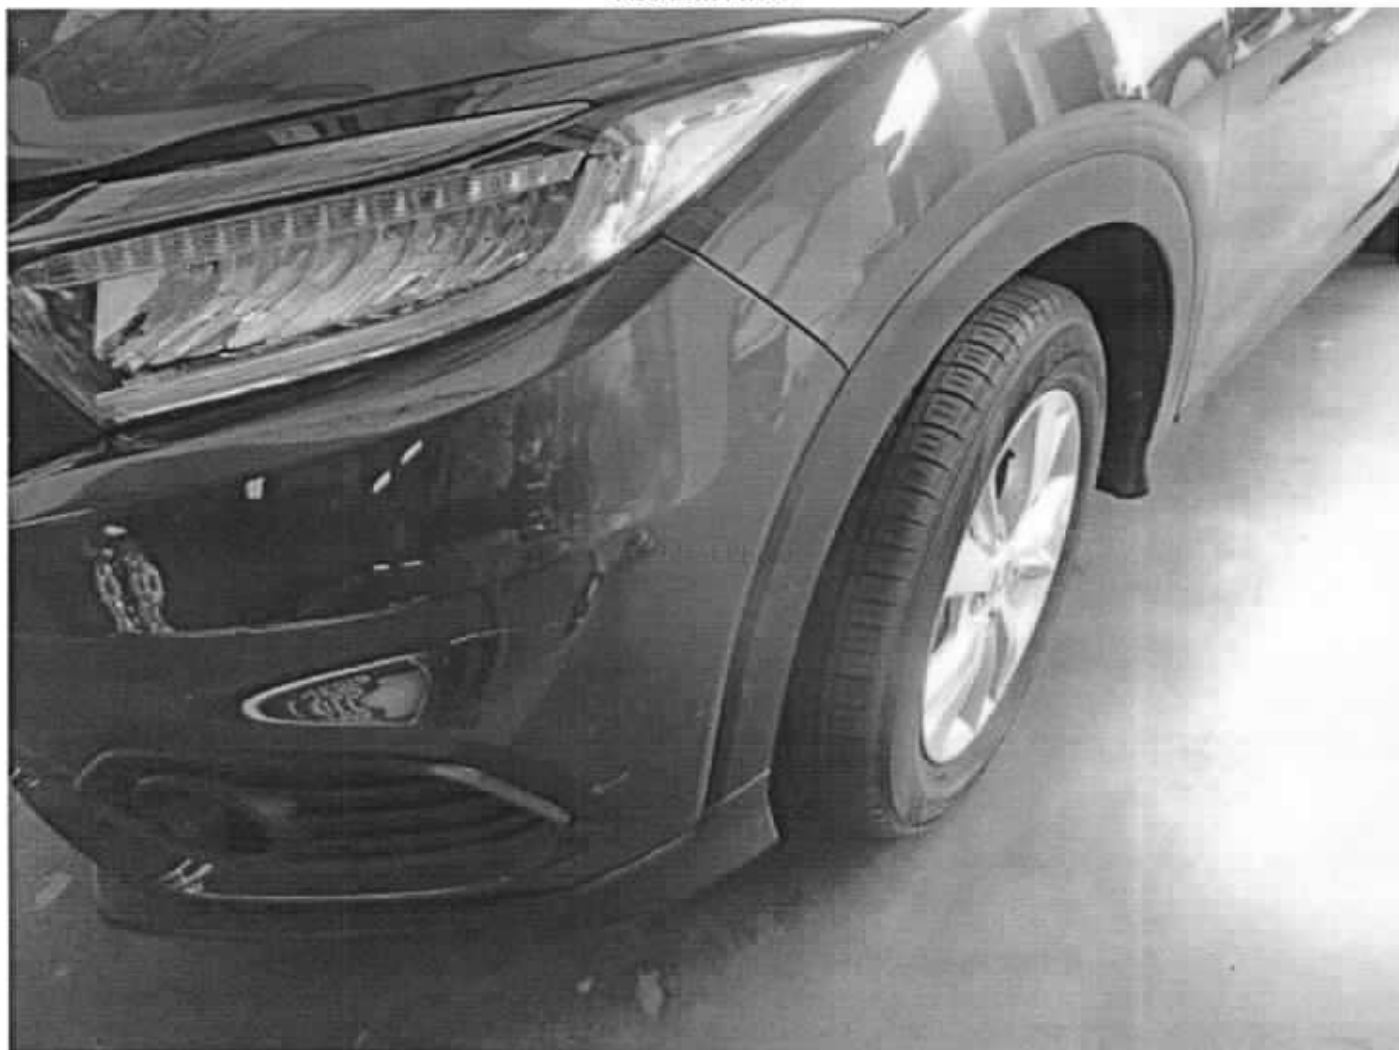
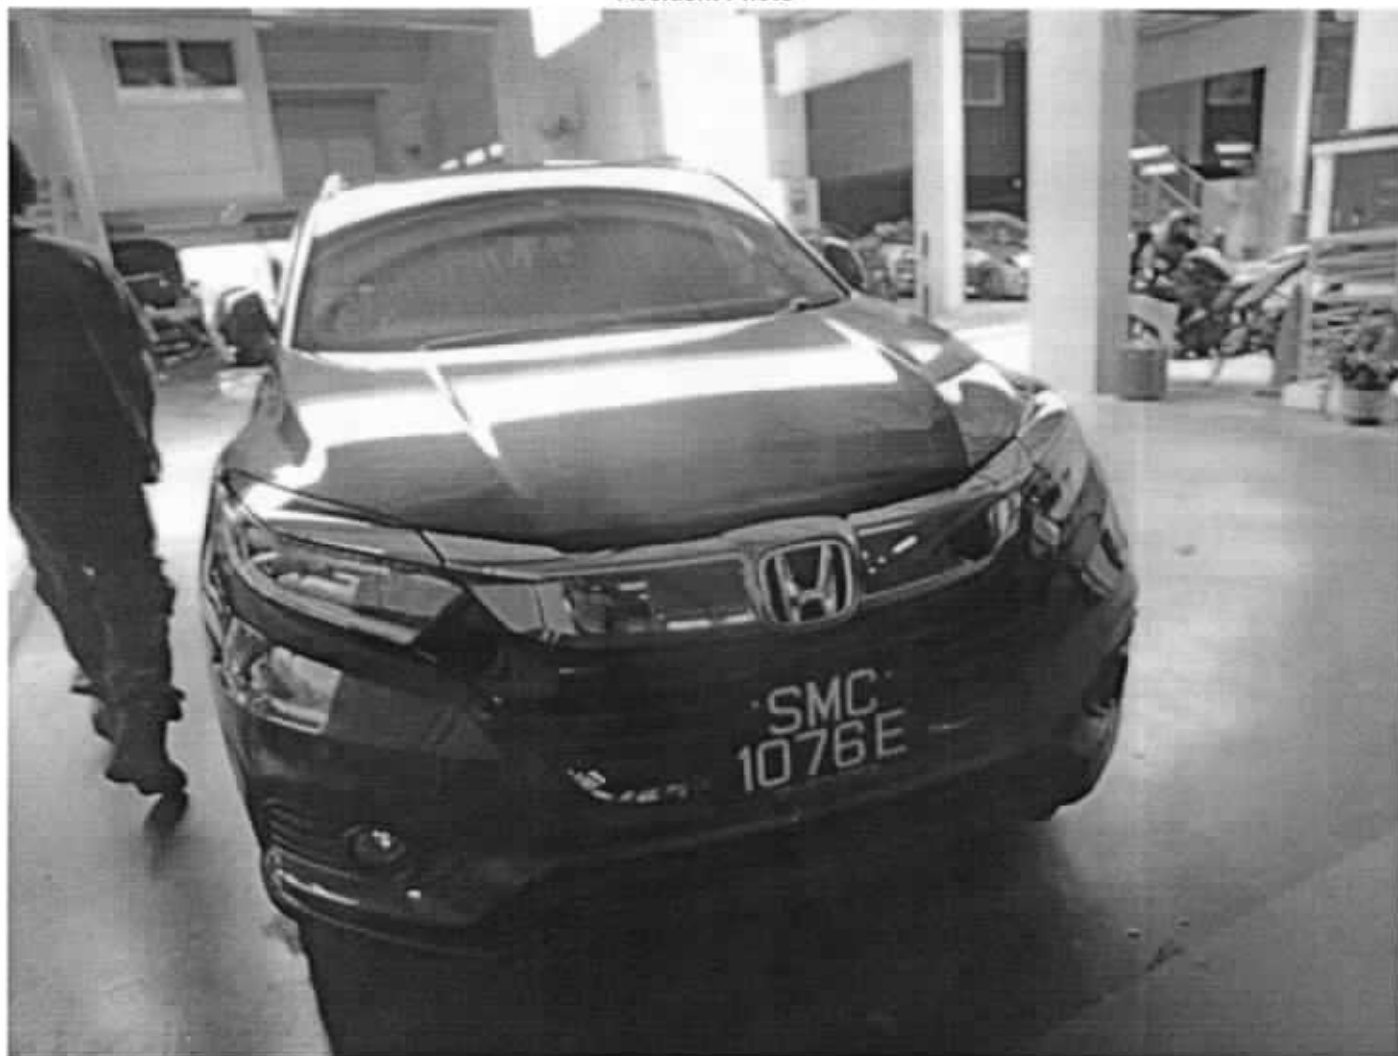
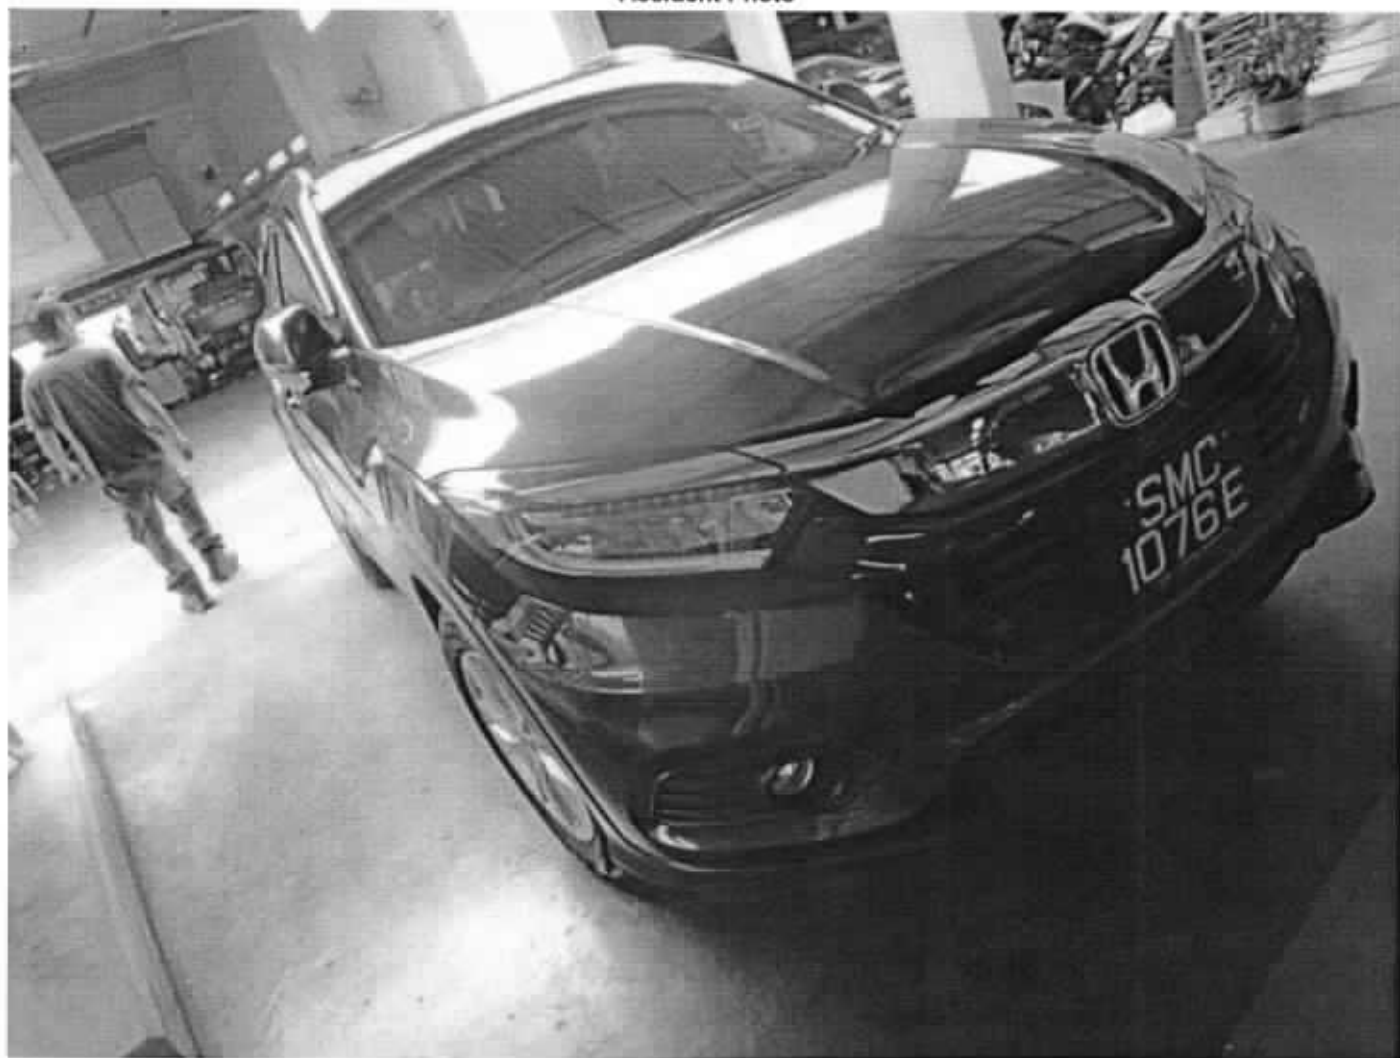
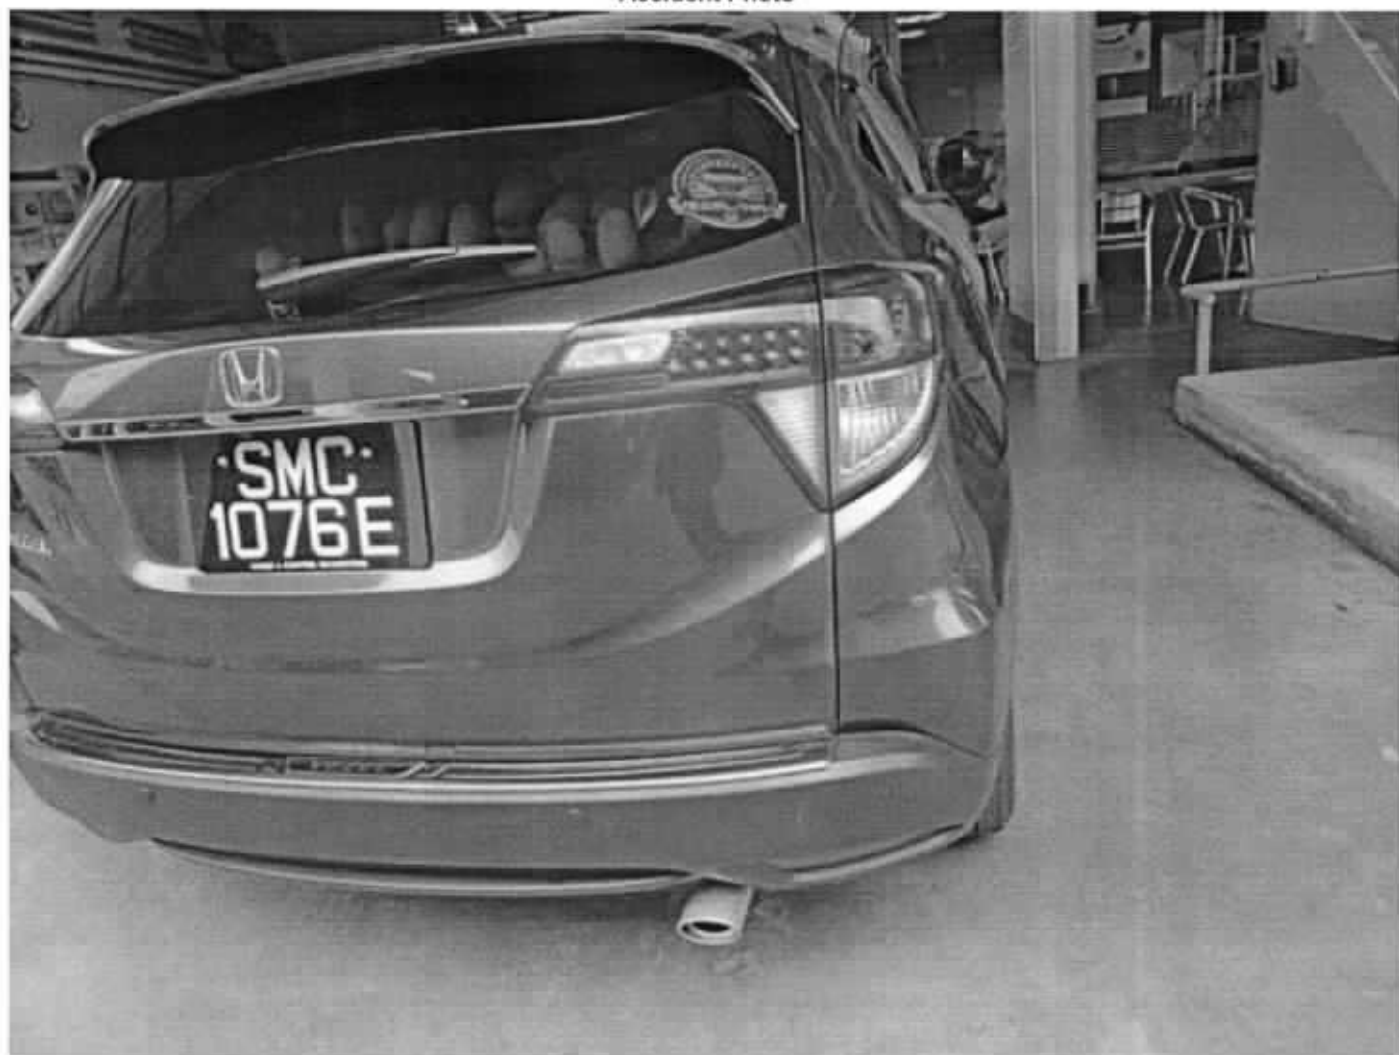
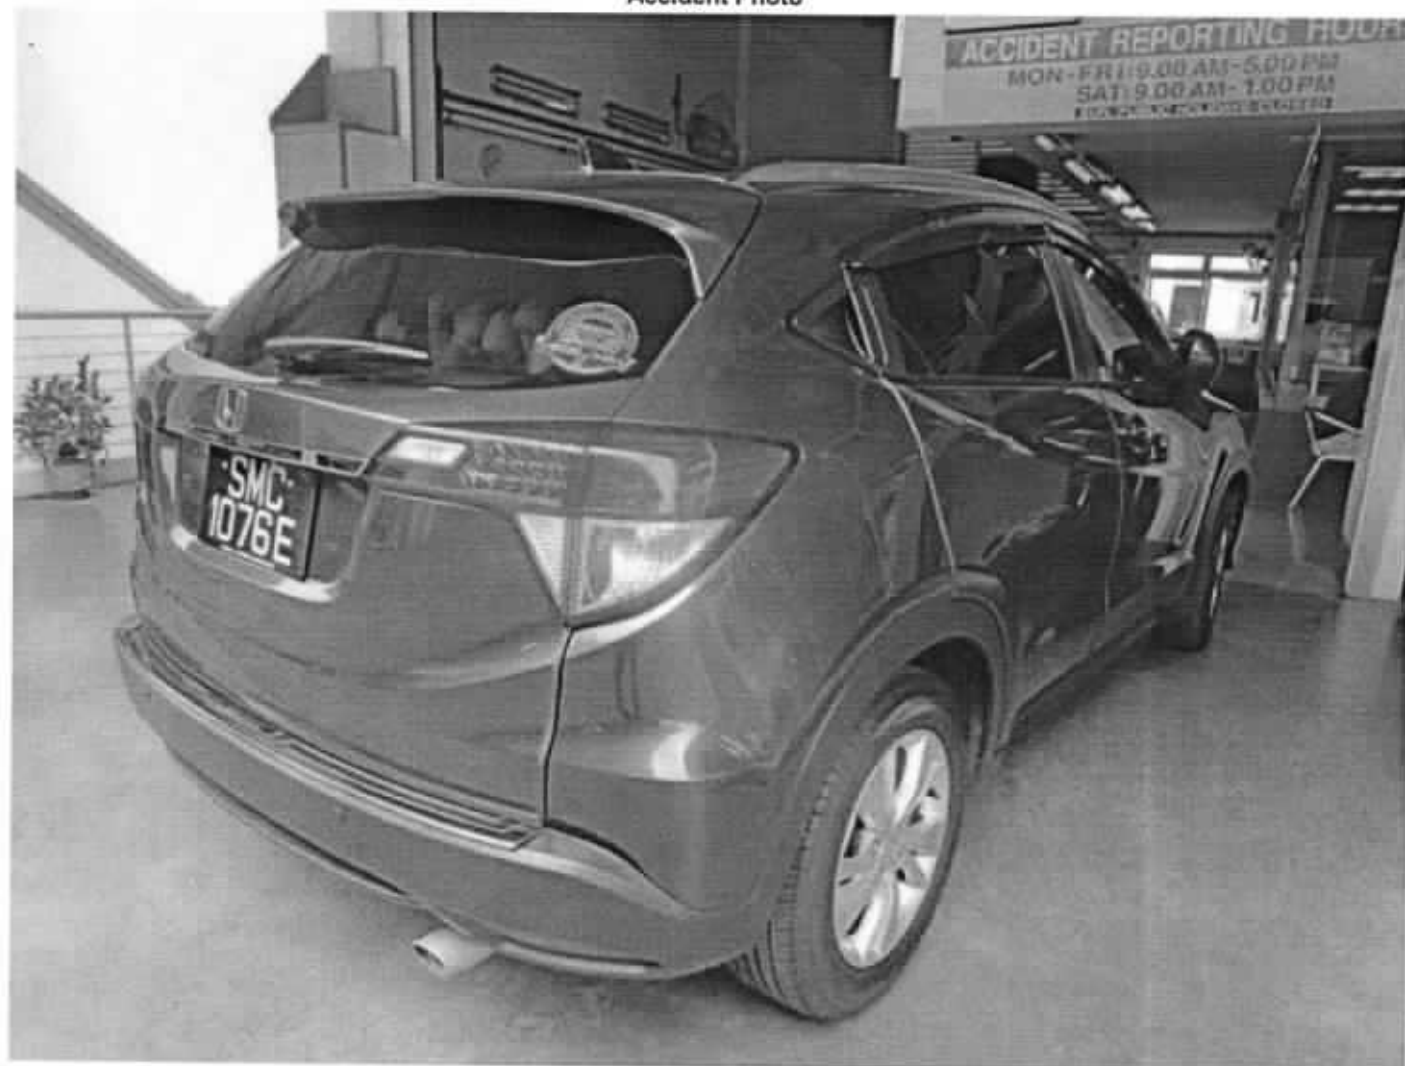
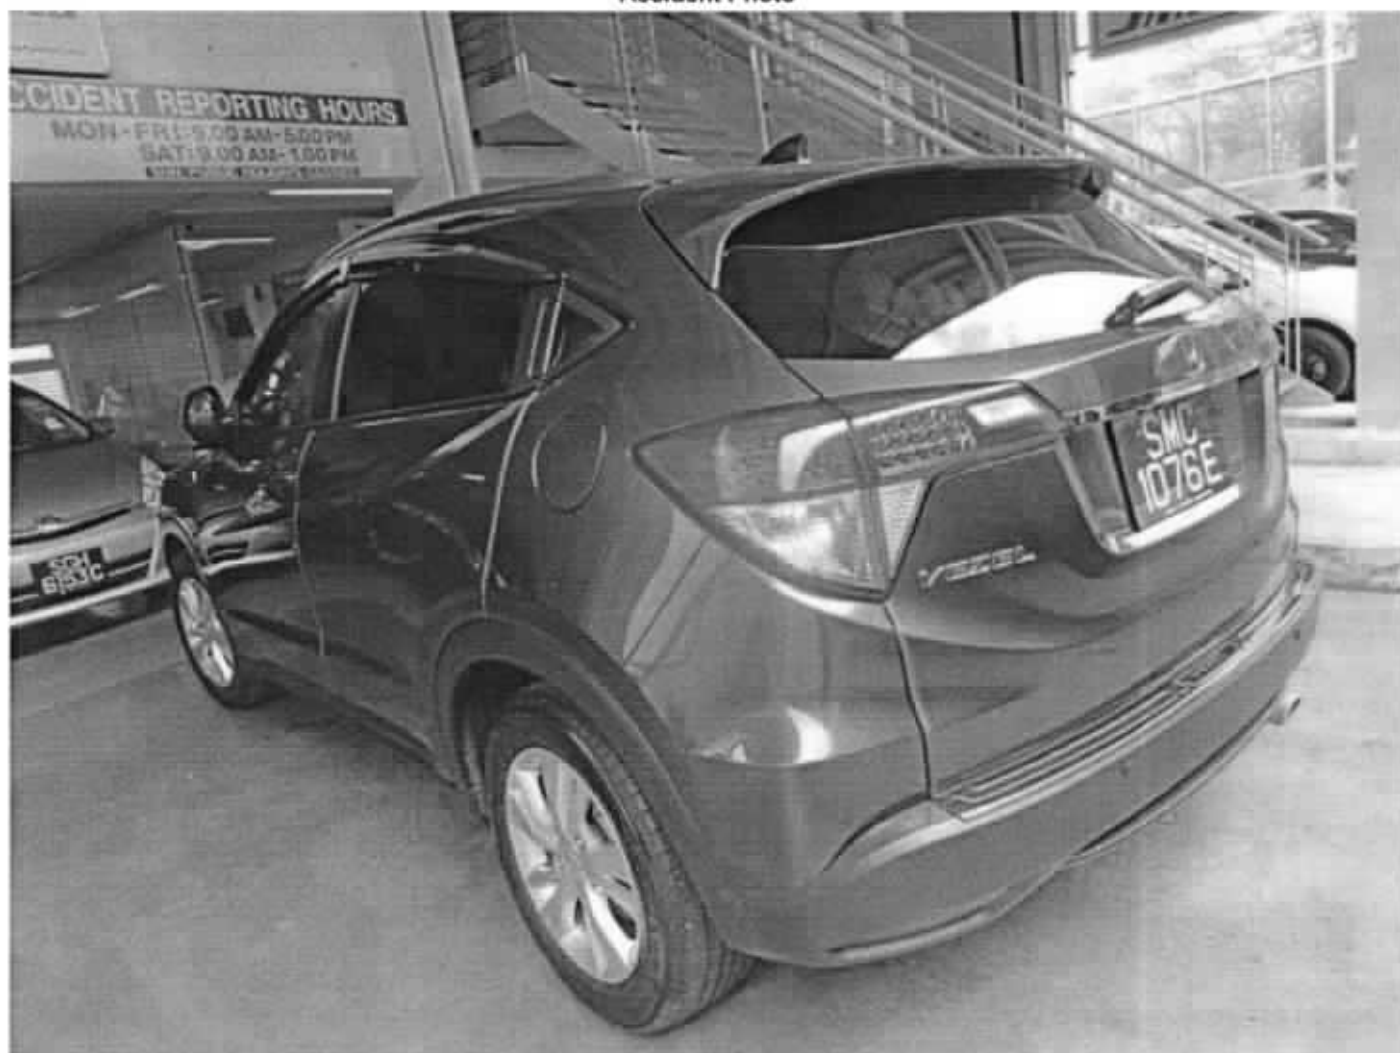
Accident Photo

Front bumper scraped/bent/deformed, front LH fender scraped/bent, LH wheel arc garnish bent/bracket distorted, LH headlamp casing bent/broken, etc. Please see para. 8 of this report for more details.

Cost of repairs : \$3,120.00 (lump sum)
Estimated no of days : Four (4)

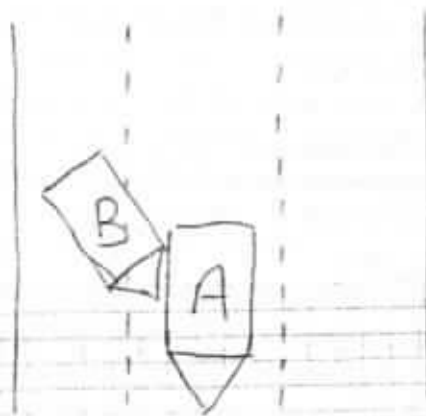
SKETCH PLAN

A = My vehicle
(SLR 2813X)
B : 3rd party
(SMC 1076E)
