# ASSIGNMENT

Veh No: SHA 1406G

**National Assessment Centre Services**

### ADJUSTMENT ON REPAIR COST FOR VEHICLE NO. SHA 1406G

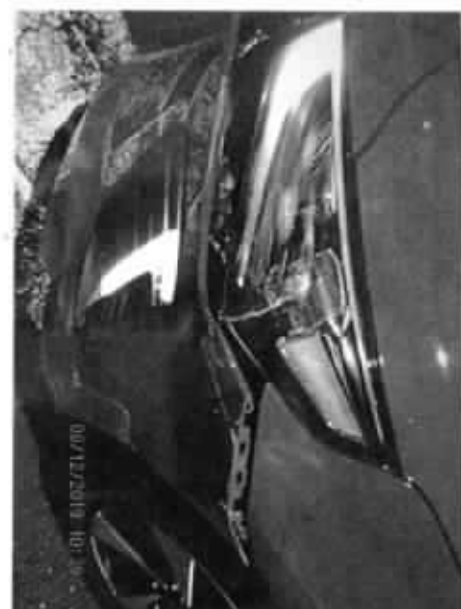
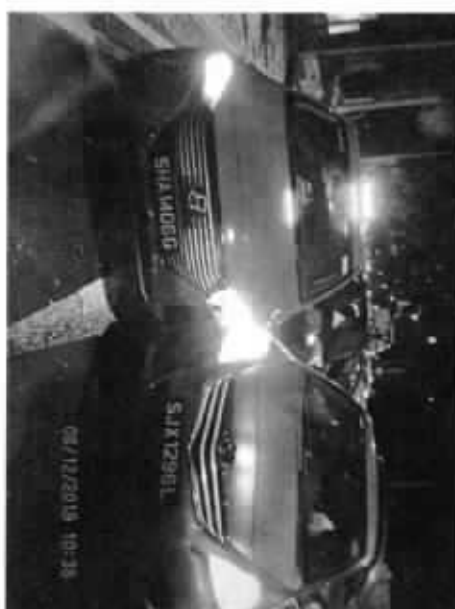
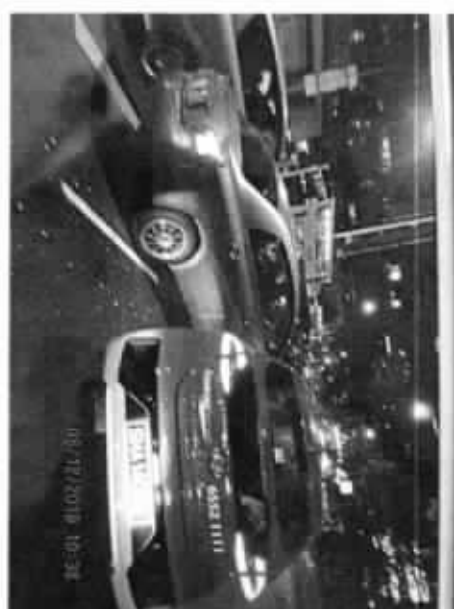
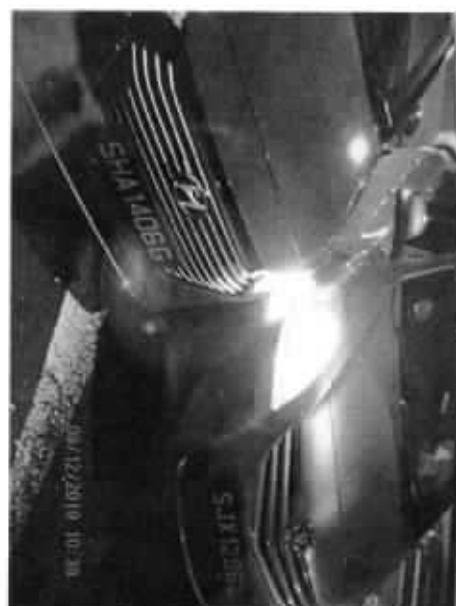
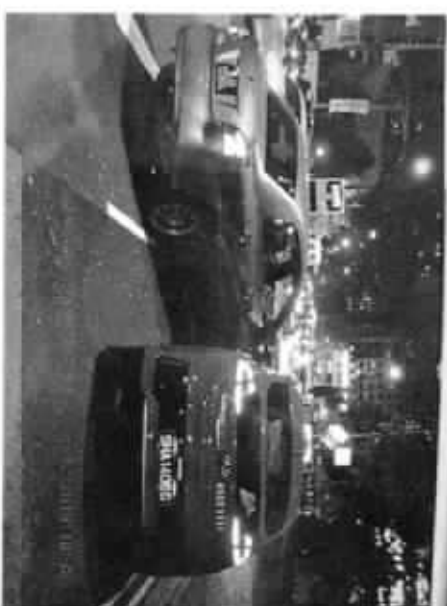
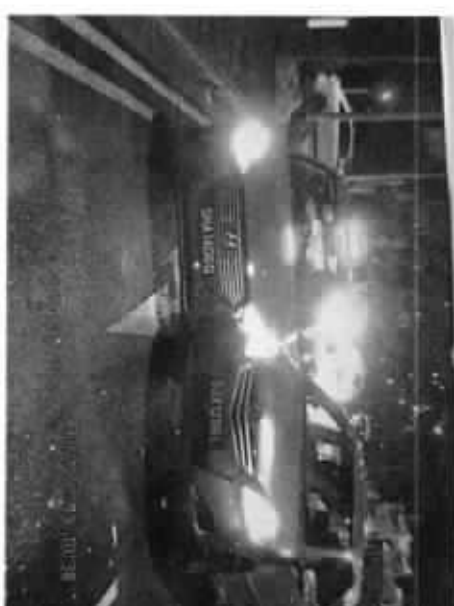
| THE VEHICLE SUSTAINED DAMAGES AT THE FRONT AND N/S FRONT PORTION.<br>DAMAGES SEE DETAILS. | | | |

| Qty | Description of Parts | Condition | Estimate By Workshop (\$) | Our Adjusted (\$) |
|---|---|---|---|---|
| 1 | FRONT BUMPER COVER | CRACKED | 418.30 | 418.30 |
| 1 | DAY LIGHT LAMP ASSY LH | CRACKED | 642.50 | 642.50 |

| Qty | Description of Parts | Condition | Estimate By Workshop (\$) | Our Adjusted (\$) |
|---|---|---|---|---|
| 1 | FRONT FENDER (LH) | TO REPAIR SEE LABOUR | 490.70 | - |
| 1 | FRONT FENDER SHIELD (LH) | TO REPAIR SEE LABOUR | 114.70 | - |
| | PANEL BEATING, INCLUSIVE OF THE REPAIR OF FRONT FENDER (LH) AND FRONT FENDER SHIELD (LH). | | 500.00 | 480.00 |
