Insured Veh.	SJW 5240B	Veh. Inspected	SHB 4073H
Policy No.	5107572417	Coverage (\$)	0.00
Claim No.	MT/1075045-002	Excess (\$)	0.00
Assign From		Assign Date	09/12/2019

4. Description of Damages

ADJUSTMENT ON REPAIR COST FOR VEHICLE NO. SHB 4073H

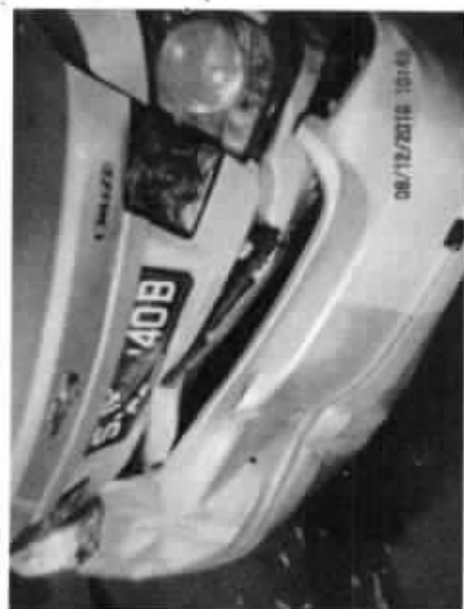
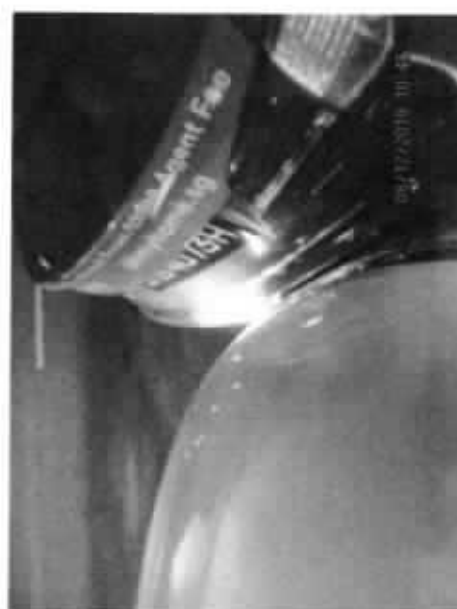
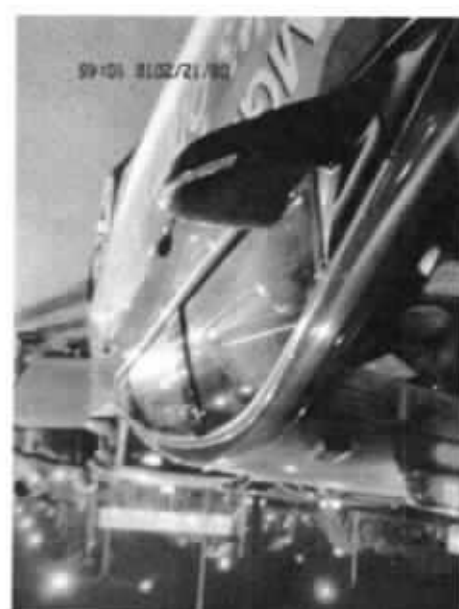
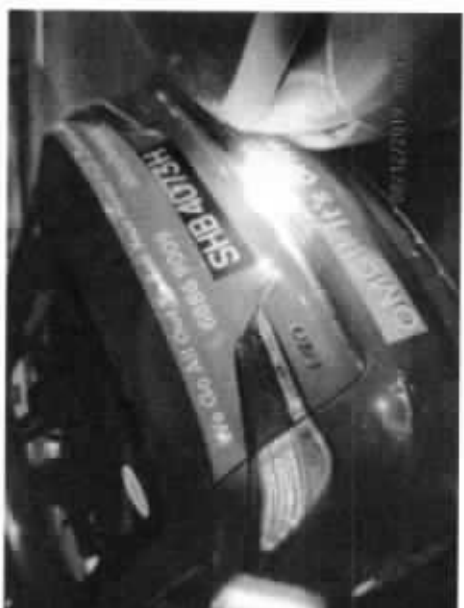
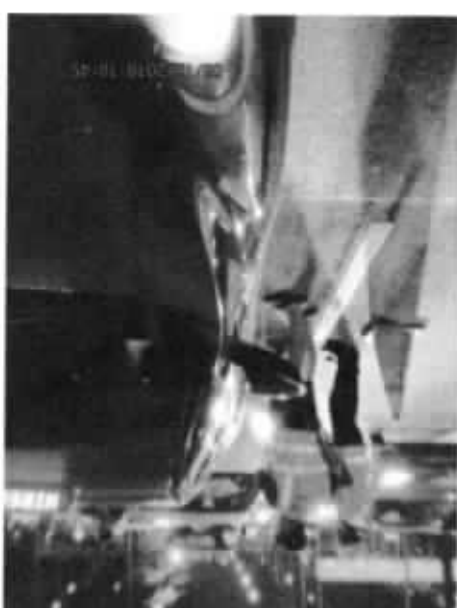
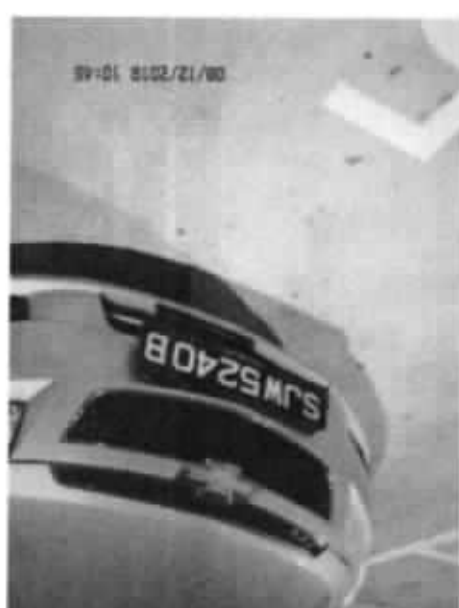
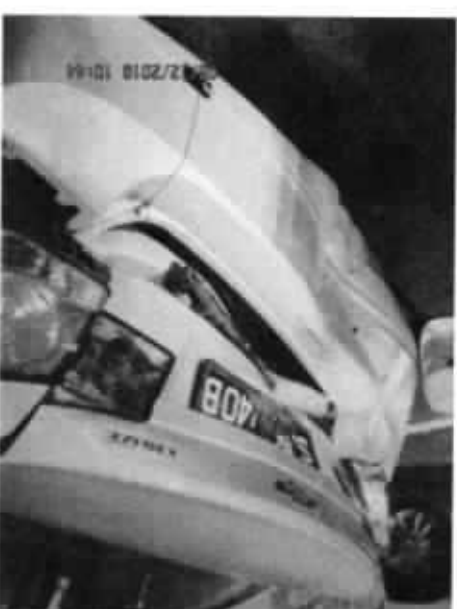
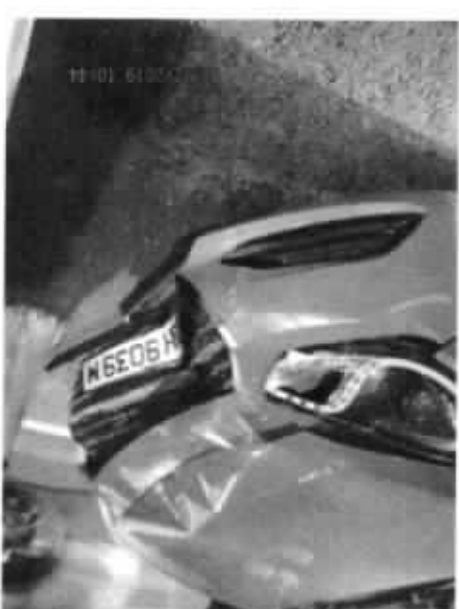
THE VEHICLE SUSTAINED DAMAGES AT THE REAR PORTION. DAMAGES SEE DETAILS.
--

Qty	Description of Parts	Condition	Estimate By Workshop (\$)	Our Adjusted (\$)
REPLACEMENT OF PARTS				
1	REAR BUMPER	CRACKED	553.00	553.00
10	REAR BUMPER CLIP	NECESSARY	22.00	22.00
2	REAR BUMPER BRACKET @\$35.60	NOT NECESSARY	71.20	-
1	REAR BUMPER UNDER COVER	SCRATCHED	228.00	228.00
1	REAR BUMPER REFLECTOR LAMP (RH)	NOT NECESSARY	30.60	-
	LESS 20% DISCOUNT		-180.96	-160.60

730.00	510.00
GRAND TOTAL			1,839.54	1,402.40
RECOMMENDED COST OF LUMP SUM REPAIRS (TO ITS PRE-ACCIDENT CONDITION) (CONFIRMED)				1,100.00
