# VEHICLE INSPECTION REPORT

Our ref.: UAM18.10.33-AK-STP-TAP-SLA3367A

Registration no.	:	SLA3367A	Odometer	:	55064 km
Make / Model	:	Toyota Vellfire 2.5X A-Edition A	Chassis no.	:	AGH300046376
Regn. date	:	26 Feb 2016	Engine no.	:	2ARH653689
Body colour	:	Black	Engine cap.	:	2493 cc

Annex A

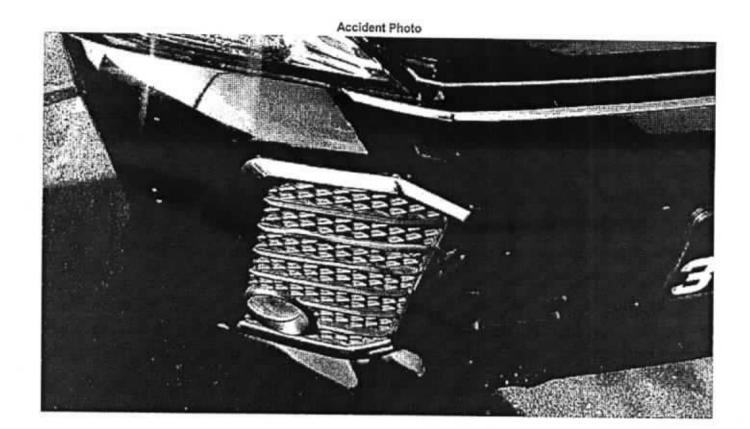
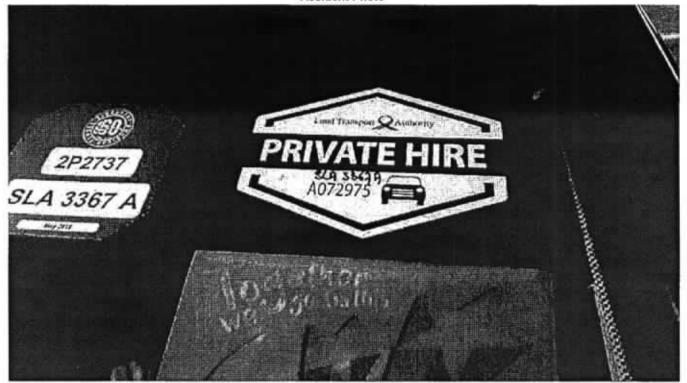
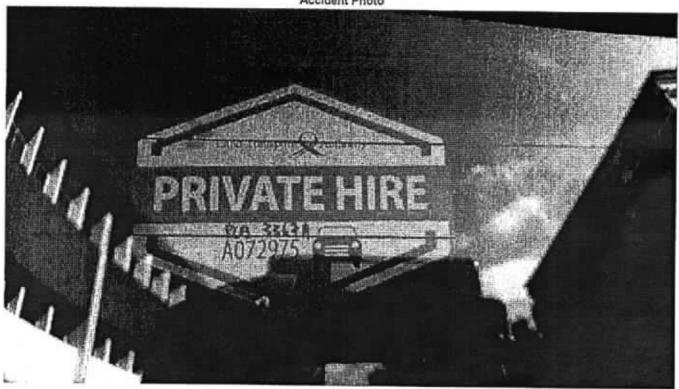
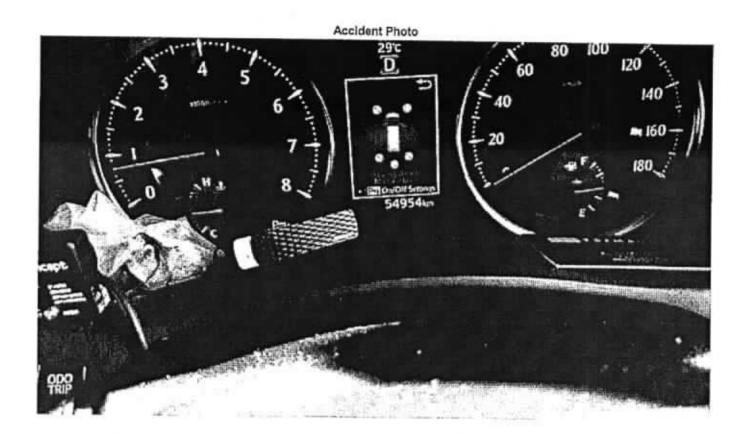
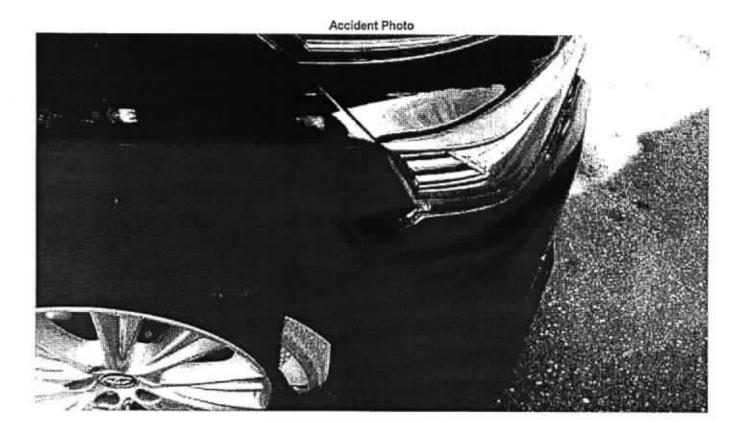
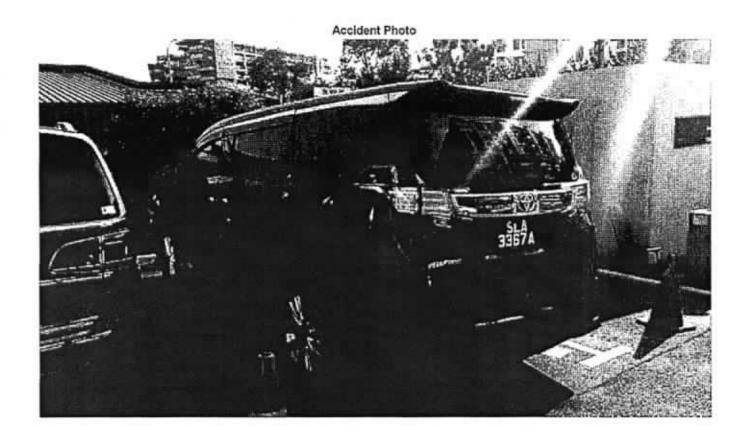
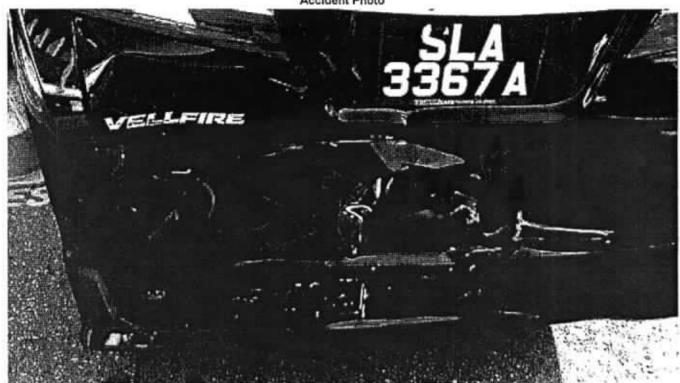
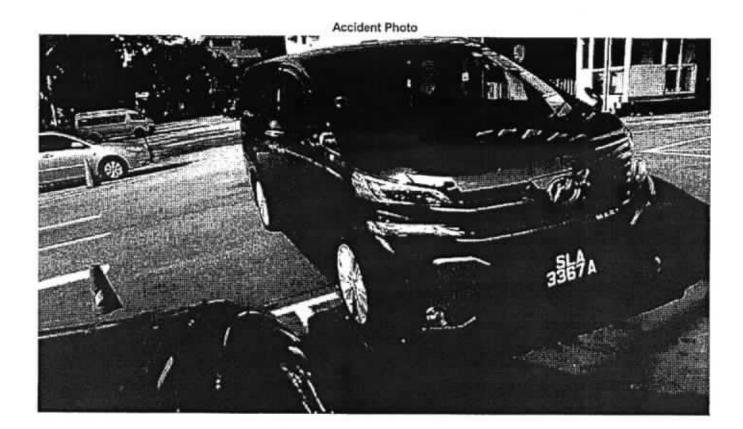
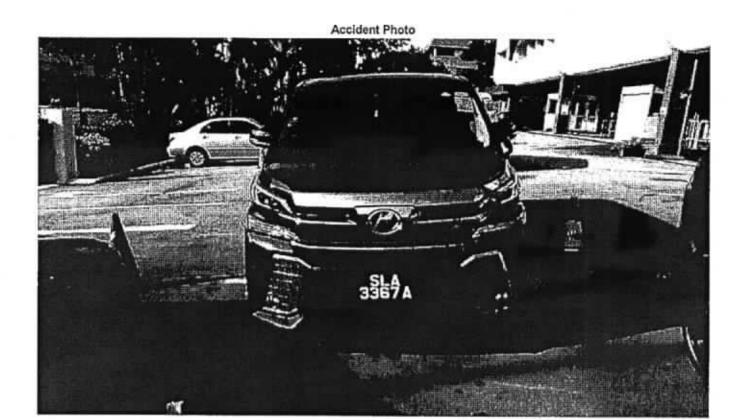
Accident Photo

The impact of the collision has damaged / affected the tailgate, rear bumper, rear end panel, rear well panel, front grille, front bumper, headlamp and etc...

Our adjusted cost of repair is SGD 28,150.00 to carry out the repairs. Please refer to Annex A (Appraisement Schedule) for a detailed account of the cost estimates.
