SKF 9246 L

Make: FORD Focus cc 1596

From: Hock Ann (LKK Auto)
Sent: Monday, 13 January, 2020 6:07 PM
To: Nur Syafirah
Cc: Shiau Chan (LKKAuto)
Subject: FW: SKF 9246L FINALIZED CALCULATE ADJUSTMENT AMOUNT UPDATED 2.1.2020

VEHICLE DAMAGE INSPECTION REPORT

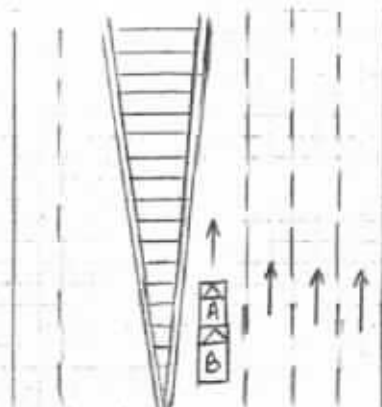
SKETCH PLAN

CTE towards AYE before PIE Changi Exit

Vehicle A: SKF9246L
Vehicle B: YP9669G

On the stated date and time, at the stated venue,
my vehicle 'A' SKF9246L was travelling straight on
my rightful lane. Vehicle in front of me stopped so I
followed suit. Moments later I felt an impact on the
rear portion of my stationary vehicle. Vehicle 'B' YP9669G
failed to stop, hence collided onto the rear portion of
my stationary vehicle.
