**1. Policy Particulars :- THIRD PARTY CLAIM**

**4. Description of Damages**

| THE VEHICLE SUSTAINED DAMAGES AT THE REAR PORTION.<br>DAMAGES SEE DETAILS. |

## ADJUSTMENT ON REPAIR COST FOR VEHICLE NO. SH 6184X

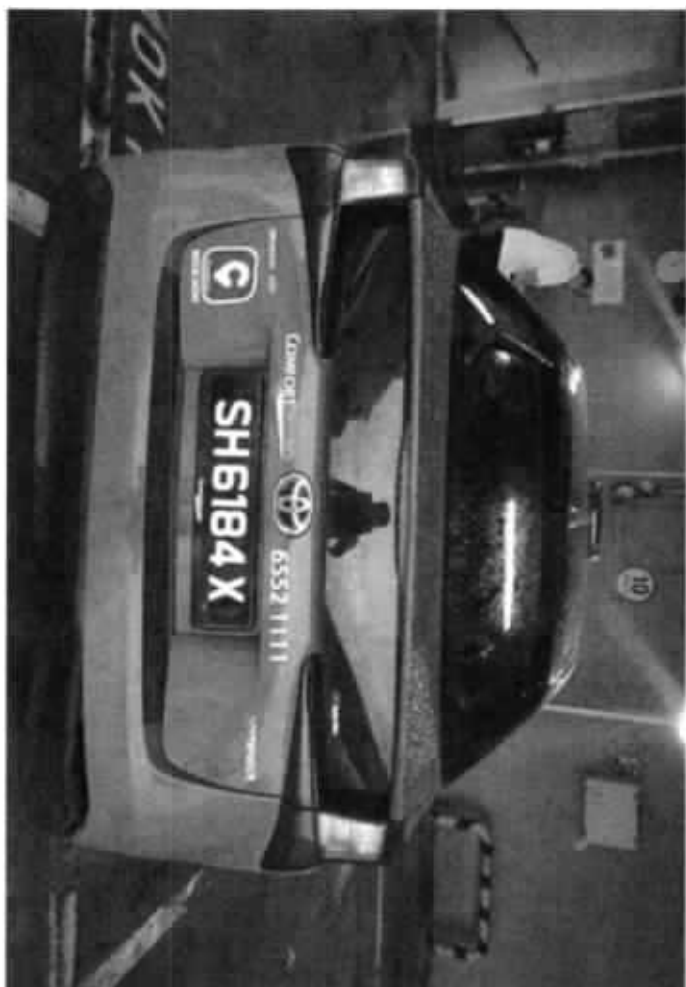
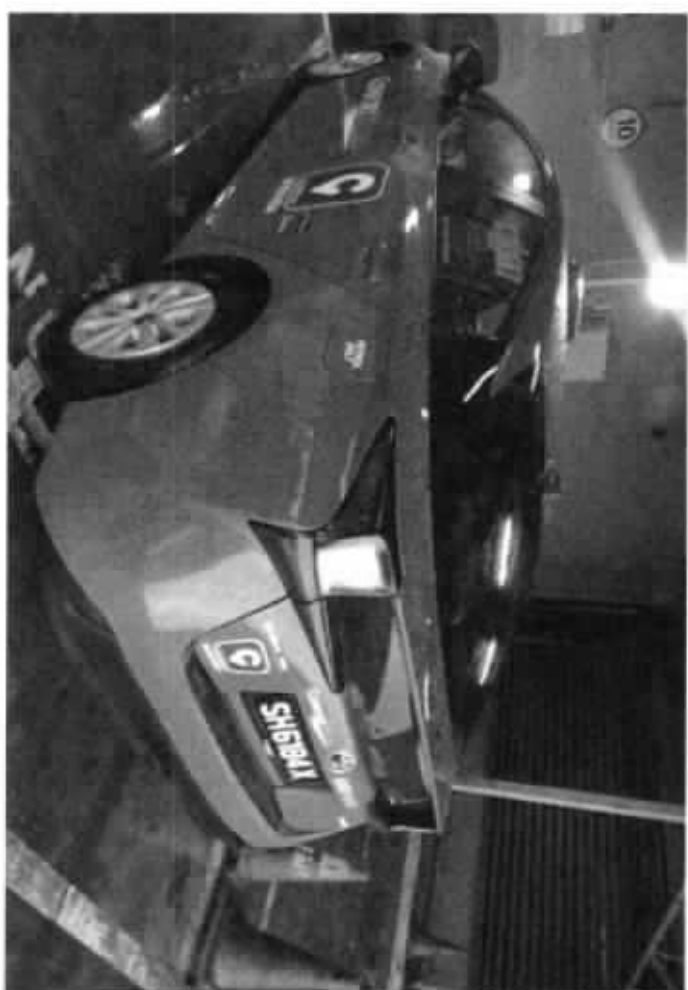
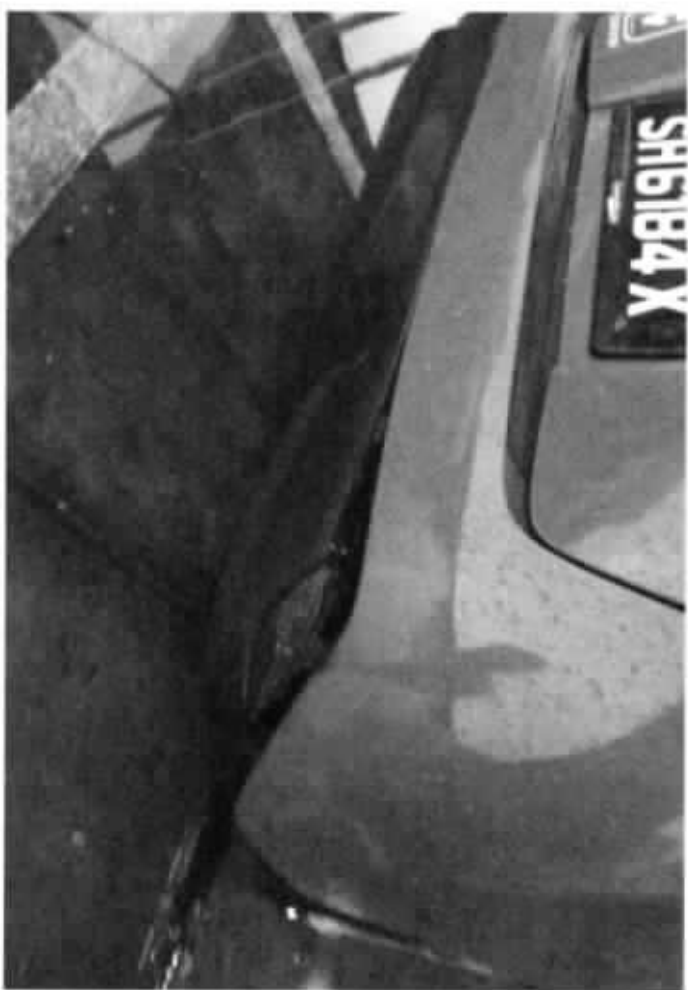
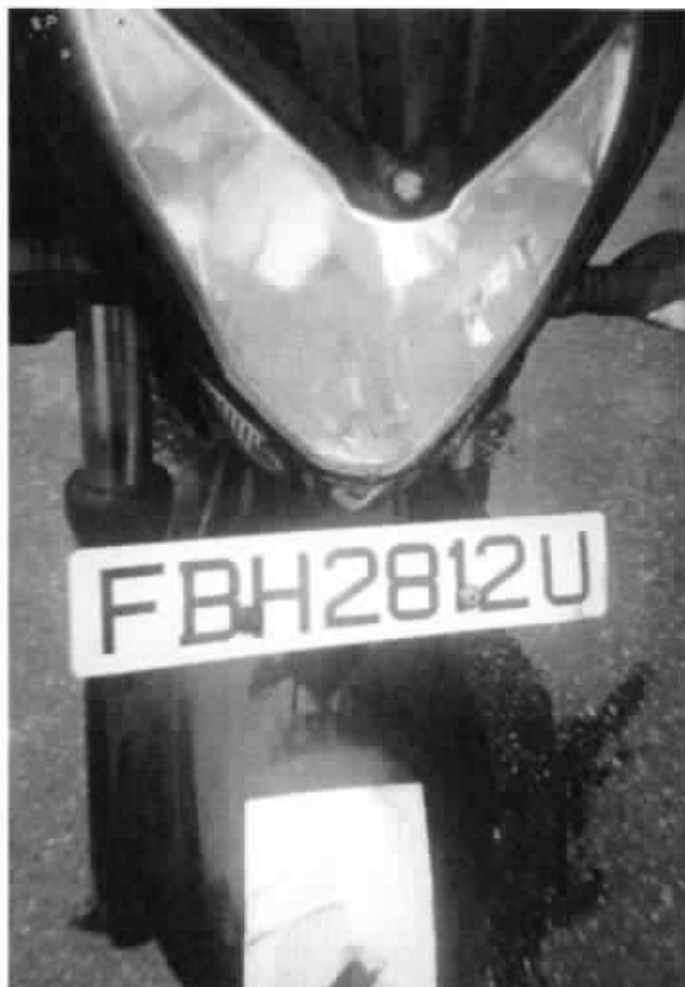
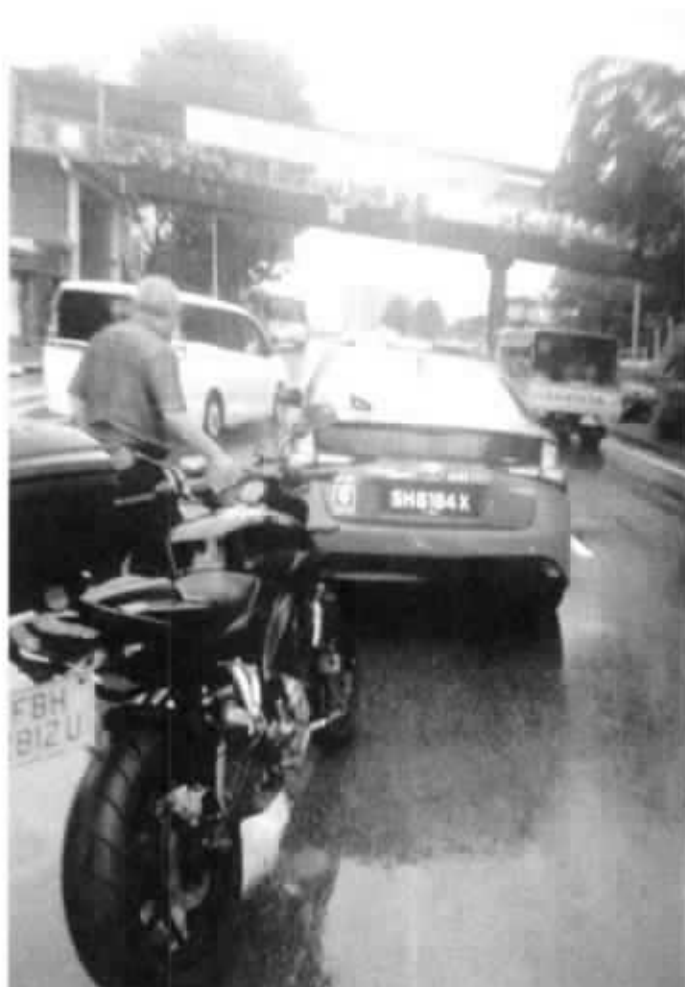
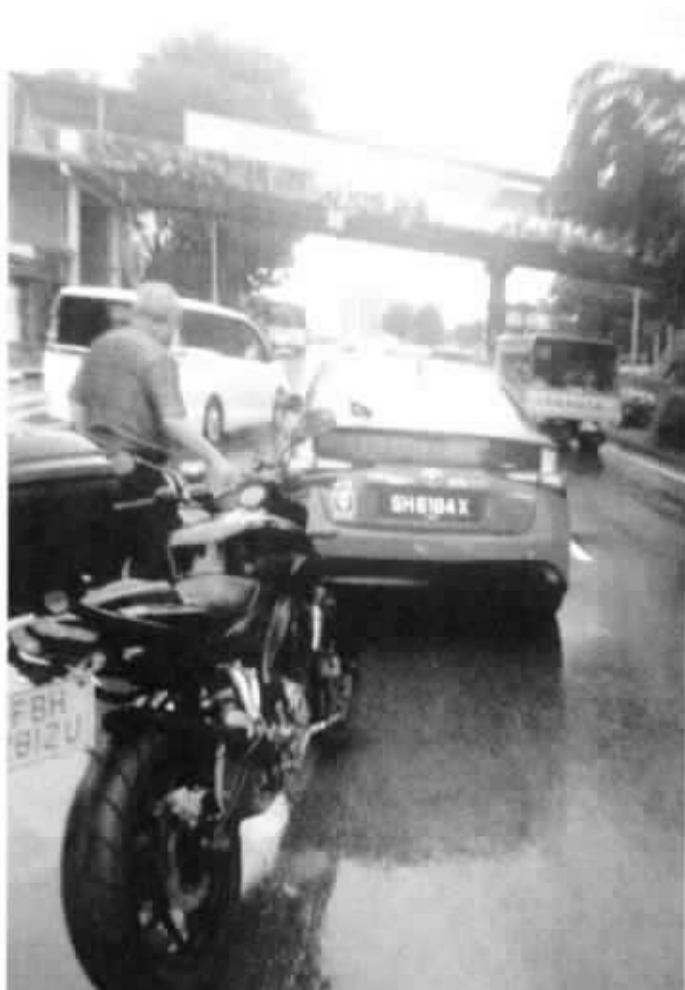
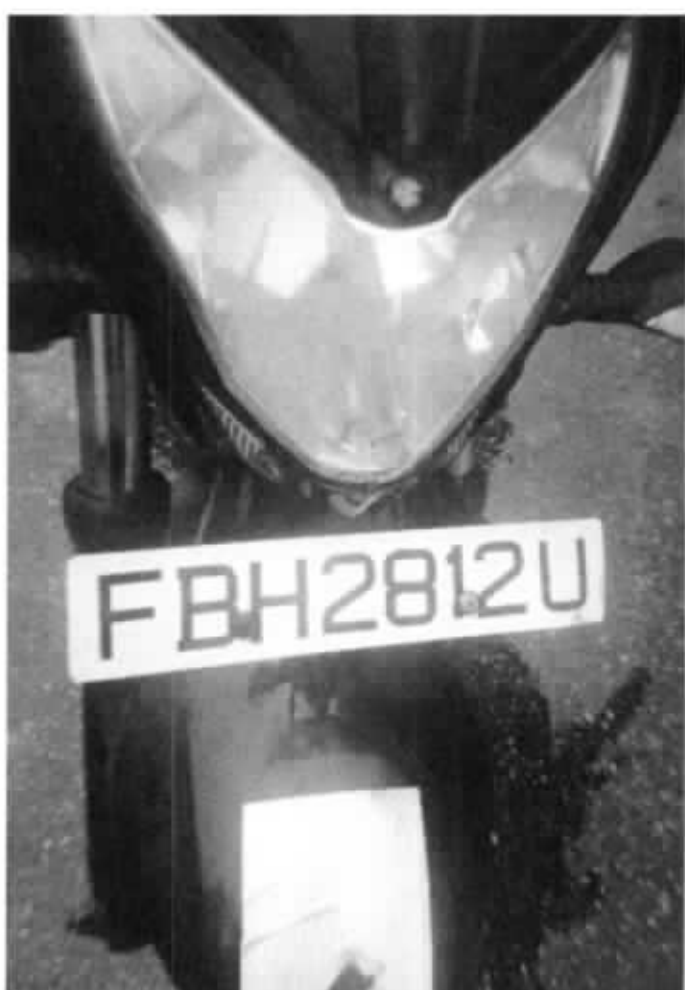
| Qty | Description of Parts | Condition | Estimate By Workshop (\$) | Our Adjusted (\$) |
|---|---|---|---|---|
| 1 | REAR BUMPER UNDER COVER | DEFORMED | 552.60 | 552.60 |

| Qty | Description of Parts | Condition | Estimate By Workshop (\$) | Our Adjusted (\$) |
|---|---|---|---|---|
| | PANEL BEATING INCLUSIVE OF THE REPAIR OF REAR BUMPER. | | 350.00 | 320.00 |
| | SPRAY PAINTING CHARGE. | | 250.00 | 200.00 |
