GBE 8715T

Make / Model  
**TOYOTA / DYNA 3.0 M**

ESTIMATE REPORT 1st QUOTATION

## VEHICLE DAMAGE INSPECTION REPORT

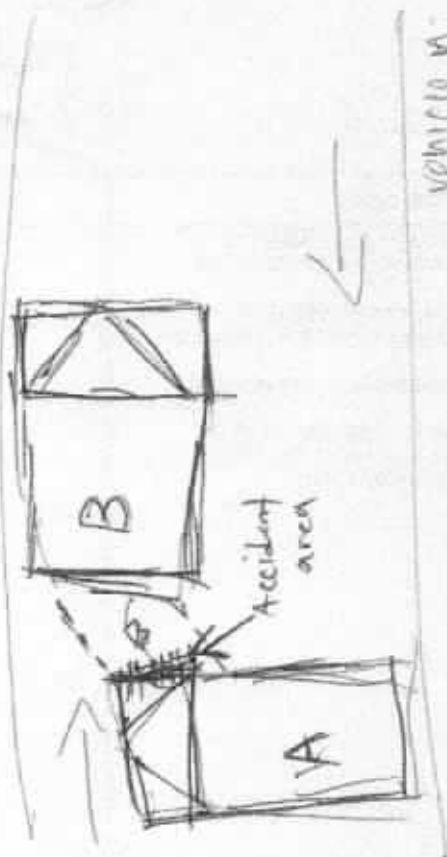
# **SKETCH PLAN**

While stationary awaiting for Inhibit vehicles to  
before turning  
clear A suddenly vehicle B inhibit reverse without  
signaling. I noticed the lung, but still collided into  
the front RH portion of my vehicle.

VEHICLE A: 6BE 871ST  
VEHICLE B: 7N 4032L
