To Inspect Vehicle No: SLG 85242

Make: Honda Fit 1.3 G. cc 1317

THIRD PARTY VEHICLE NO. : SLG8524Z
III INSURED VEHICLE NO. : SHC8391H
DATE OF LOSS : 20.12.2019

VEHICLE DAMAGE INSPECTION REPORT

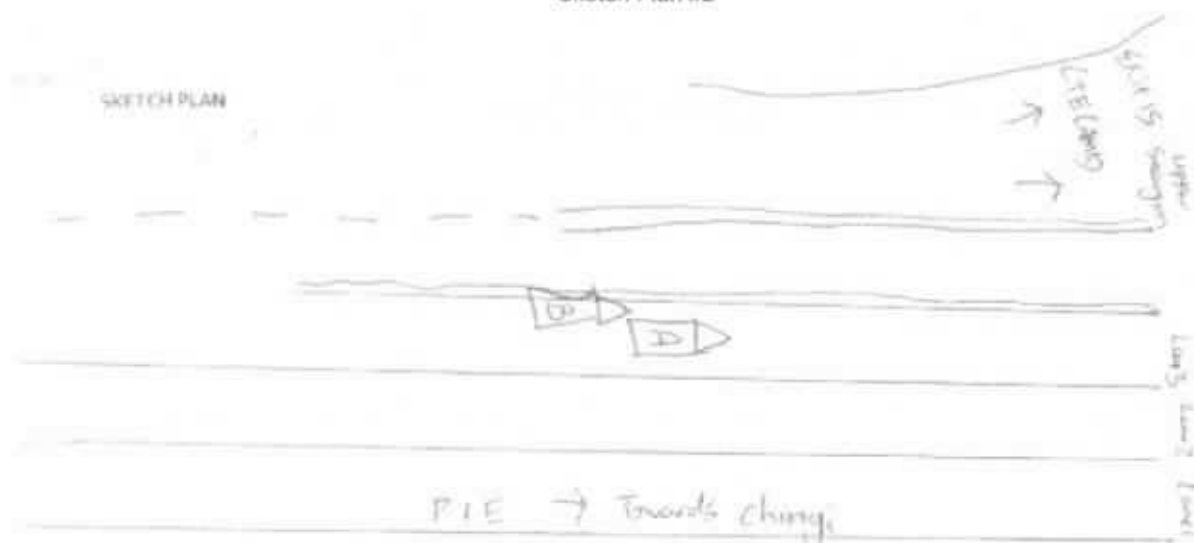
Sketch Plan #2

I was driving along the mentioned location, Date & Time. As I was going to Marina via KPE, I was driving in Lane 3. As the car in front stopped, I slow down and stop my vehicle (SL688524Z). A Combi/Delgo taxi SLR8591H collide onto the rear of my car, the impact was huge and my car is badly damaged.

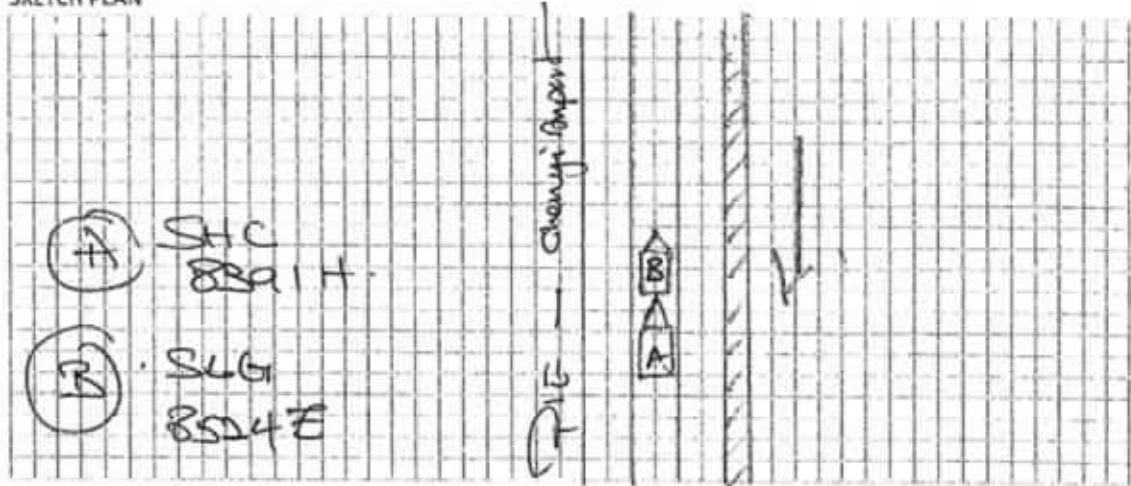
SKETCH PLAN

ON. 20 Dec. 2012 @ 1200 hrs I

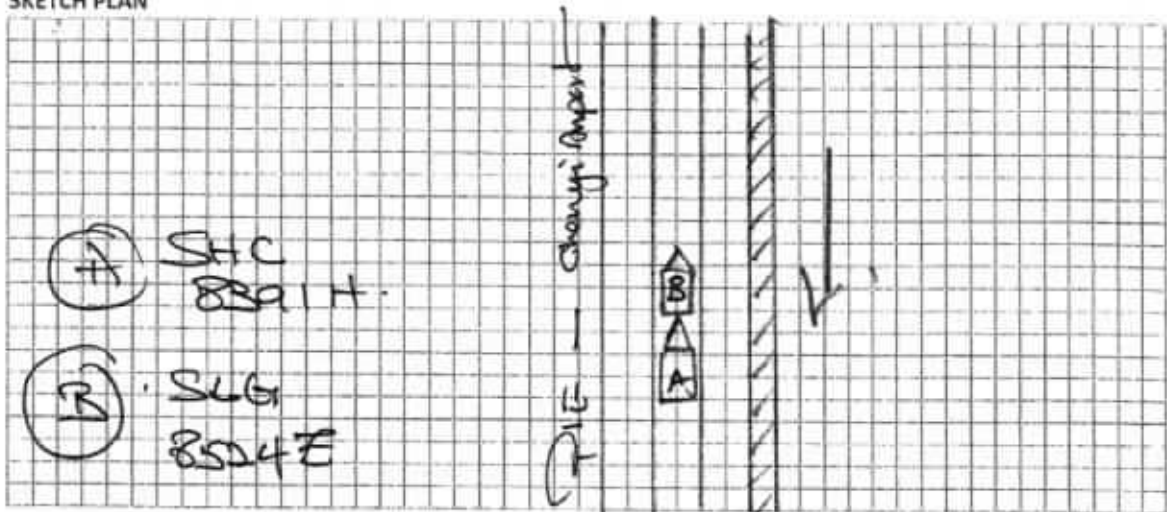
SKETCH PLAN

ON 20 Dec 2011 @ 1500 hrs I
