NTUC INCOME INSURANCE CO-OPERATIVE LTD Ref: NS/INC19022779/Ftd3n2			
73 BRAS BASAH ROAD #05-01 NTUC TRADE UNION HOUSESINGAPORE 189556		Date: 13-01-2020

4. Description of Damages			
THE VEHICLE SUSTAINED DAMAGES AT THE FRONT AND N/S FRONT PORTION. DAMAGES SEE DETAILS.			
5. General Information			
Accident Date	23/12/2019	Inspection Date	26/12/2019
Survey held at	COMFORTDELGRO ENGINEERING PTE LTD 59 LOYANG DRIVE SINGAPORE 508969		
5a. Remarks			
A)THE INSPECTION WAS CONDUCTED ON A"WITHOUT PREJUDICE" BASIS. B)IN ACCORDANCE TO YOUR INSTRUCTIONS, WE HAVE NOT AUTHORISED REPAIRS.			
5b. Estimate Days of Repair			
ESTIMATED NORMAL PERIOD FOR REPAIR:		3 Working Days

ADJUSTMENT ON REPAIR COST FOR VEHICLE NO. SHA 7390C

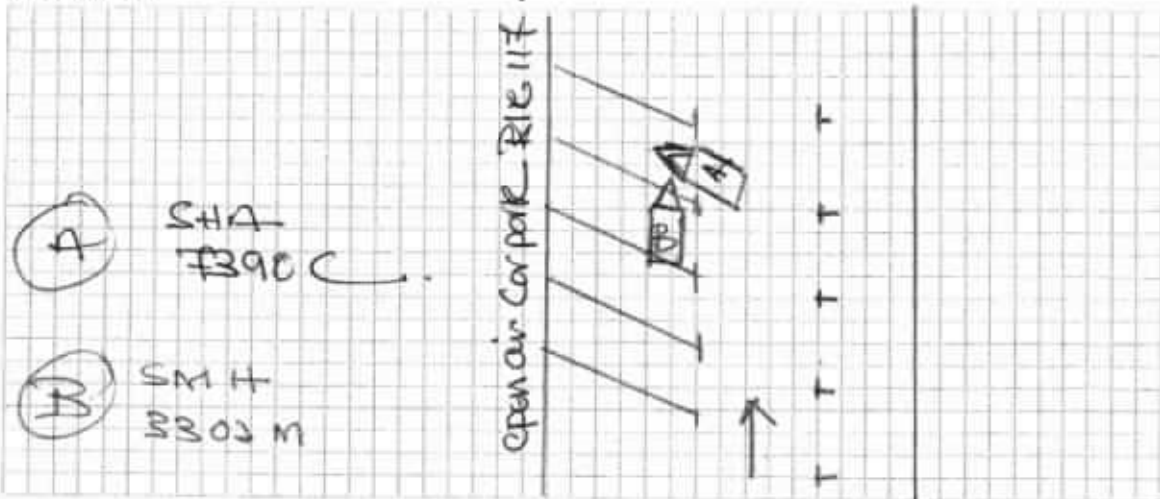
SKETCH PLAN

Go. 23 Dec 2019 @ 16:10 hr T

veh (A) was driving along the above location to park veh (A) in the

lot. I veh (A) stop and left turn to the lot suddenly veh (B) from left go straight and hit veh (A) left front. @ the point of accident veh (A) no park.

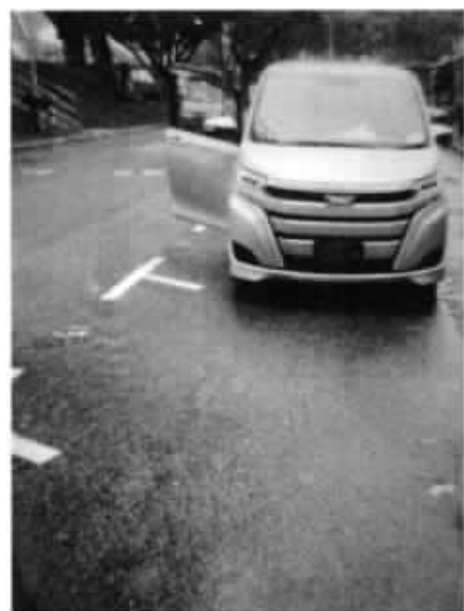
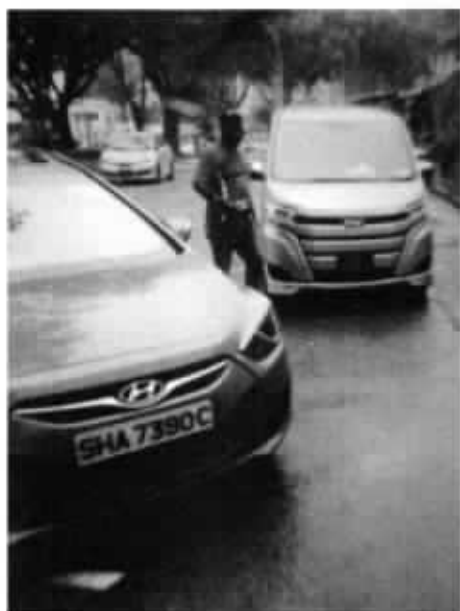
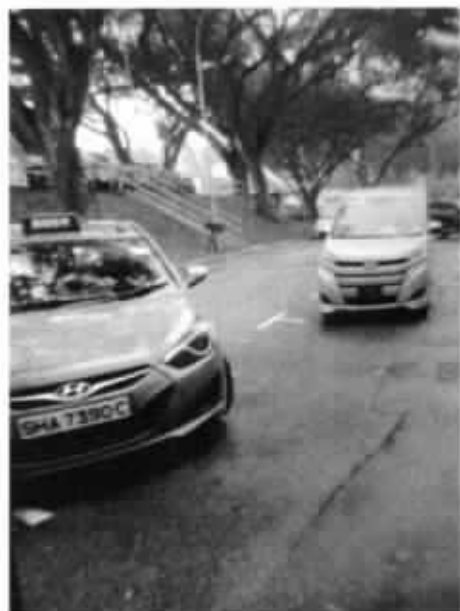
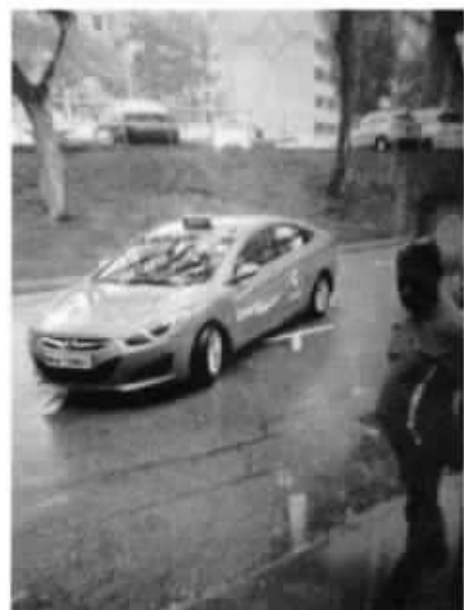
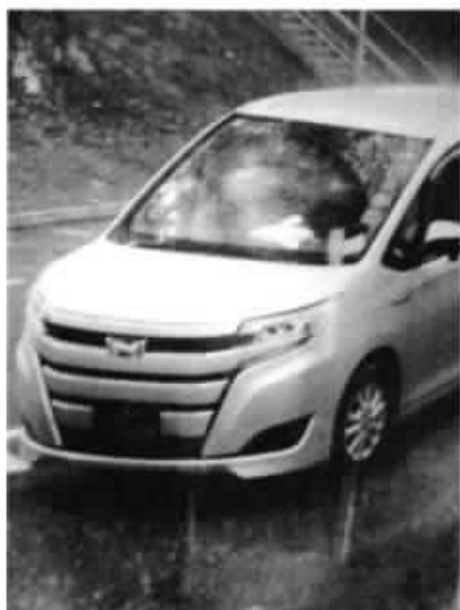
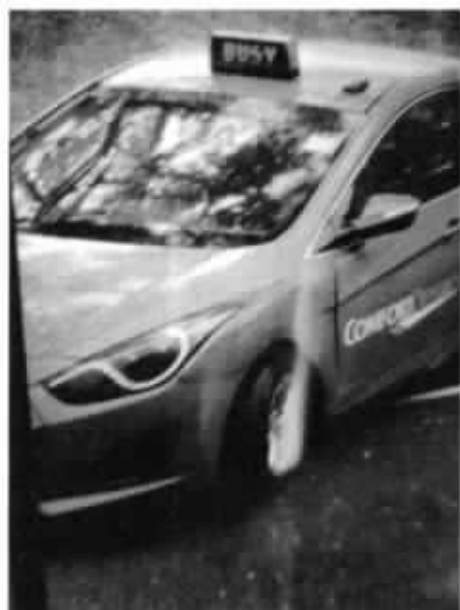
The U/C / Chassis frame / Body Structure affected due to collision.

Qty	Description of Parts	Condition	Estimate By Workshop (\$)	Our Adjusted (\$)
REPLACEMENT OF PARTS				
1	HEADLAMP (LH)	SCRATCHED	1,388.00	1,388.00
1	FRONT FENDER (LH)	BUCKLED	663.00	663.00
1	FRONT FENDER SHIELD (LH)	NOT NECESSARY	174.90	-
1	FRONT FENDER RETAINER	NOT NECESSARY	24.60	-
1	FRONT WHEEL HUB CAP (LH)	SCRATCHED	107.10	107.10
1	FRT LEFT DOOR (NPA)	TO REPAIR SEE LABOUR	-	-
	LESS 20% DISCOUNT		-471.52	-431.62
			1,886.08	1,726.48
LABOUR				
	PANEL BEATING.INCLUSIVE OF THE REPAIR OF FRT LEFT DOOR.		560.00	560.00
	SPRAY PAINTING CHARGE.		250.00	200.00
	TUFF KOTE.		50.00	30.00
	FRT WHEEL ALIGNMENT.		80.00	60.00
			940.00	850.00
GRAND TOTAL			2,826.08	2,576.48
RECOMMENDED COST OF LUMP SUM REPAIRS (TO ITS PRE-ACCIDENT CONDITION) (CONFIRMED)				2,050.00
