## Preliminary Advice

Insured Vehicle No	: SLU155J		
TP Vehicle No	: FV8288Y	Accident Date	: 22/11/2019
Make	: YAMAHA MT-03 ABS (MTN320-A)	Assignment Date	: 31/12/2019
Date of Inspection	: 31/12/2019	Est. Duration of Repair	: 3.00
Inspection At	: PLANET MOTORCYCLE SERVICE CENTRE (HQ) BLK 3007 UBI ROAD 1 #01-430 SINGAPORE 408701

### Point of Impact / General Description of Damages

## VEHICLE DAMAGE INSPECTION REPORT

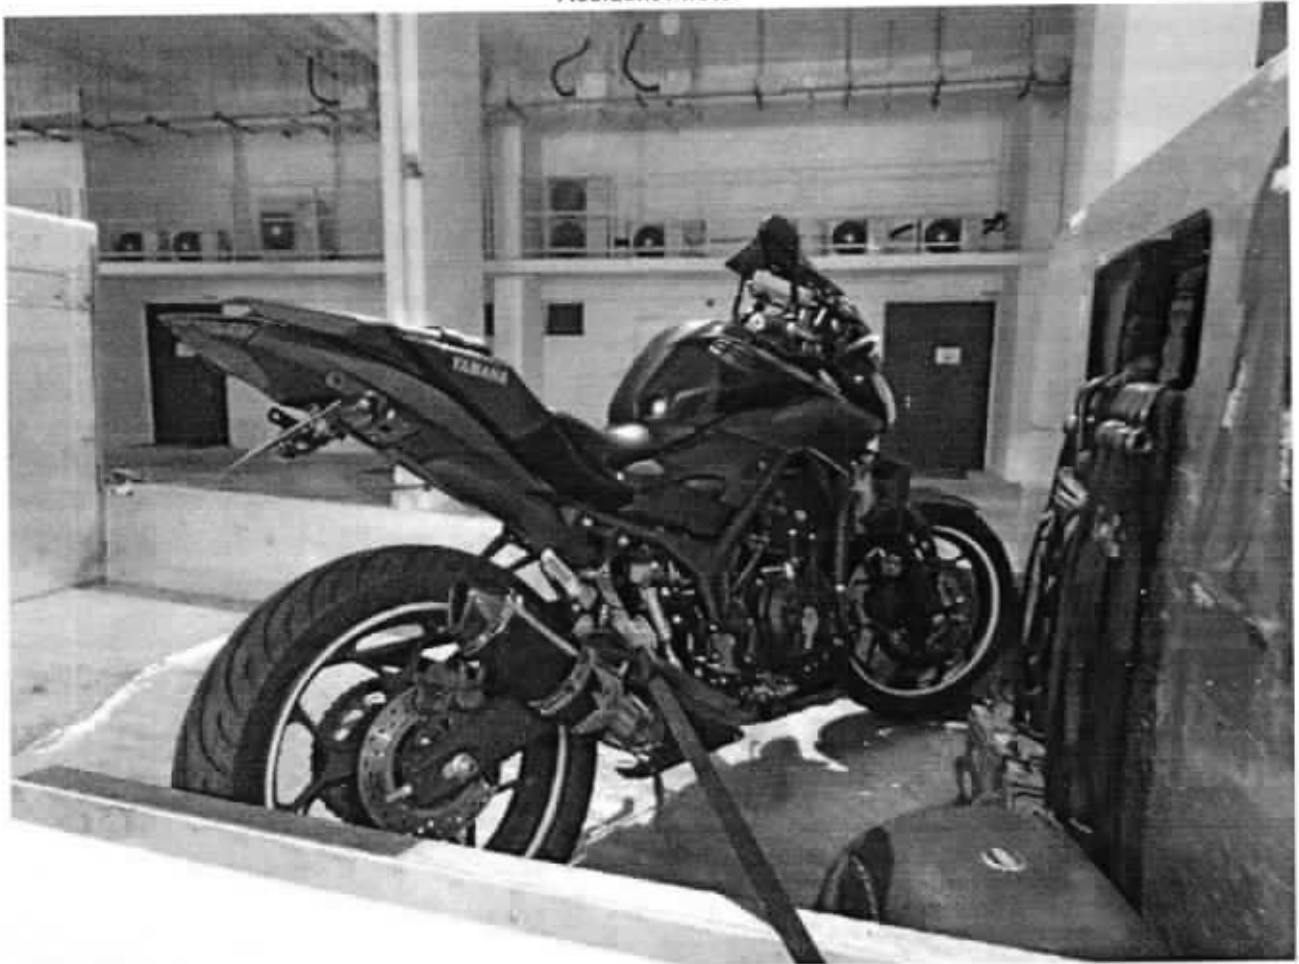
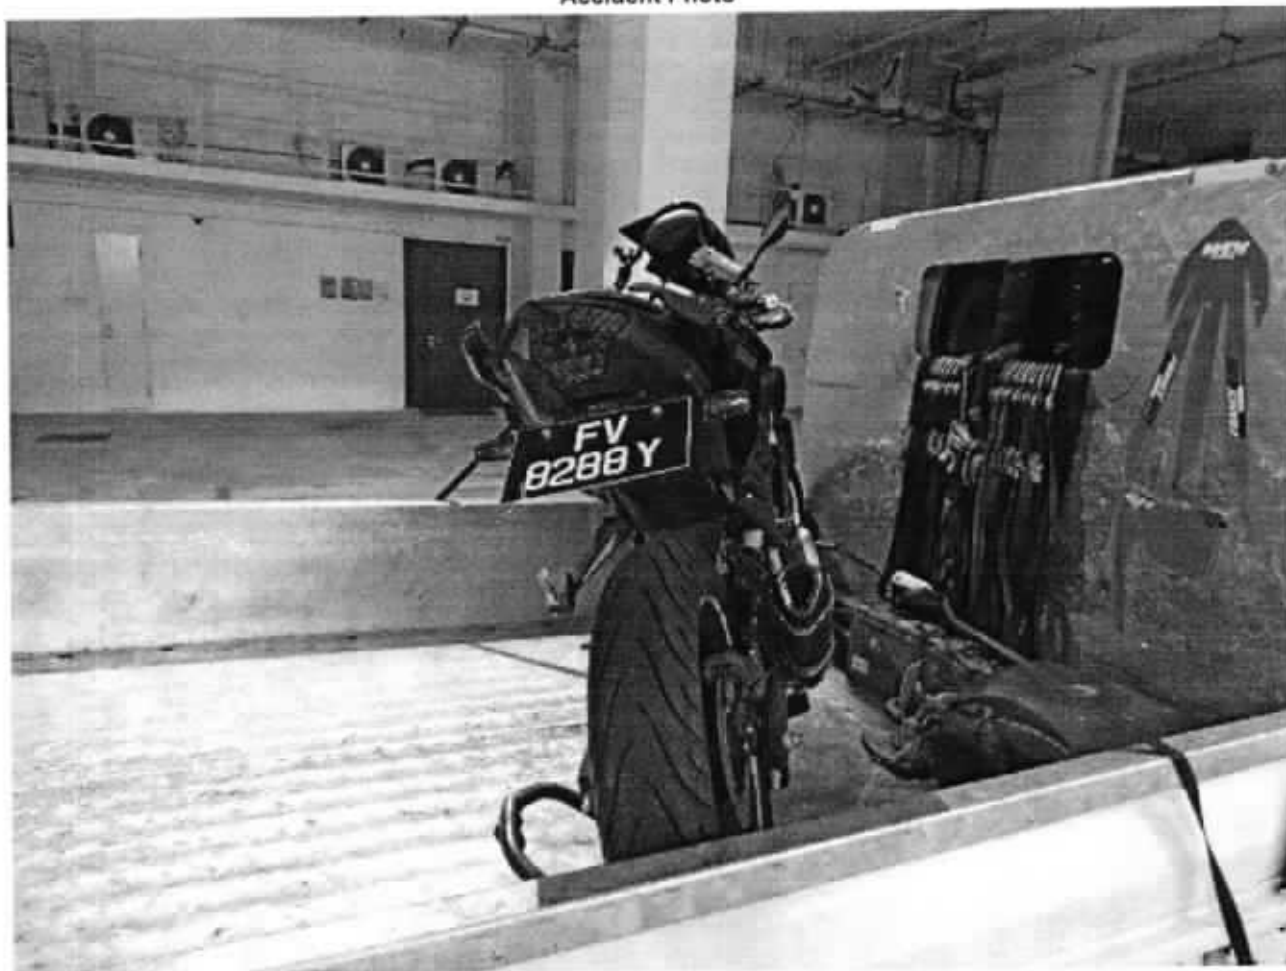
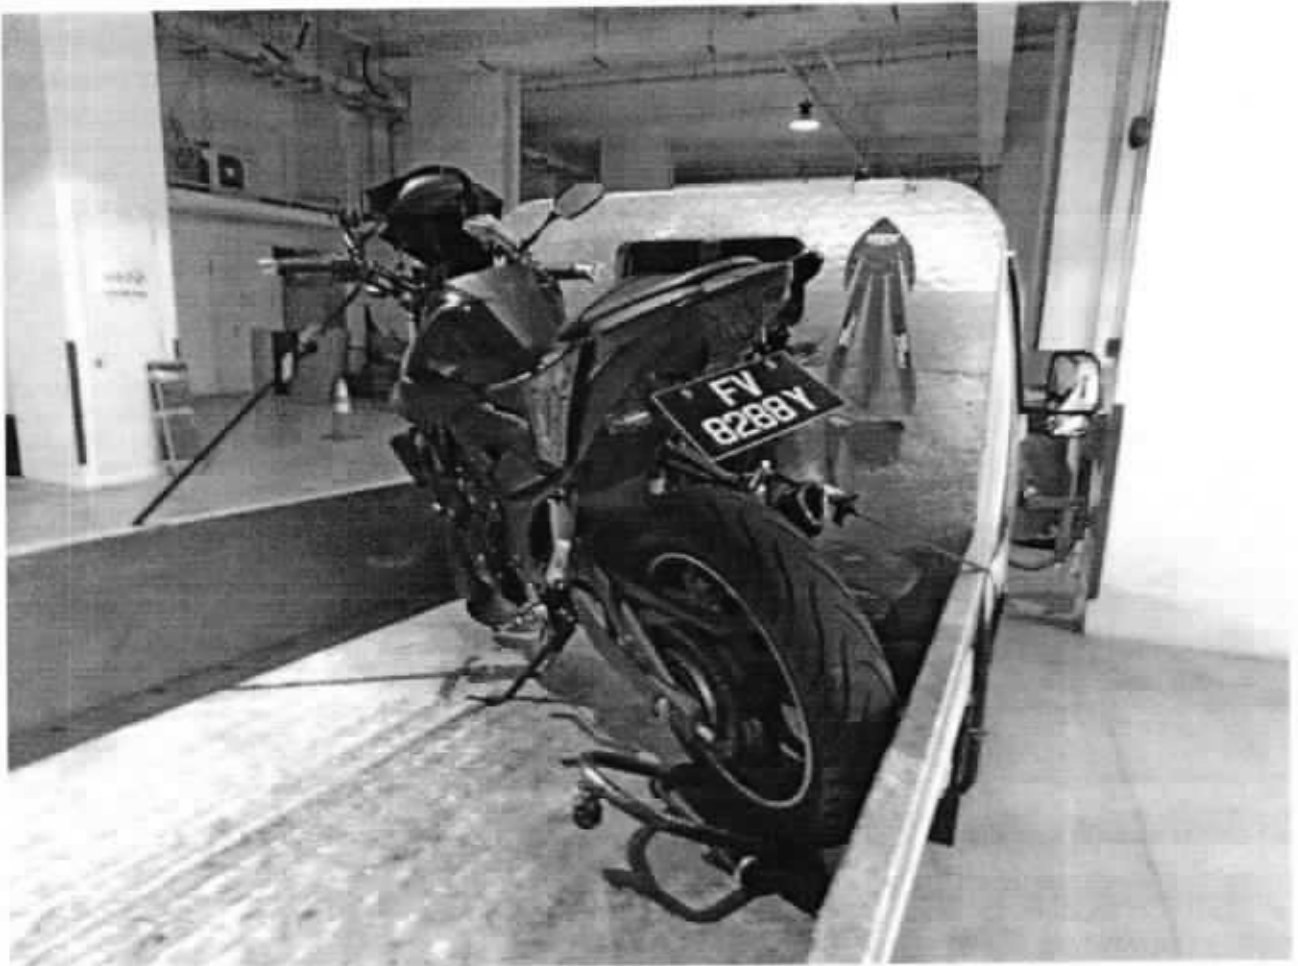
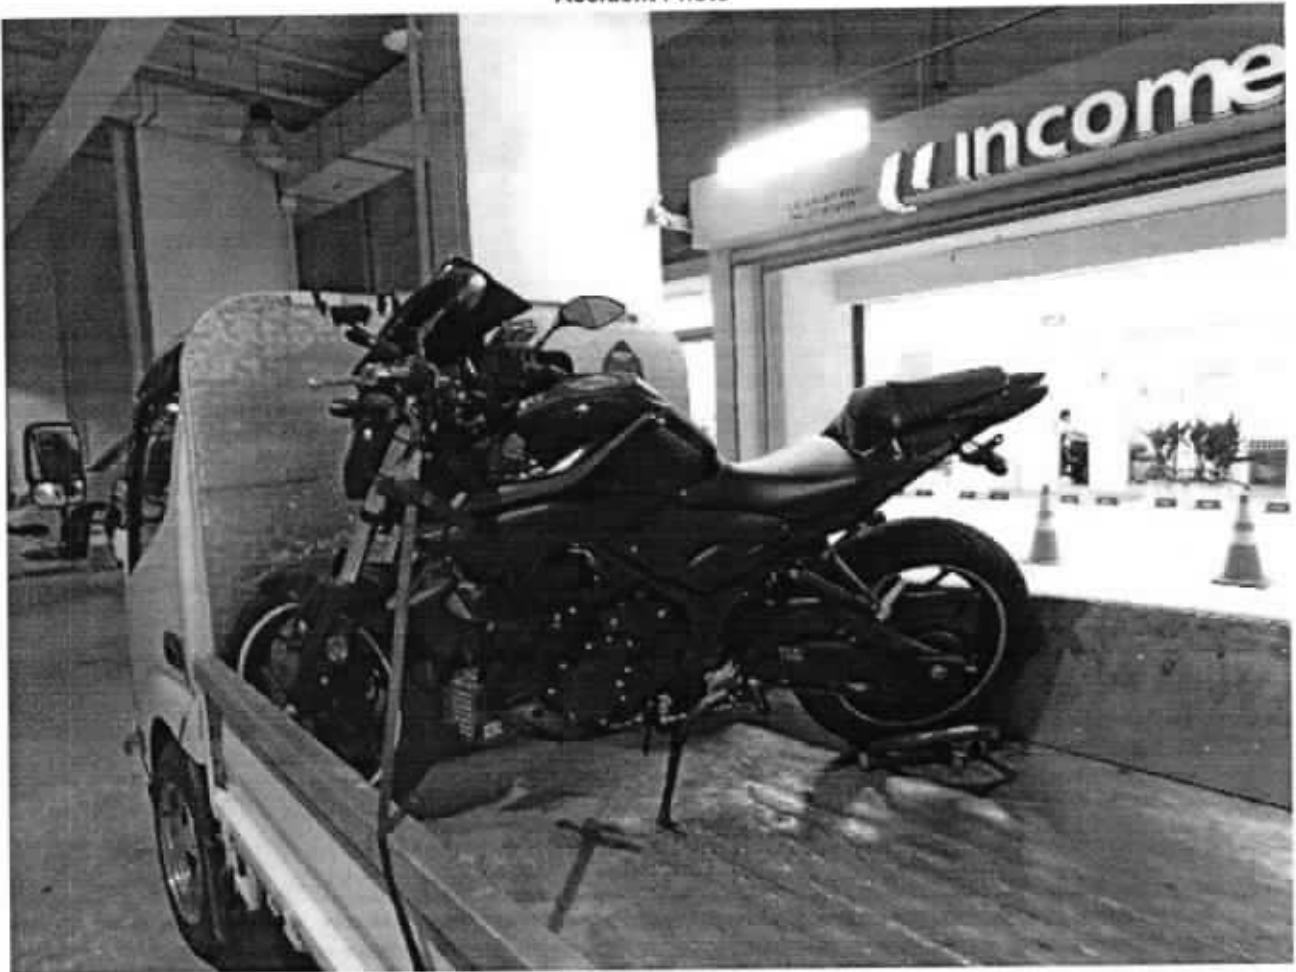
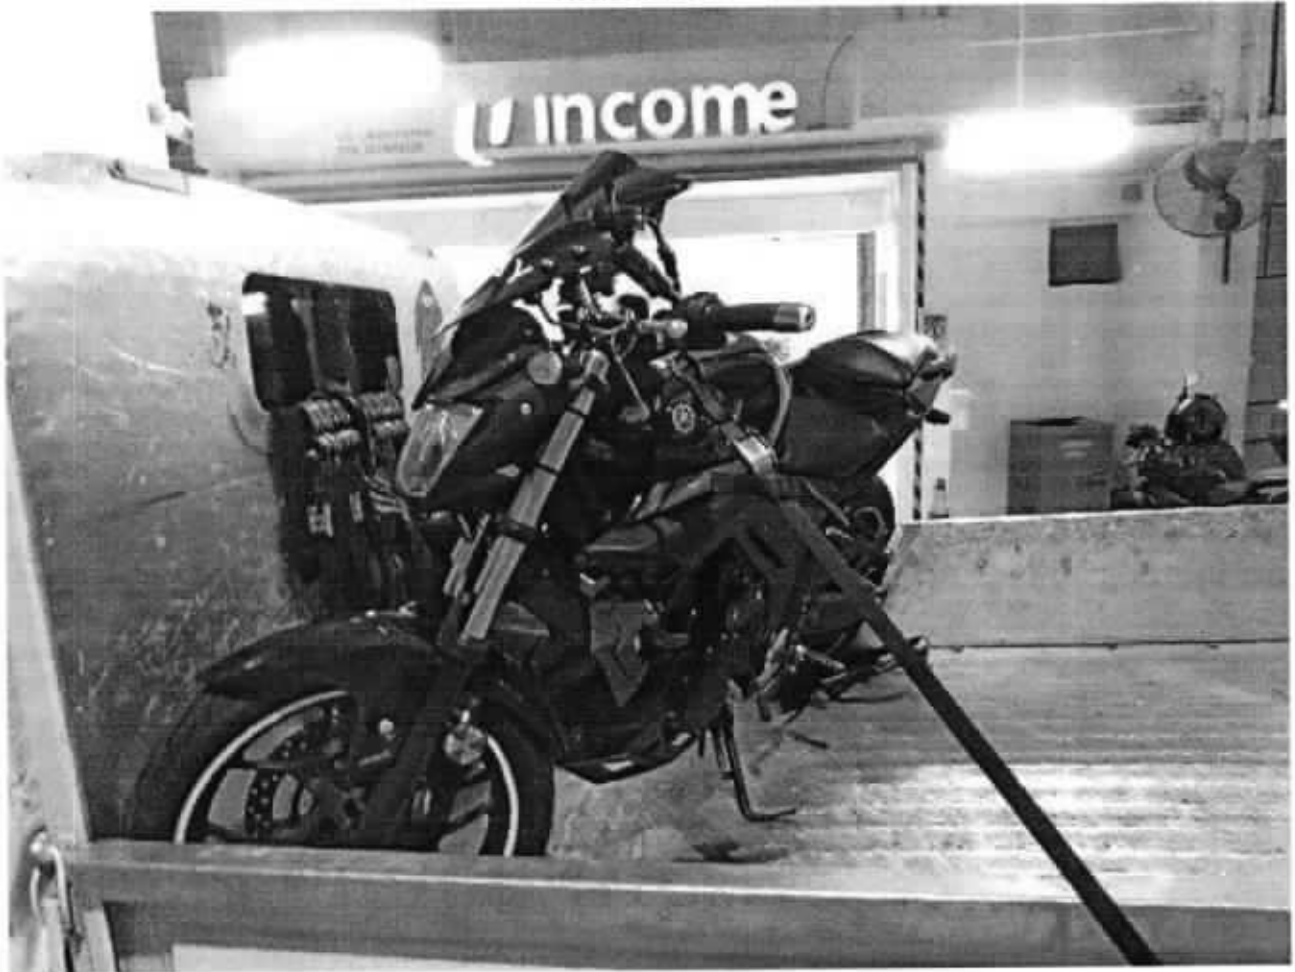
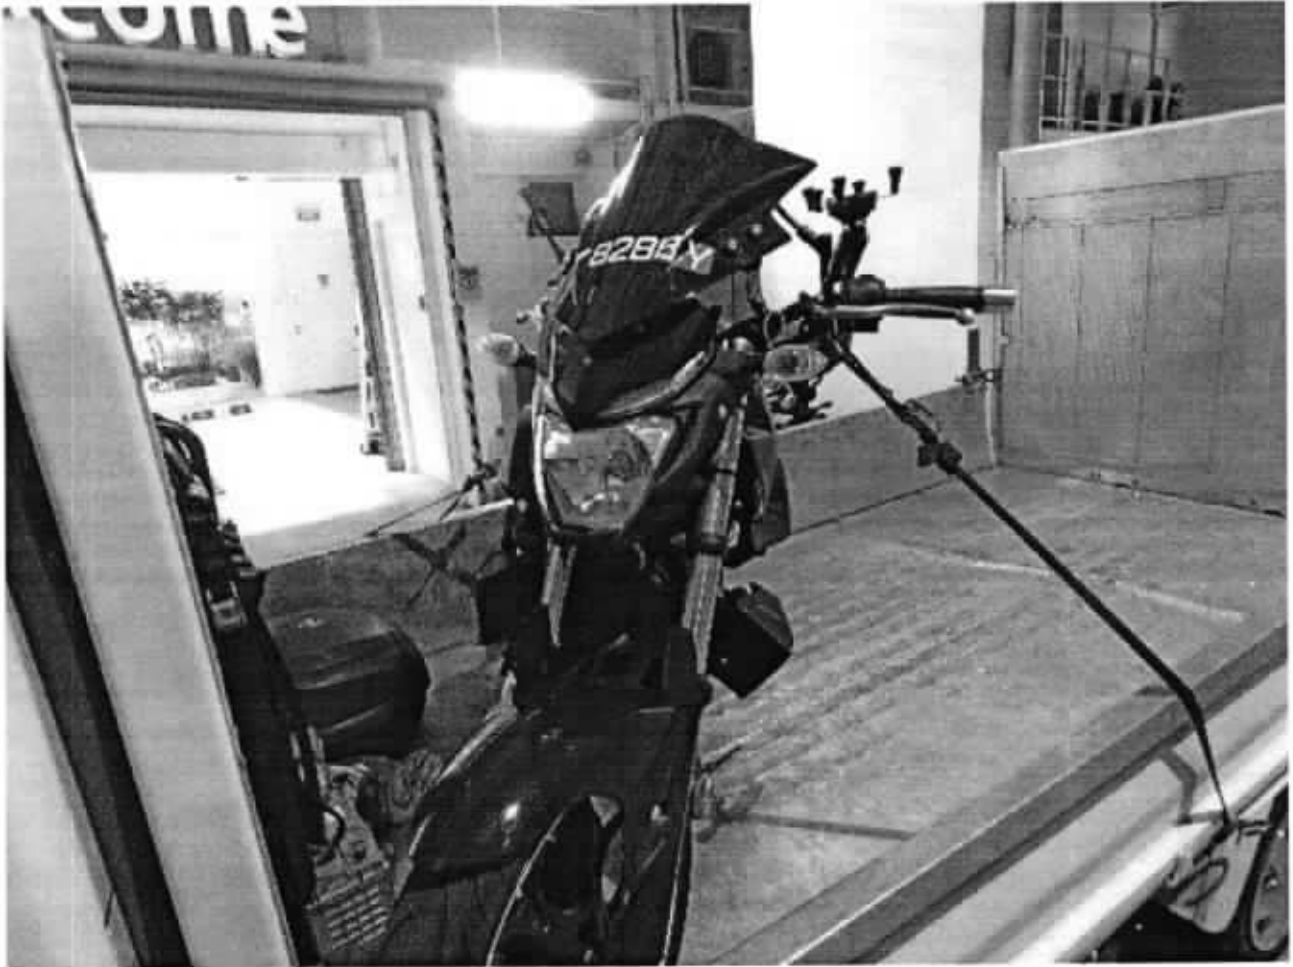
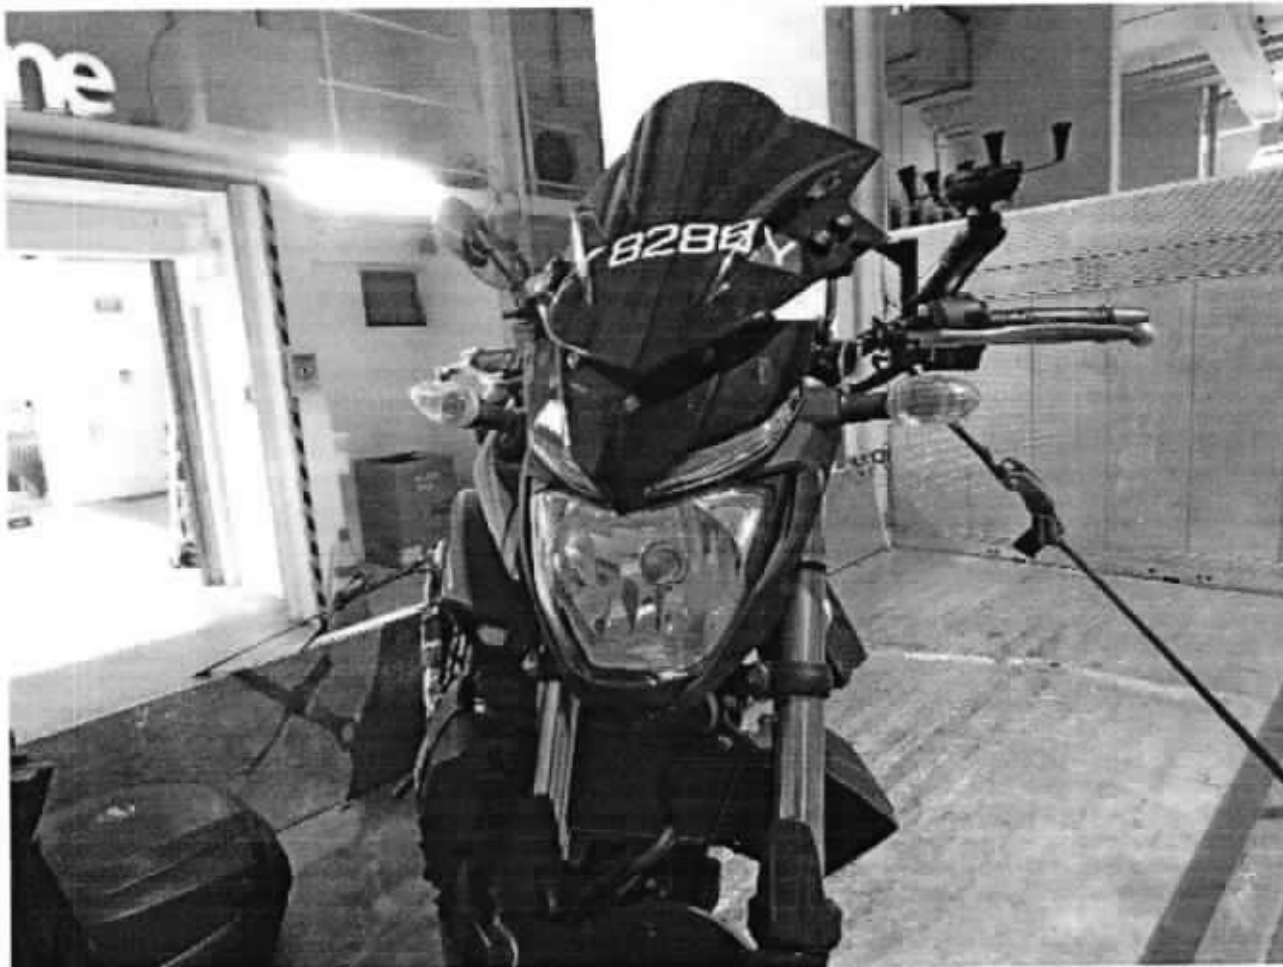
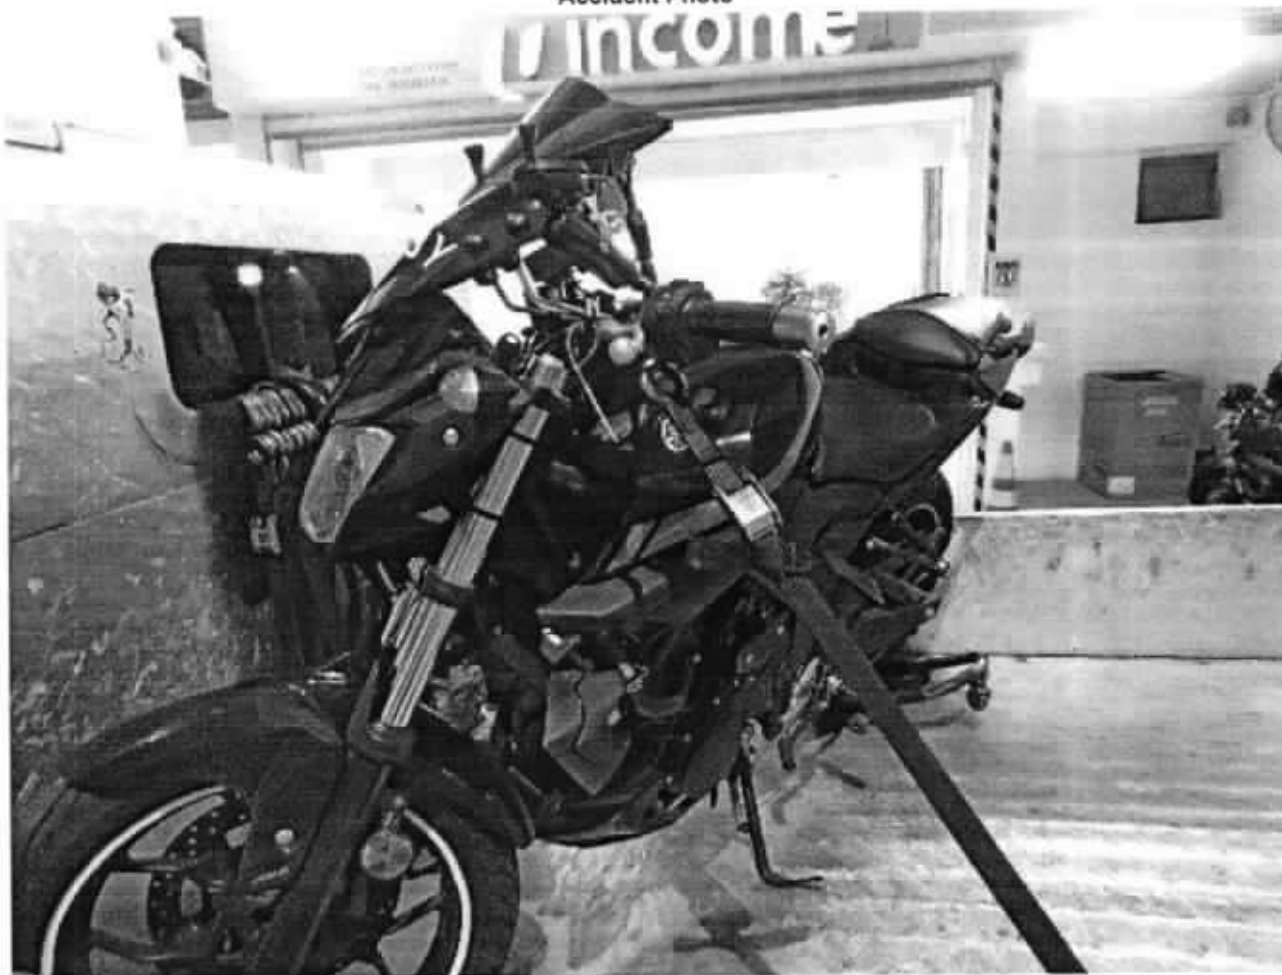
The vehicle sustained impact / damages o/s body and parts claimed are consistent to the accident.

No.	Qty	Part No.	Particulars	Condition	Repairer's	Amount
1	1		*TOP COWLING	Cut	180.00 F	*180.00 FL
2	1		*FRONT R/H SIGNAL LAMP	Cut	35.00 F	*35.00 FL
3	1		*FRONT BRAKE LEVER	Cut	65.00 F	*65.00 FL
4	1		*HANDLE BAR	Bent	65.00 F	*65.00 FL
5	1		*HEAD LAMP COVER	Cut	18.00 F	*18.00 FL
6	1		*HANDLE BALANCER	Cut	28.00 F	*28.00 FL
7	1		*GEAR LEVER	Missing	35.00 F	*35.00 FL
8	1		*R/H AIR INTEX	Cut	48.00 F	*48.00 FL
9	1		*RADIATOR	Not Necessary	260.00 F	*- FL
10	2		*R/H RADIATOR COVER	Cut	45.00 F	*45.00 FL
11	1		*R/H ENGINE COVER	Cut	180.00 F	*180.00 FL
12	1		*ENGINE OIL	Necessary	40.00 F	*40.00 FL
13	1		*CLUTCH GASKET	Necessary	12.00 F	*12.00 FL
14	1		*COOLING WATER	Not Necessary	25.00 F	*- FL
15	1		*FOOTREST ASSY	Missing	280.00 F	*250.00 FL
16	1		*EXHAUST PIPE	Cut	1,200.00 F	*1,100.00 FL
17	1		*R/H REAR FOOT REST	Cut	18.00 F	*18.00 FL
					<b>Sub Total (S\$)</b>	<b>2,534.00</b>
					<b>- List Item Discount on L Items 0.00/10.00% (S\$)</b>	<b>0.00</b>
