FBP 7578X

Honda - CB190X

From: Tan Kah Leong <KahLeong.Tan@sg.cntaiping.com>
Sent: Thursday, 2 January 2020 3:33 PM
To: alfred_ng@juseq.com.sg; 'assignments'
Subject: RE: ACCIDENT INVOLVING FBP7578X AND YP7251R ON 30 DECEMBER 2019.
Attachments: PRI FBP7578X.PDF

VEHICLE DAMAGE INSPECTION REPORT

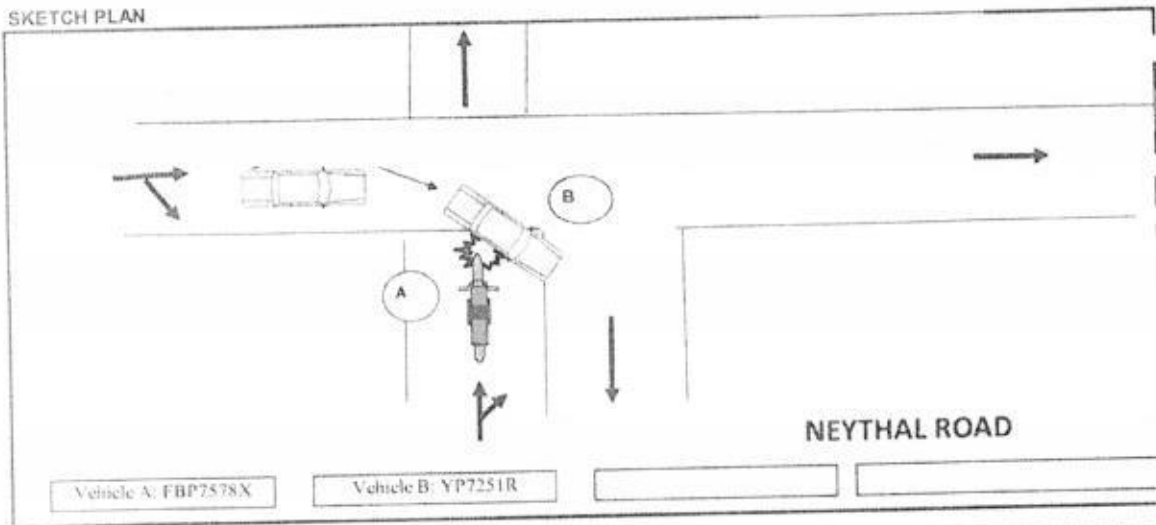
SKETCH PLAN

MY MOTORBIKE WAS STOPPED STATIONARY ALONG NEYTHAL ROAD. WHILE WAITING FOR MAIN TRAFFIC CLEARANCE, I SAW VEHICLE B TURNING IN AT A NARROW ANGLE. I SOUNDED MY HORN AT VEHICLE B BUT STILL VEHICLE B HIT ONTO MY MOTORBIKE FRONT PORTION. I THEN FELL TO THE RIGHT SIDE.
