To Inspect Vehicle No: XD 6545A

**Preliminary Advice**

Vehicle No	: XD6545A	Accident Date	: 07/01/2020
Make	: VOLVO FMX420	Policy No.	: DMCVSN1900161900
Assignment Date	: 08/01/2020	Excess	: S\$1,500.00
Date of Inspection	: 09/01/2020	Est. Duration of Repair	: 30 days
Inspection At	: Vfix Auto Service Pte Ltd (HQ) 26 Chia Ping Road Singapore 619977

## VEHICLE DAMAGE INSPECTION REPORT

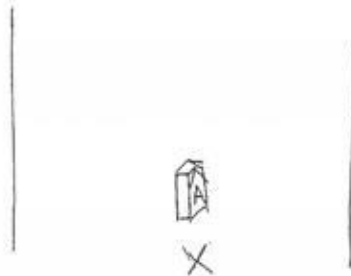
## SKETCH PLAN

Vehicle A - XD6545A

X - dropping soil material Area

On 7/1/2020 around 1300 hrs, vehicle A along Tuas Ave 5 (lamp post 3) construction site reverse and dropping the soil material suddenly vehicle A turn over to right portion. No one injury.
