VEHICLE DAMAGE INSPECTION REPORT

Our File No: CS/TM20001565/NYD3E2
Date: 12/02/2020

Handling Insurer: Tokio Marine Insurance Singapore Ltd	Policy No: MK000577
Claimant Vehicle No : SH2614Z	Insured Vehicle No : SLU9677K
Date of Loss: 27/01/2020	Nature of Claim: TP Claim No: M2000701

Reg No: SH2614Z	Engine No: G4LEJU184183
Make & Model: HYUNDAI AE IONIQ HEV DCT, 1.6 (A)	Chassis No: KMHC851CVKU139871
Reg. Date: 01/03/2019 (Man. Year: 2018)	Odometer: 104916 km
Colour: Blue	
Engine Capacity: 1580 cc	
Market Value/New Car Price: N/A	
Sum Insured (S\$): Market Value/New Car Price

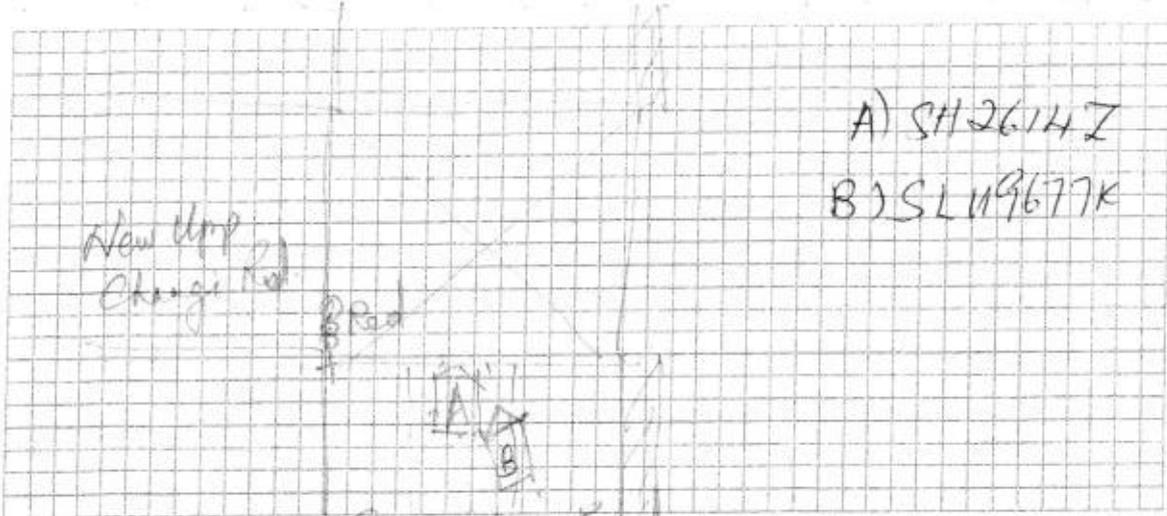
Sketch Plan Pg. 2

On 27/1/20 at about 1230hrs when I Veh. A stopped at the traffic junction upon seeing the red light, Veh B collided onto the rear right ^{Rear} portion of my vehicle

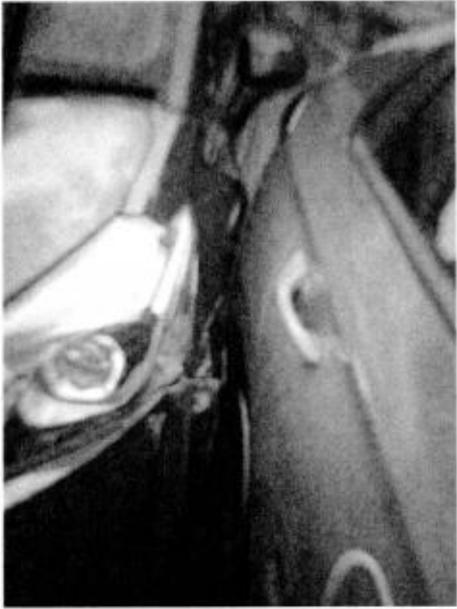
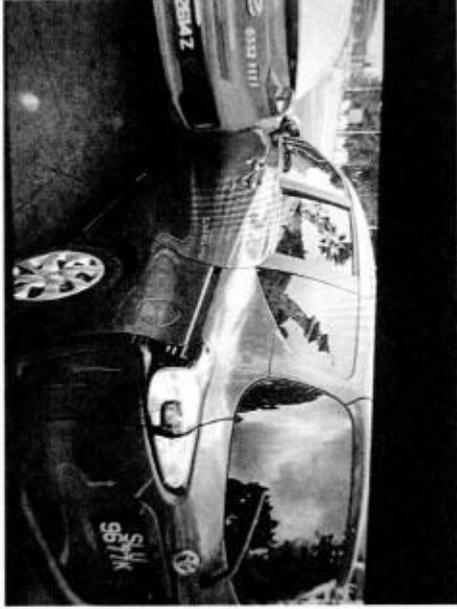
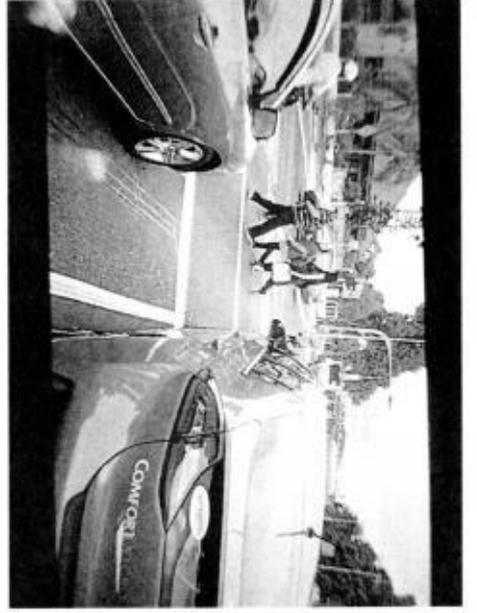
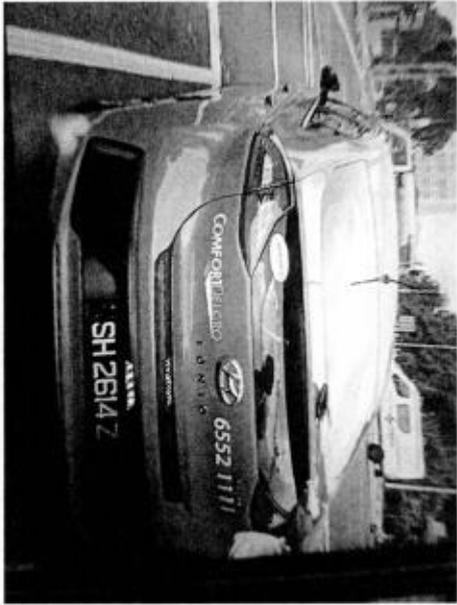
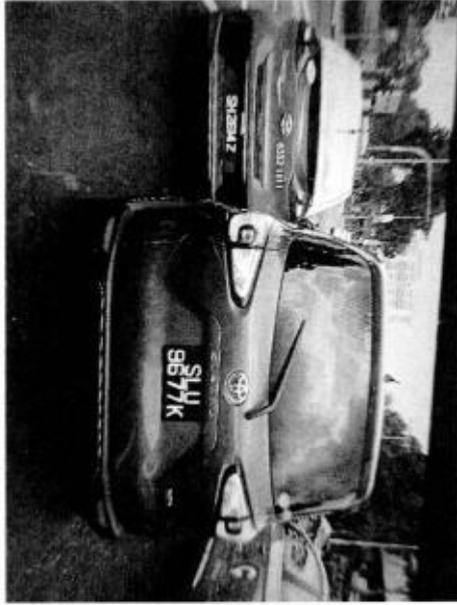
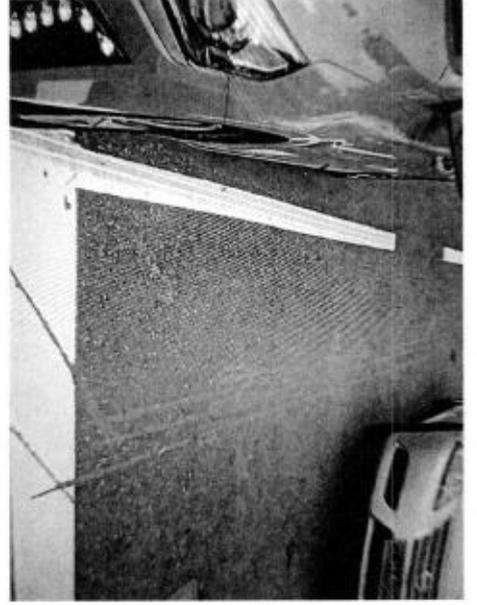
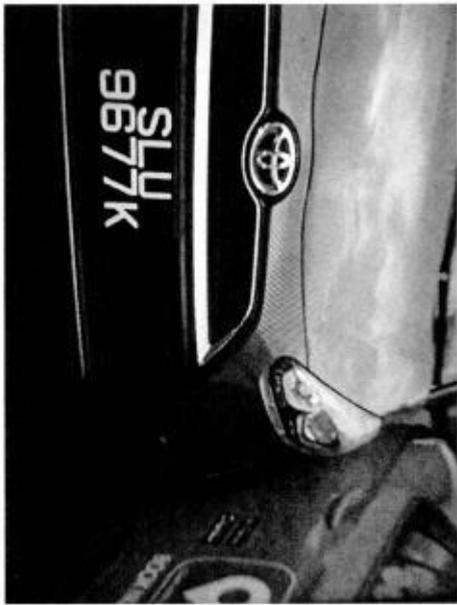
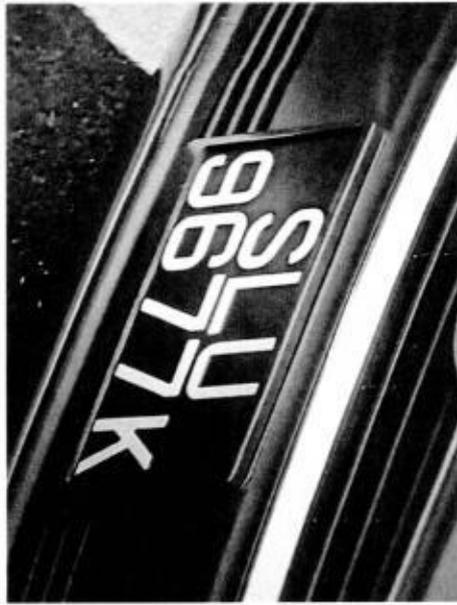
Remark: The veh had commenced its repair at the time of inspection.

Survey held at EDGE COVANGT
 Dis. of Damages: Frt / Rear / O/S / N/S / U/C / Roof/Top or
O/S REAR

The U/C / Chassis frame / Body Structure effected due to collision

No.	Qty	Part No.	Particulars	Condition	Repairer's	Reference	Amount
1	1		*REAR BUMPER	Cracked	459.40 FL	-	*459.40 FL
2	1		*REAR BUMPER CENTER MOULDING	Serviceable	451.25 FL	-	*. FL
3	1		*REAR BUMPER LOWER MOULDING	Serviceable	155.00 FL	-	*. FL
4	1		*REAR BUMPER REVERSE SENSOR	Serviceable	135.70 FS	-	*. FS
5	1		*REAR BUMPER MAT	Necessary	50.00 FS	-	*50.00 FS
					Sub Total (\$\$)	1,251.35	509.40
					- List Item Discount on L Items 20.00/20.00% (\$\$)	213.13	91.88
					Total Parts (\$\$)	1,038.22	417.52
