SHD8555Y

**Preliminary Advice**

Insured Vehicle No	: SLK9832G	Accident Date	: 27/01/2020
TP Vehicle No	: SHD8555Y	Assignment Date	: 29/01/2020
Make	: HYUNDAI I40	Est. Duration of Repair	: 3 days
Date of Inspection	: 29/01/2020		
Inspection At	: ComfortDelGro Engineering Pte Ltd (Loyang) 59 Loyang Drive Singapore 508969

### VEHICLE DAMAGE INSPECTION REPORT

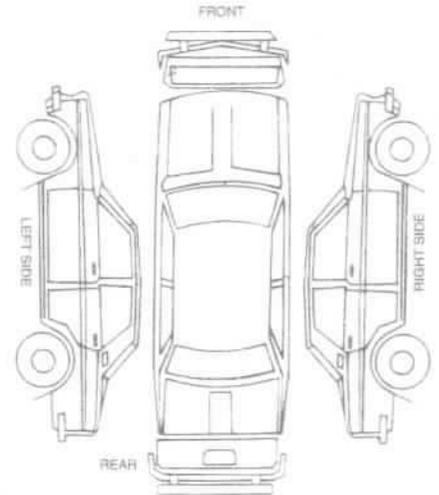
TOKIO - Right Front

The vehicle sustained impact / damages o/s front portion and parts claimed are consistent to the accident.

Finalized Lump Sum Repair \$3,050 / 3 Repair Days subject to insurance approval.

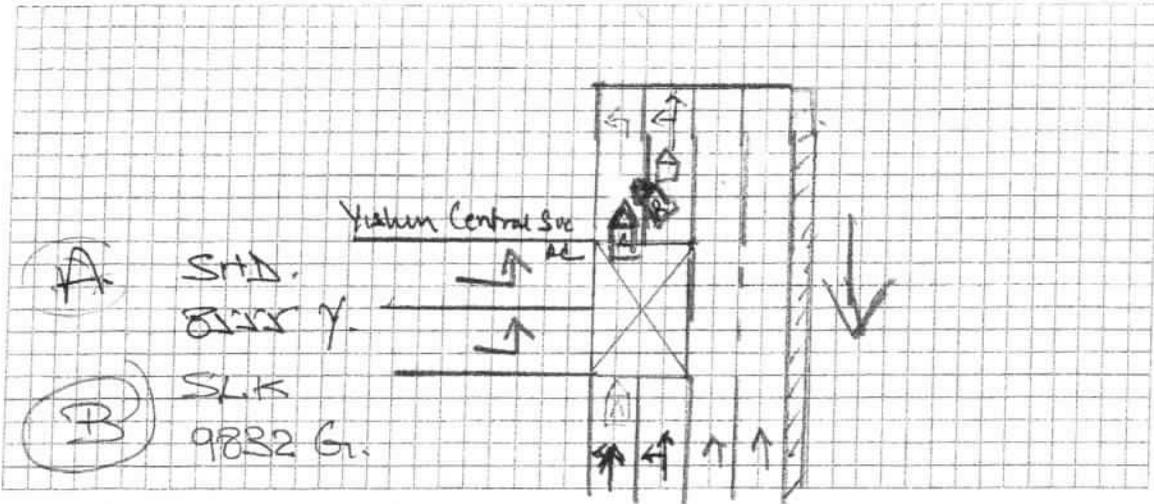
Sketch Plan Pg. 1

DESCRIBE CIRCUMSTANCES OF THE ACCIDENT

On 27 Jan 2020 @ 1800 hr I, veit A  
 corinhat stop.  
 Slow down B4 Box Junction due Red light  
 once I veit (A) notice vehicle in front  
 make my lane was clear suddenly veit  
 (B) 3rd lane cut across to my lane  
 I veit (A) cannot stop intime all  
 collide with veit (B) @ the point  
 of accident veit (A) ferry ferry  
 a female passenger seat injure.
