**ASSIGNMENT**

Des. of Damages: Frt / Rear / O/S / N/S / U/C / Rooftop or  
The U/C / Chassis frame / Body Structure affected due to collision.

Insured:			
Main Claimant:	<b>SITT WEI HONG LEX</b>		
Vehicle Reg. No.:	<b>SMP1375Z</b>	Date of Loss:	25/01/2020 14:00 - :59
Claim Type:	<b>TP / SNM20D200541C02</b>	Policy/Cover Note No.:	DMPCSN30293519066
Vehicle Reg. No. (Insured):	<b>SJX2297C</b>	Policy No. (Claimant):	
		Excess:	S\$0.00
Repairer:	<b>Z-One Automotive Pte Ltd (HQ)</b> 1 Kaki Bukit Avenue 6, Blk D #01-87, Autobay @ Kaki Bukit, 417883 Kaki Bukit - Tel: 6634 2112		
Handling Insurer:	<b>China Taiping Insurance (Singapore) Pte. Ltd. (HQ)</b> - Tel: 6389 6111 ... [Handled by <b>Irene Tay Hui Ping</b> - 638986192]		
Adjuster:	<b>LKK Auto Consultants Pte Ltd (HQ)</b> - Tel: 6256-3561 ... <b>[Final Rpt due 11/02/2020]</b>		
Adj Asg. Remarks:	PLEASE SURVEY AND REVERT

## VEHICLE DAMAGE INSPECTION REPORT

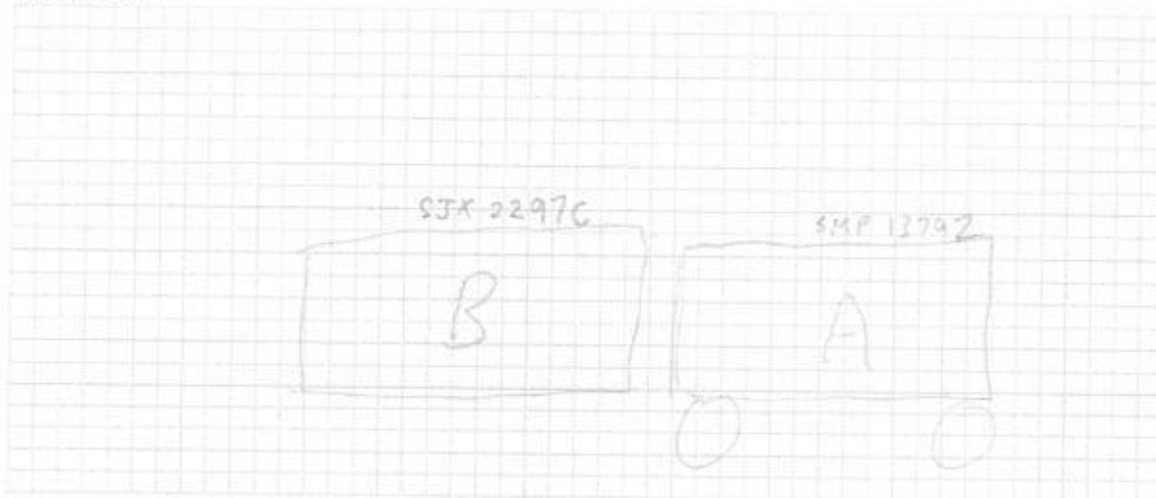
## SKETCH PLAN

- I was driving <sup>straight</sup> ~~on~~ MCE <sup>forwards</sup> ~~backwards~~ the Fort Road exit on the lane 3.
- While I was driving, I saw the car bang ~~was~~ at the back of ~~the~~ car.
- Suddenly, there was an impact at the back of my car.
