PRE-REPAIR INSPECTION - ACCIDENT INVOLVING OUR INSURED VEHIC...

**ACCIDENT INVOLVING GBJ 7712G / GT 3333G ON 21.01.2020 ALONG TIONG BAHRU ROAD
TOWARDS GREAT WORLD CITY**

VEHICLE DAMAGE INSPECTION REPORT

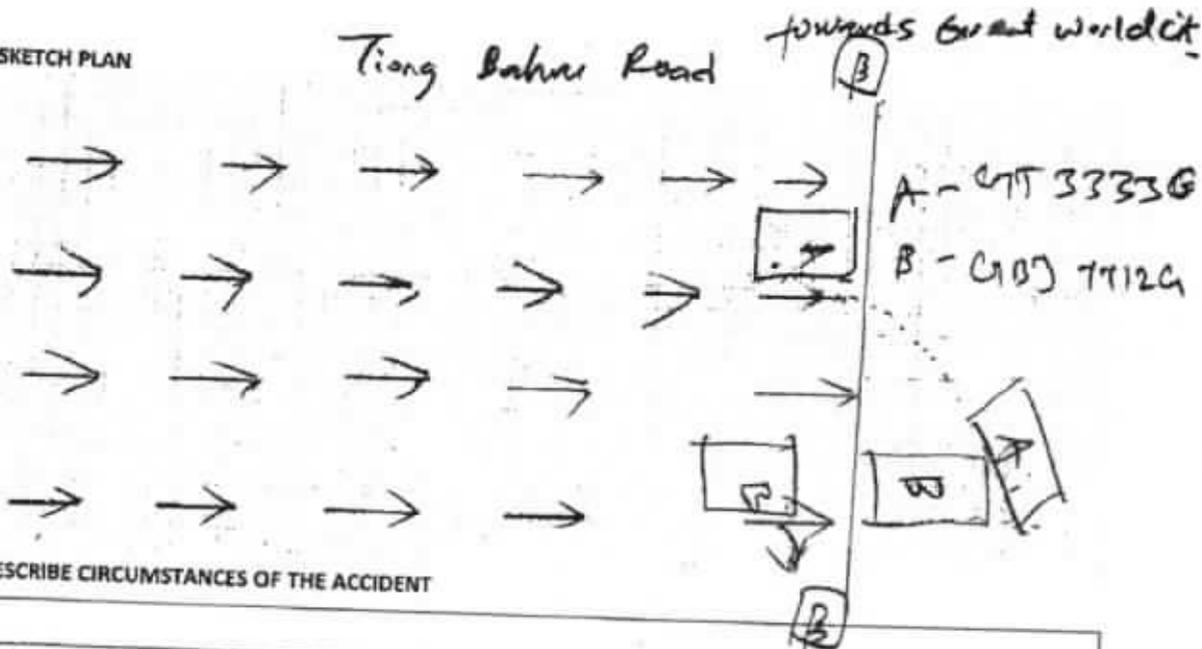
SKETCH PLAN

DESCRIBE CIRCUMSTANCES OF THE ACCIDENT

The accident happened on 21/1/2020 about 2-20pm along Tiong Bahru Road on my lane. The other vehicle (A) CGT 3333G suddenly turned and cut into my lane and braked onto my vehicle (B) CGJ 7712G and on the left hand side.
