AUTOMOTIVE ENGINEERING &amp; MGT DIVISION Ref : CS/SPF20002164/Ktf3e2

**1. Policy Particulars :- THIRD PARTY CLAIM**

THE VEHICLE SUSTAINED DAMAGES AT THE FRONT N/S PORTION. DAMAGES SEE DETAILS.
---

### ADJUSTMENT ON REPAIR COST FOR VEHICLE NO. PC 4641T

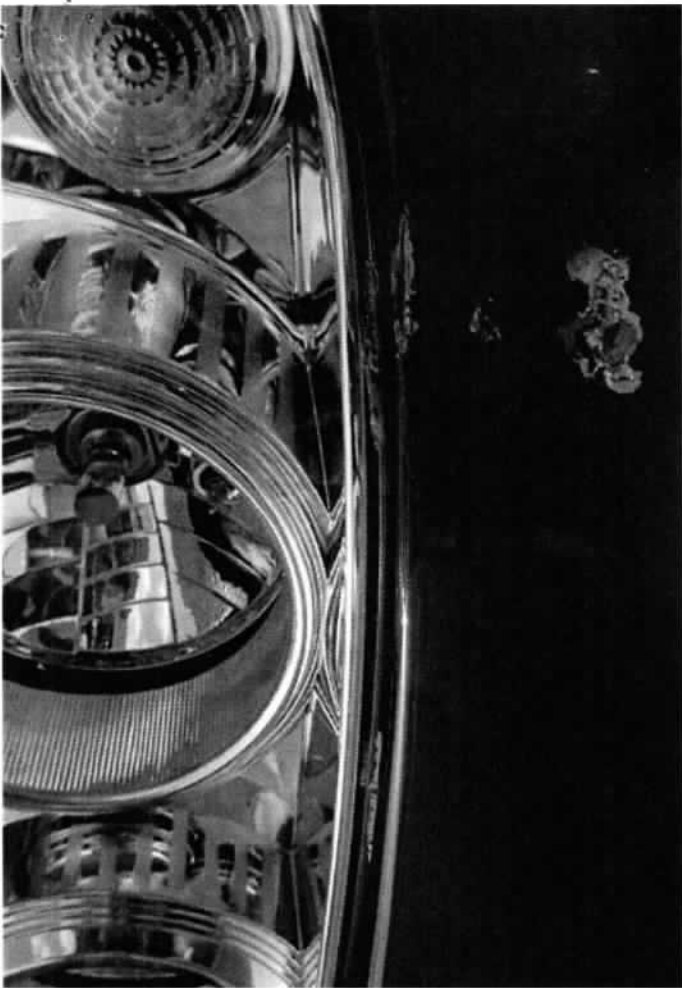
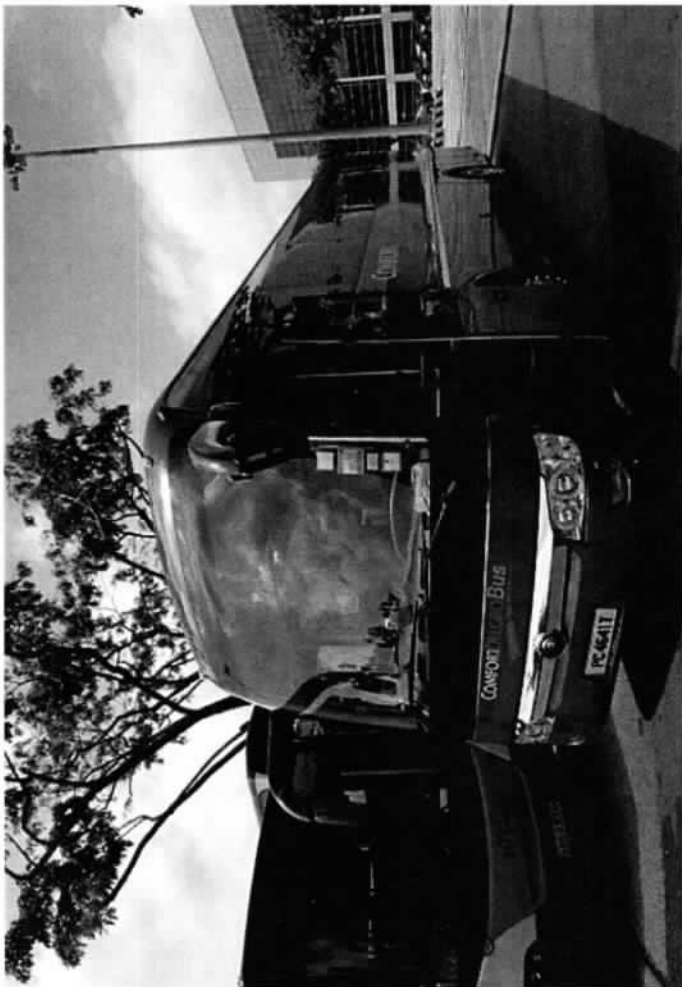
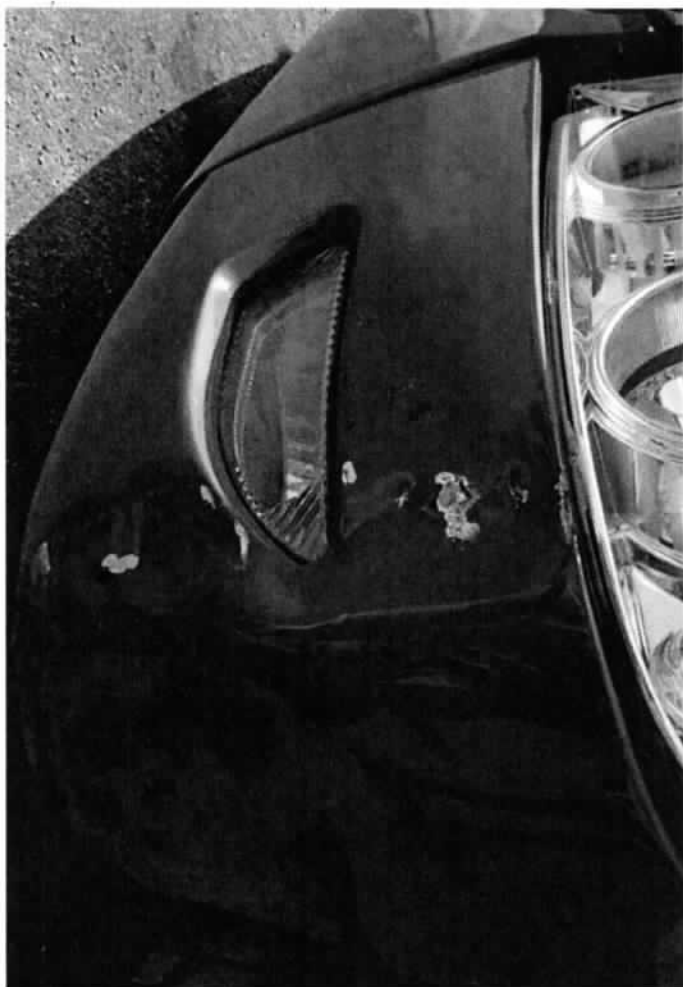
Qty	Description of Parts	Condition	Estimate By Workshop (\$)	Our Adjusted (\$)
	<b><u>REPLACEMENT OF PARTS</u></b>			
1	HEADLAMP LH	CRACKED	580.00	580.00
1	LH WING MIRROR	CRACKED	460.00	460.00
	LESS 10% DISCOUNT		-104.00	-104.00
			936.00	936.00
	<b><u>SPECIAL NETT ITEMS</u></b>			
1	STICKER 'COMFORTDELGRO' (SN)	NECESSARY	200.00	150.00
			200.00	150.00
	<b><u>LABOUR</u></b>			
	TO KNOCK, STRAIGHTEN AND RENEW ACCIDENT AREA SUCH AS HEADLAMP LH, LH WING MIRROR, FRT BUMPER LH SIDE, FRT LOWER DOME AND ETC.		1,200.00	960.00
	TO PUTTY AND RESPRAY ACCIDENT AREA SUCH AS LH WING MIRROR AND FRT BUMPER LH SIDE, FRT LOWER DOME AND ETC.		1,000.00	750.00
	TO CHECK LIGHTING AND WIRING.		50.00	30.00
			2,250.00	1,740.00
	<b>GRAND TOTAL</b>		<b>3,386.00</b>	<b>2,826.00</b>
<b>RECOMMENDED COST OF REPAIRS</b>				<b>2,826.00</b>

NOTES : THE ESTIMATED UPPER RANGE OF REPAIR COST FOR THE DAMAGED VEHICLE IS IN THE REGION OF \$2,826-\$3,000
