**From:** Veron Chen (LKKAUTO)  
**Sent:** Monday, 27 April 2020 4:14 PM  
**To:** Hsiao Tong (LKKAUTO); Zuhaidah Samsuri; SUR  
**Subject:** RE: MCT20020212/ LKK REF: CS/III20002602/Kvd3n2 -SMN 3538T

**Subject:** MCT20020212

| Reg No: | <b>SMN3538T</b> |
| Make & Model: | MERCEDES-BENZ C180, 1.6 Kompressor (A) |

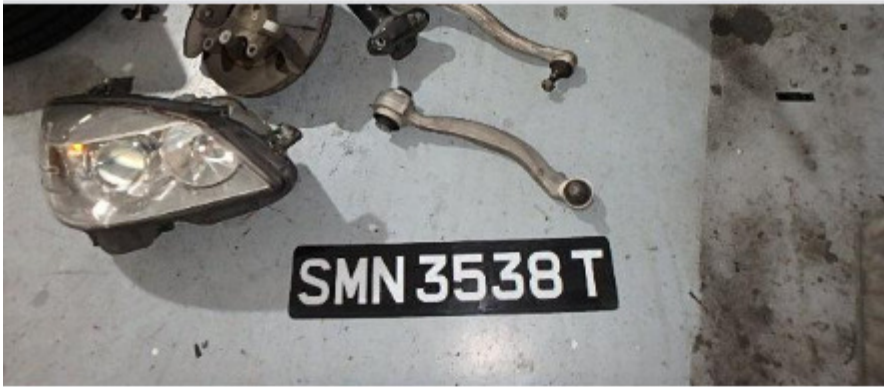
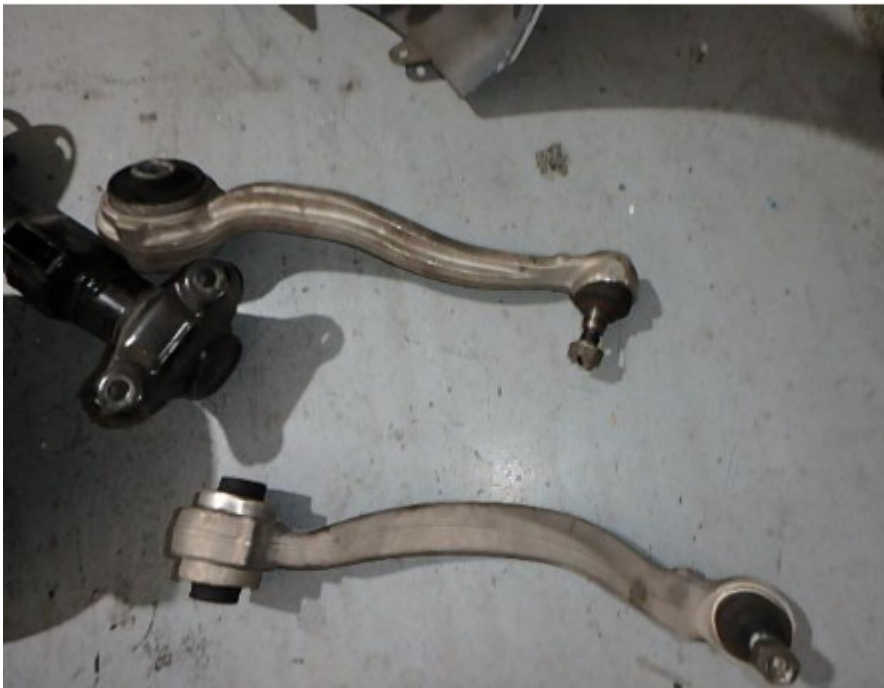
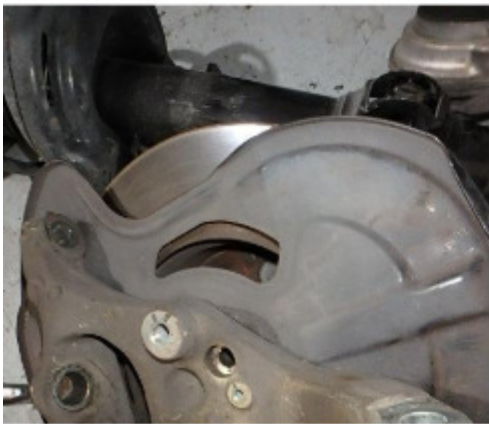
According to surveyor, after going through the damaged photos, his opinion that the repair cost is reasonable. The front right wheel rim was found with marks of grazing nature, due to contact with the taxi. Undercarriage items affected as a result of the contact.

**But could we request for TP CCTV footage – not sure if I ma with LKK that the TP Mercedes 2010 has sustained such extensive damages to its vehicle - wheel hub etc can be damaged ??**

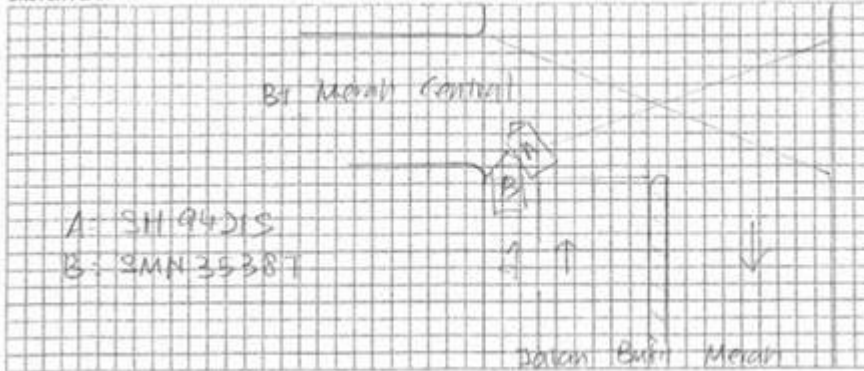
SKETCH PLAN

| On 10/02/2020 at about 14:00 hrs, I veh A |
| made a left turn at above road location after I |
| checked traffic is clear. In the process, my taxi left |
| front portion came into slight collision onto veh B |
| front right portion. No passengers in my taxi. No |
| injury reported in this accident. |
