### 1. Policy Particulars :- THIRD PARTY CLAIM

### 2. Vehicle Particulars & Condition

### 4. Description of Damages

**ADJUSTMENT ON REPAIR COST FOR VEHICLE NO. SHC 3512J**

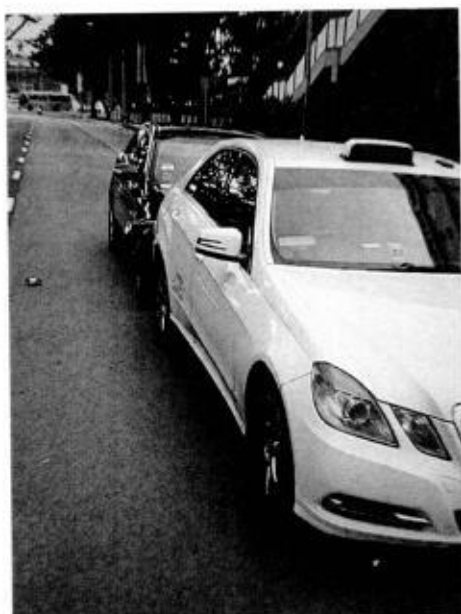
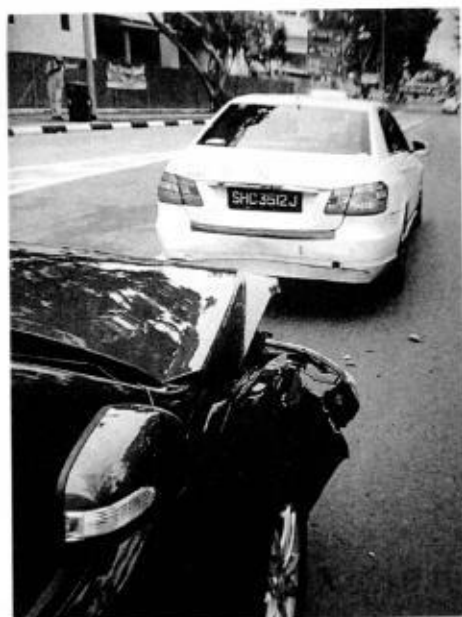
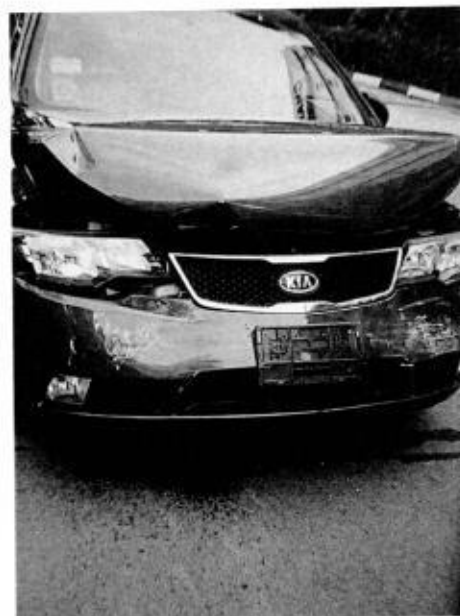
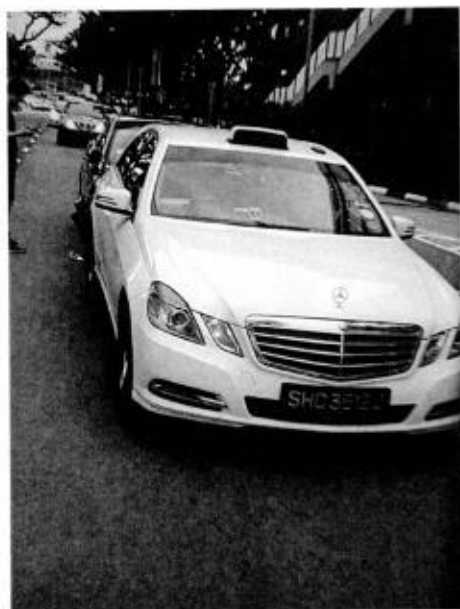
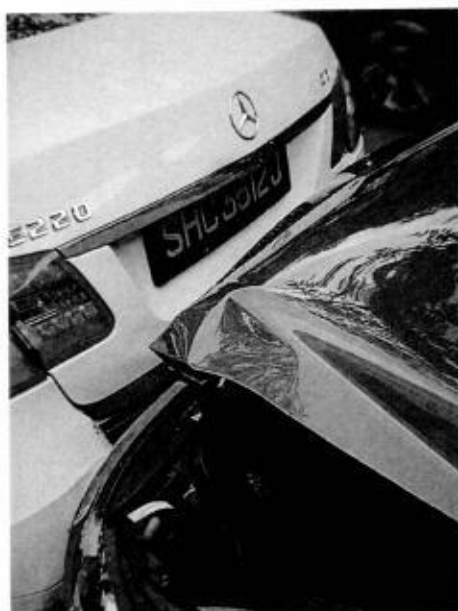
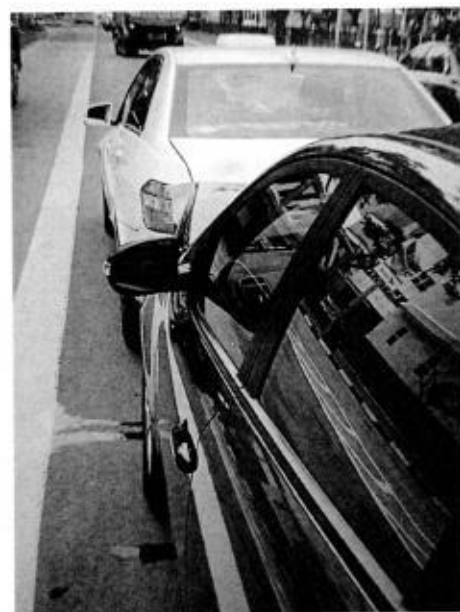
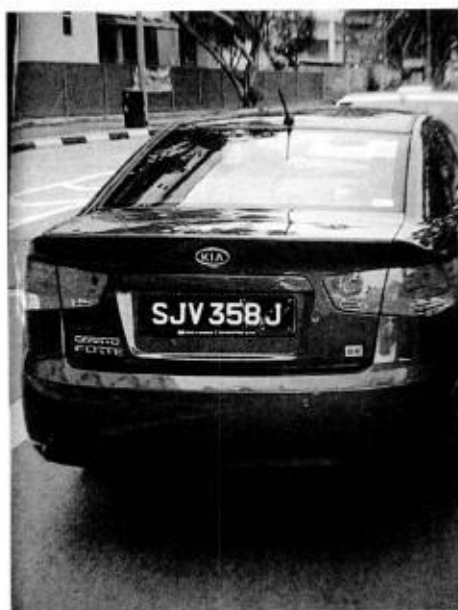
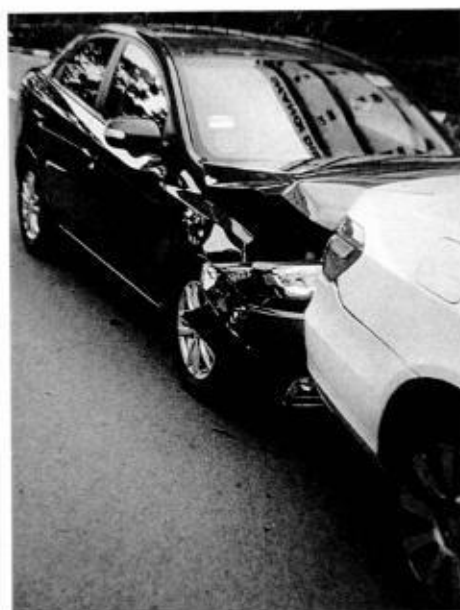
The U/C / Chassis frame / Body Structure affected due to collision.

THE VEHICLE SUSTAINED DAMAGES AT THE REAR PORTION. DAMAGES SEE DETAILS.
--

Qty	Description of Parts	Condition	Estimate By Workshop (\$)	Our Adjusted (\$)
	<b><u>REPLACEMENT OF PARTS</u></b>			
1	BOOTLID	DENTED	2,470.00	2,470.00
1	BOOTLID LOCK	NOT NECESSARY	275.00	-
1	BOOTLID STRICKER	NOT NECESSARY	90.00	-
1	BOOTLID E 220 EMBLEM	NECESSARY	54.30	54.30
1	BOOTLID STAR LOGO	NECESSARY	45.00	45.00
1	REAR BUMPER ASSY	CUT / CRACKED	1,510.00	1,510.00
1	REAR BUMPER REINFORCEMENT	BENT	1,150.00	1,150.00
1	REAR BUMPER LOWER COVER	SCRATCHED / DEFORMED	325.00	325.00
2	REAR BUMPER BRACKET LH/RH @\$135.00	NOT NECESSARY	270.00	-
1	REAR PANEL END	NOT NECESSARY	1,380.00	-
1	REAR PANEL GARNISH	NOT NECESSARY	240.00	-
1	BOOTLID CDI EMBLEM	NECESSARY	54.30	54.30
	LESS 20% DISCOUNT		-1,572.72	-1,121.72
			6,290.88	4,486.88
	<b><u>SPECIAL NETT ITEMS</u></b>			
1	REVERSE SENSOR (SN)	DAMAGED	388.00	388.00
1	BUMPER MAT (SN)	NECESSARY	50.00	50.00

RECOMMENDED COST OF LUMP SUM REPAIRS (TO ITS PRE-ACCIDENT CONDITION) (CONFIRMED)			4,900.00
--	--	--	----------
